## **SCHEDULE OF CONDITION**

The Old Post Office and attached house, West Ashling,  
Chichester

June 2017

**JULIAN RA LIVINGSTONE CHARTERED ARCHITECT**

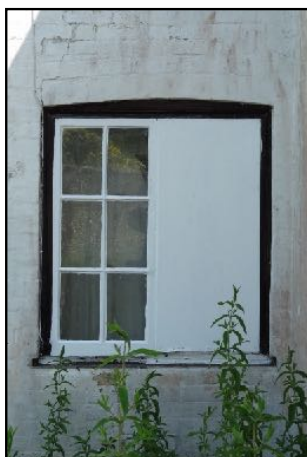
**West face South ground floor window**

Cill rotted away; right-hand casement missing and left-hand casement painted shut; glazing putty failing

B

Remove casements and window frame; make new cill and scarf in sections of new jambs; make new casement and ease out existing; clean off, re-putty and re-fit; redecorate all round

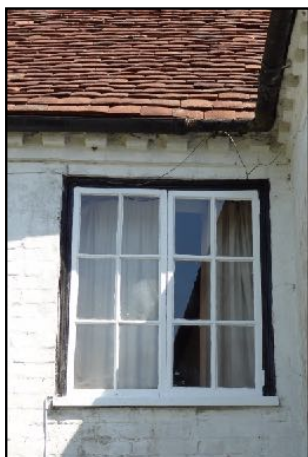
## West face, South first floor window

Cill appears to have new section fixed to face of existing; frame jambs rotting; Casements painted shut; left-hand casement bottom rail rotted and open joints to junctions with styles; glazing putty failing

B

Remove casements and remains of frame, construct new frame and cill; scarf in new sections of casement bottom rail; re-glue joints remove glazing putty where failing and re-putty; redecorate and re-fit.

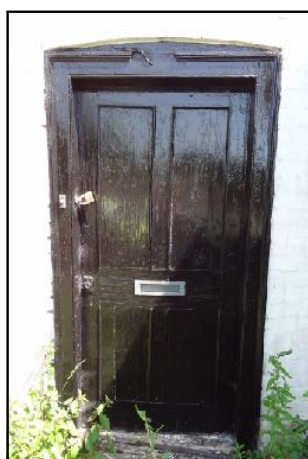
## West face, Front door

Door cill rotten and threshold bar loose; door frame jambs rowing at base; joints in door panels open; moulding missing at head; ironmongery missing or inappropriate

B

Remove door and re-build door frame inserting new cill and threshold bar; scarf in new sections to jambs and head; re-glue joints in panelling; overhaul ironmongery and fit new where the existing is damaged or missing; redecorate door and frame

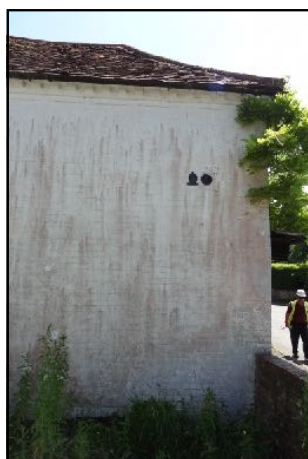
## North face, Post office

Roof tiling and batten nails rusting and slipping; gutter failing and gutter brackets missing at West end and decorations poor; wall decorations poor; cellar ventilation grill broken and coffer blocked

A

Strip roof tiling and battens and replace; strip gutters, repair brackets, shot blast ironwork, re-decorate and refix; strip wall paint work and redecorate wall; repair ventilation grill and clear out coffer

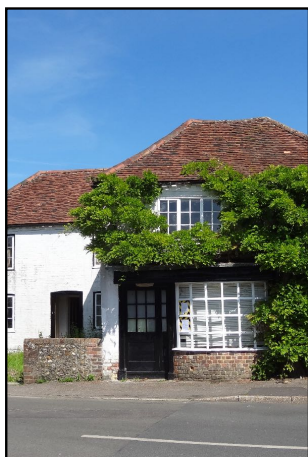
## West face generally

<b>Condition:</b> Roof battens and tiling have rusting nails and are failing; tiles are slipping; generally the post office section is overgrown with wisteria; decorations to both Post office and house brickwork is poor; decorations to gutters, gutter brackets and downpipes is poor	A  B
---	------------

<b>Repair Needs:</b> Remove existing wall paintwork where not lime based and re-decorate brickwork; take down existing gutters and take apart; sand blast clean and redecorate; re-fit re-making all joints and sealing; redecorate gutter bracketry	
---	--

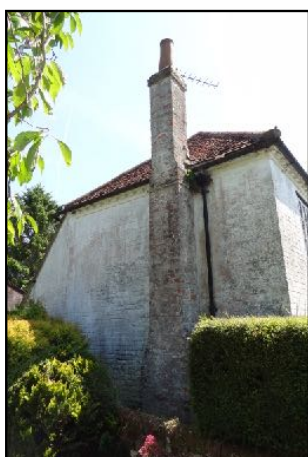
## North face generally

<b>Condition:</b> roof tiles slipped and missing; batten and tile nails are rusting; chimney lead flashing looks in poor condition; decorations poor and failing to chimney; hopper blocked with vegetation; gutter decorations poor;	B  A
--	------------

<b>Repair Needs:</b> Strip roof tiling and re-tile; strip chimney lead flashings and re-make back gutter; strip gutters, hopper and downpipe and sand blast, re-decorate and re-fix; clean off gutter brackets and redecorate; re-fit gutters, hopper and downpipe	
---	--

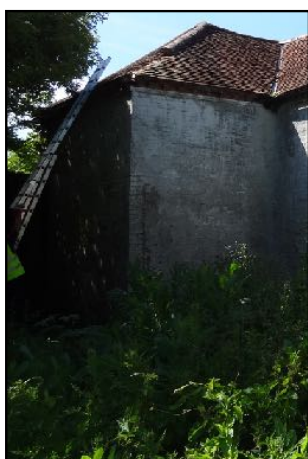
## South and East faces of Post office

<b>Condition:</b> Roof tiling poor, batten nails rusting and slipping; tile nails rusting; hip tiles missing; gutters broken and missing; vertical crack to corner of shop with unbonded brickwork; wall decorations poor; earth build-up at wall base	A  B
---	------------

<b>Repair Needs:</b> Strip roof battens and tiling and re-tile; fit new cast iron gutters and downpipe to new gully and soakaway; cut out and stitch vertical cracking; strip earth away from building to below floor level and form french drain; strip existing wall paint and redecorate	
--	--

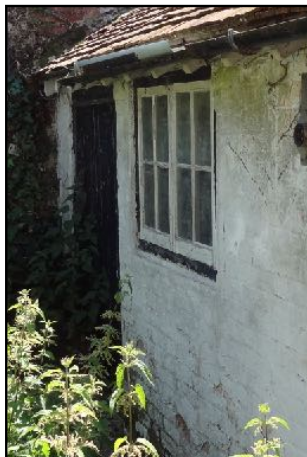
## East face of outshot, South end

Window cill rotten and insufficient overhang of masonry below; casement joints loose and open; glazing putty missing, cracked and in poor condition

B

Remove window and frame and repair all round adding a new cill; reglaze and re-putty

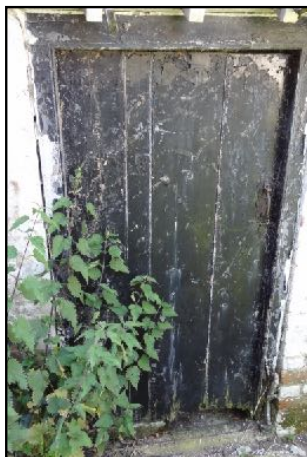
## East face of outshot, South door

Door and frame rotten at base; decorations poor; ironmongery condition poor

B

Remove door and repair, replace to include a new weather bar and threshold door stop; scarf in new sections of frame; strip paint from door and redecorate; overhaul ironmongery and fit new if damaged or missing

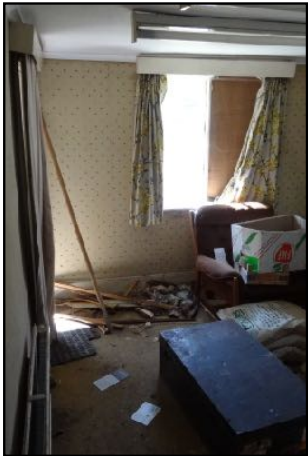
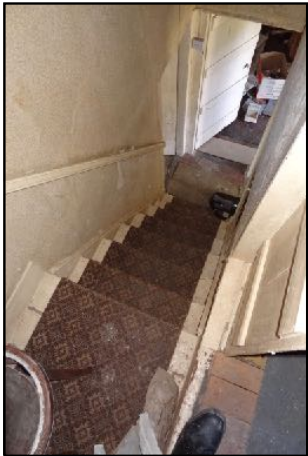
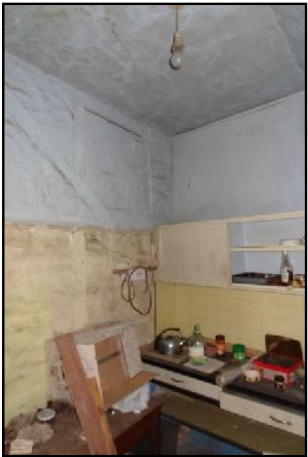
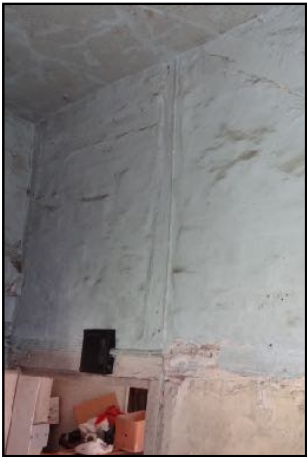
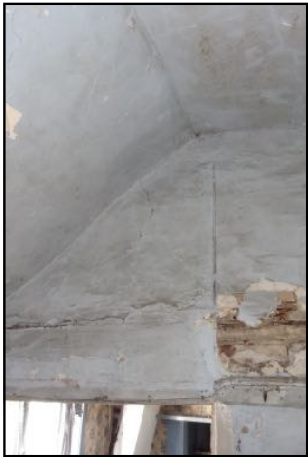
Ground floor house, northern front room, staircase and back room in outshot (pantry)

<p><b>Condition:</b> Decorations poor, staircase weak and flexible, some plaster loss in pantry but generally appears in sound condition</p>	C
<p><b>Repair Needs:</b> Patch plaster failed areas consolidation masonry with deep pointing; strip existing decorations and redecorate; strengthen stair with additional glued and screwed blocks.</p>

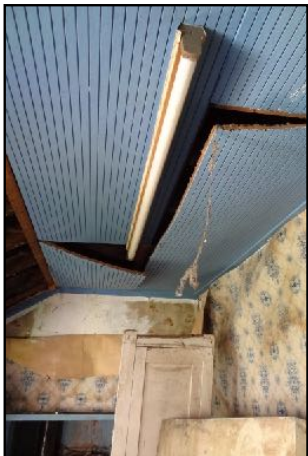
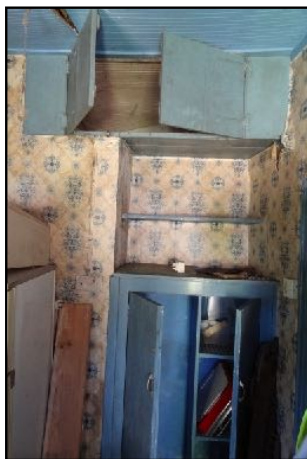
<p><b>Condition:</b> Decorations poor in middle front room; chimney breast has been re-plastered in hard plaster, cracked; ceiling boards partly collapsed in kitchen, no insulation; decorations poor, damp staining on walls; boiler falling off wall</p>	C
<p><b>Repair Needs:</b> Strip all decorations in front room; strip ceiling and walls in kitchen and reform ceiling with insulation; strip all paintwork and redecorate</p>

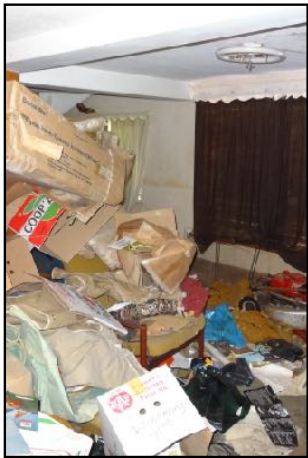
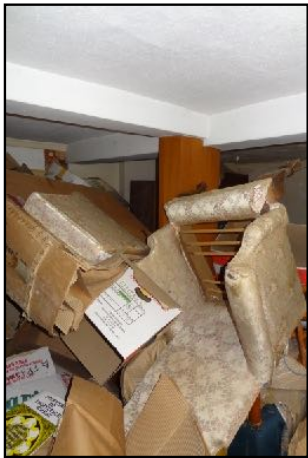
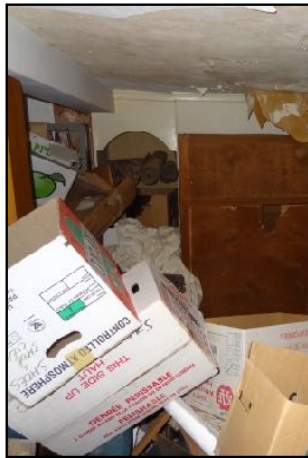
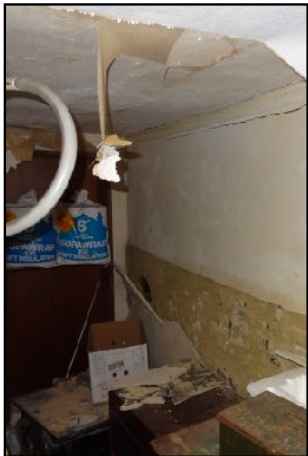
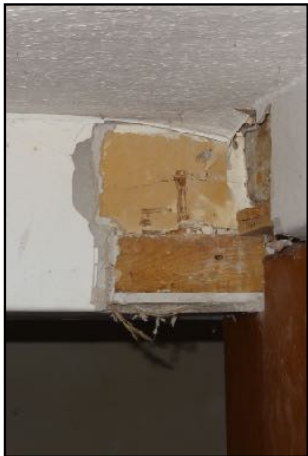
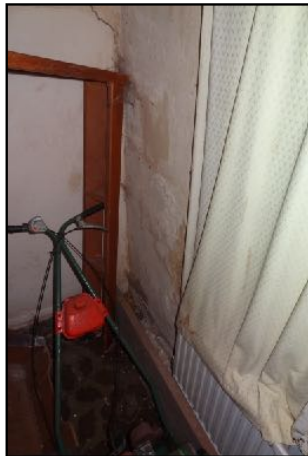
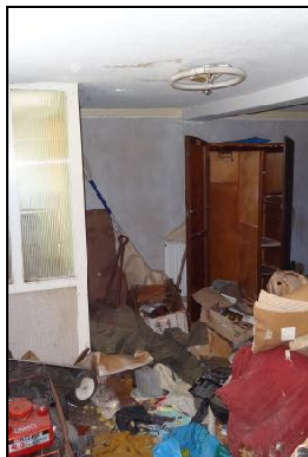
Ground floor Post office, front room

<p><b>Condition:</b> Decorations poor; southern wall has hard plaster, cracked and failed; ceiling has been replaced in part, remaining failing; further investigation of structural beams in ceiling, post and bearing required; decorations poor; damp salt damage to southern and western corner of walls, low level;</p>	<p>C A C</p>
<p><b>Repair Needs:</b> Strip all decoration; repair damaged ceiling where failed; remove hard and salt damaged plaster and re-plaster; investigate further the condition and support of the ceiling beams and post; strip all paintwork and re-decorate</p>

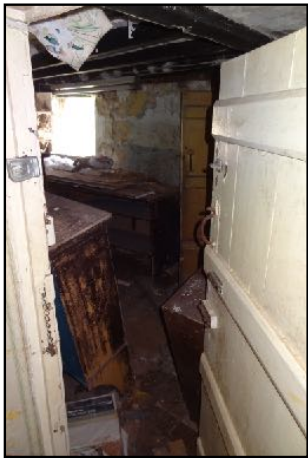
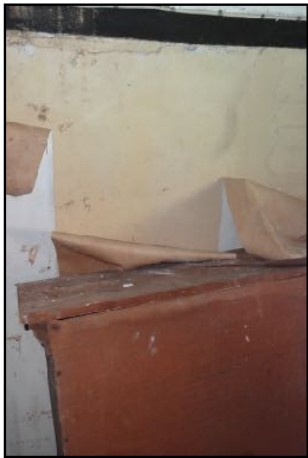
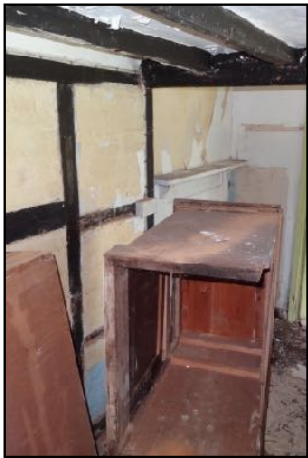
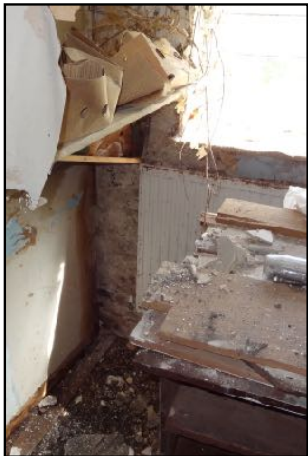
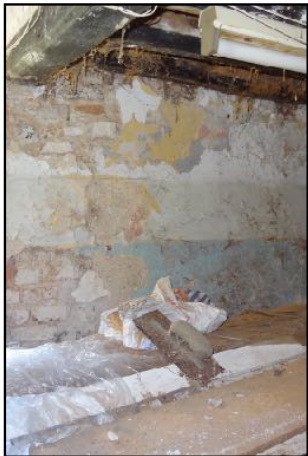
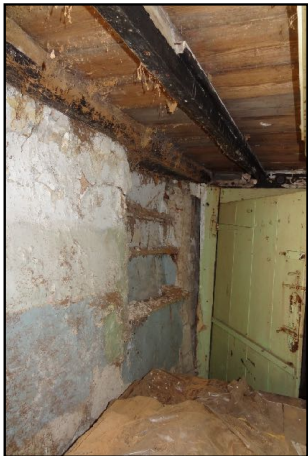
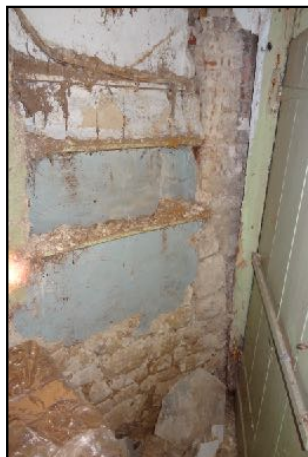
Ground floor house, rear room South

<p><b>Condition:</b> Decorations poor; southern wall bulging, cracked and failed plaster; ceiling has been removed in part, remaining failing; further investigation of structural beams in ceiling, and bearing required; decorations poor, damp salt damage to South eastern corner of wall, low level;</p>	<p>A C A A</p>
<p><b>Repair Needs:</b> repair damaged ceiling where failed; remove salt damaged plaster and re-plaster; investigate further the condition and support of the ceiling beams; strip all paintwork and redecorate</p>

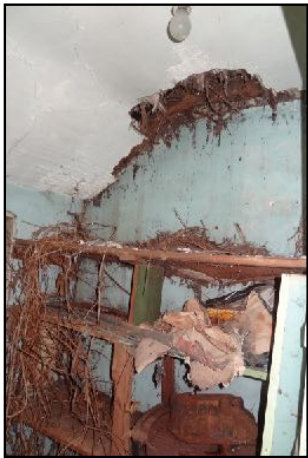
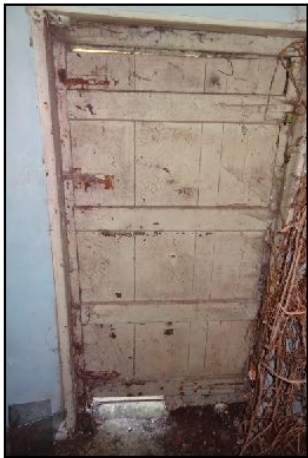
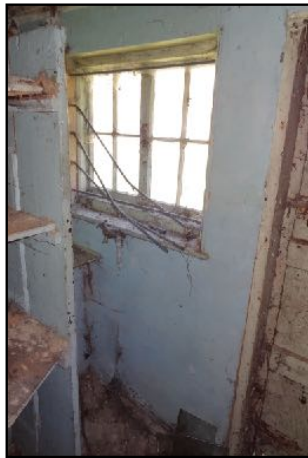
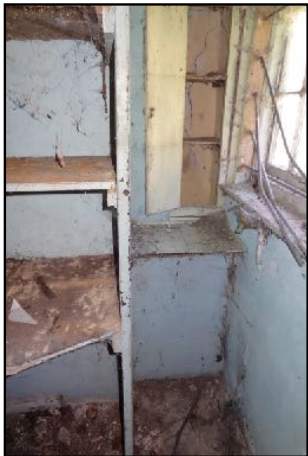
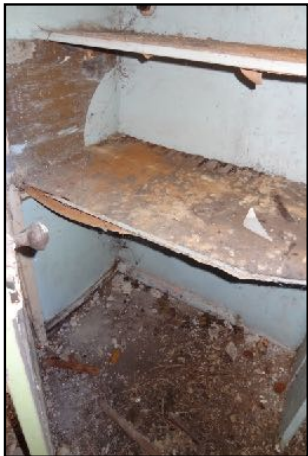
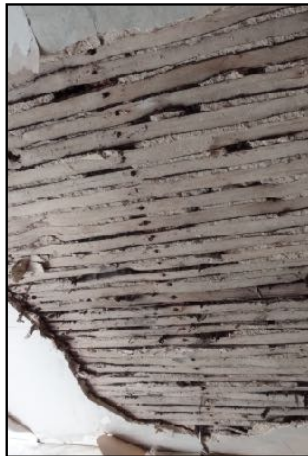
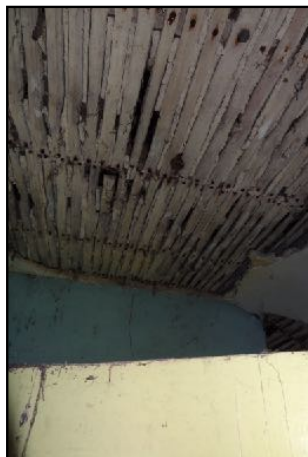
Ground floor house, outshot South

<p><b>Condition:</b> ceiling plaster has failed from water ingress, exacerbated by leaking WC above; decorations poor; window and door rotten as illustrated in external photographs</p>	<p>C B</p>
<p><b>Repair Needs:</b> repair damaged ceiling where failed; strip all shelving and timber fittings; strip all paintwork and re-decorate; repair window as mentioned in external report</p>

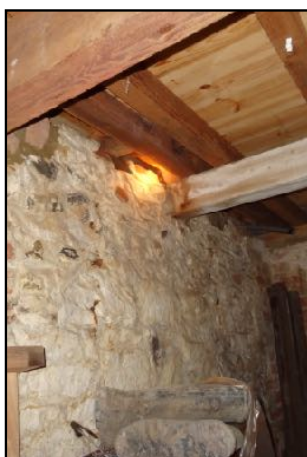
Cellar Post office, below northern half of front room

<table><tr><td><b>Condition:</b> Cellar door frame rotted at base; access steps damp and salting; cellar ceiling has been replaced but beams built into wall with no damp proof protection; cellar window bricked up and ventilation grill broken; chalk rubble walls appear sound and relatively dry; beam over cellar steps has rotten bearing to cellar wall.</td><td>C  C  A</td></tr><tr><td><b>Repair Needs:</b> Repair cellar door frame; overhaul door and</td><td></td></tr></table>		<b>Condition:</b> Cellar door frame rotted at base; access steps damp and salting; cellar ceiling has been replaced but beams built into wall with no damp proof protection; cellar window bricked up and ventilation grill broken; chalk rubble walls appear sound and relatively dry; beam over cellar steps has rotten bearing to cellar wall.	C  C  A	<b>Repair Needs:</b> Repair cellar door frame; overhaul door and	
<b>Condition:</b> Cellar door frame rotted at base; access steps damp and salting; cellar ceiling has been replaced but beams built into wall with no damp proof protection; cellar window bricked up and ventilation grill broken; chalk rubble walls appear sound and relatively dry; beam over cellar steps has rotten bearing to cellar wall.	C  C  A					
<b>Repair Needs:</b> Repair cellar door frame; overhaul door and

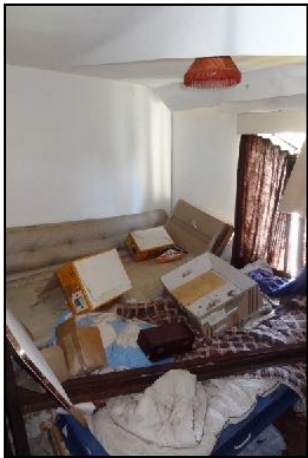
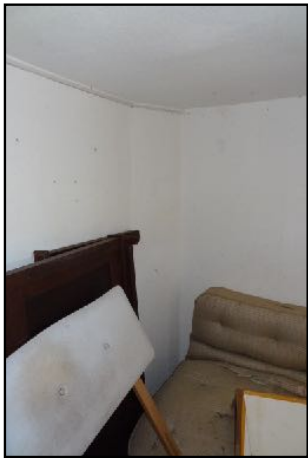
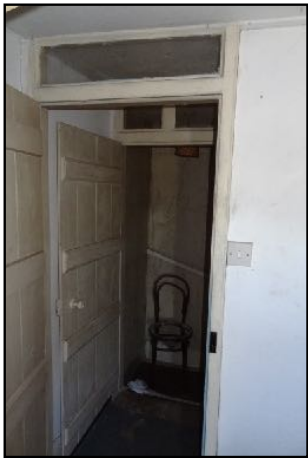
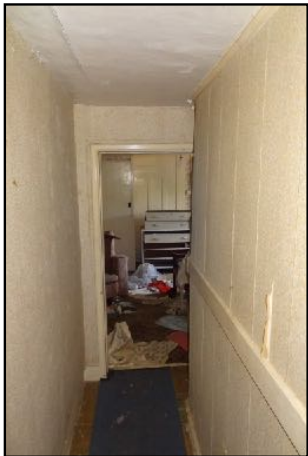
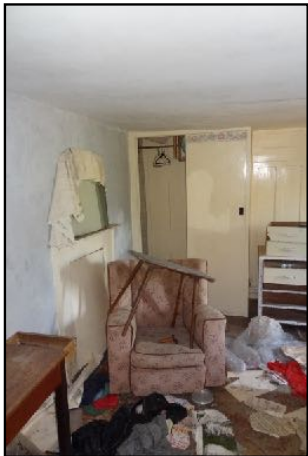
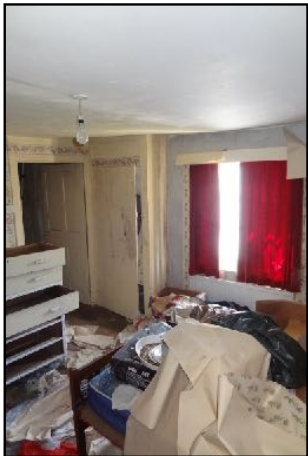
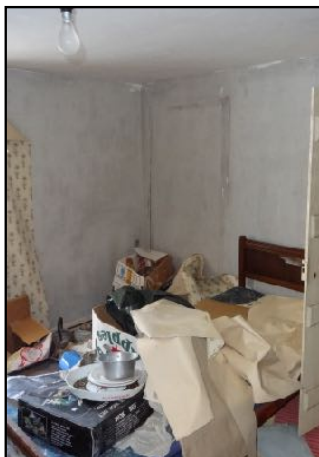
First floor house, northern bedroom, corridor and middle bedroom

<p><b>Condition:</b> Decorations reasonable to northern bedroom and corridor, though corridor ceiling cracked and decorations to joinery elements in all spaces tired; Middle room has been re-plastered to all walls with a modern plaster which is cracked in North West corner, to South wall and to North East wall</p>	<p>C</p> <p>A</p>
<p><b>Repair Needs:</b> Redecorate joinery elements in northern bedroom and corridor; repair corridor ceiling; remove plaster to middle bedroom walls, investigate cracking and review (possible spreading of roof timbers); stitch cracks where found necessary; re-plaster walls; strip and redecorate all joinery elements</p>

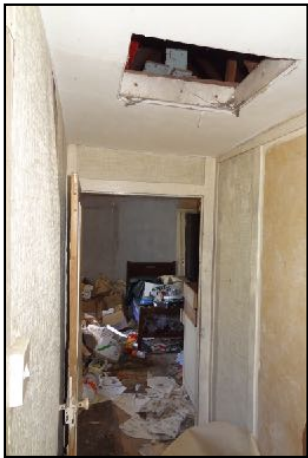
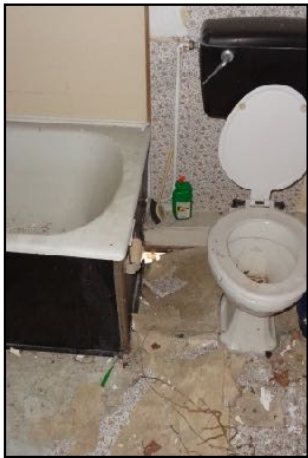
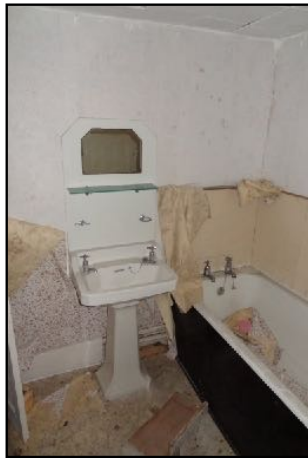
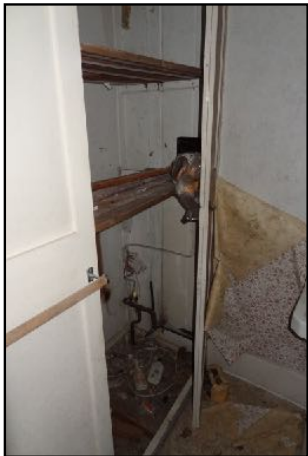
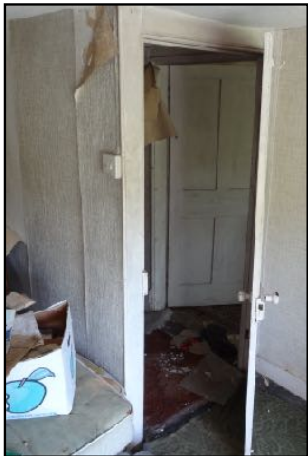
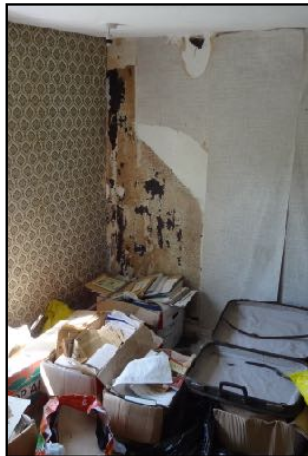
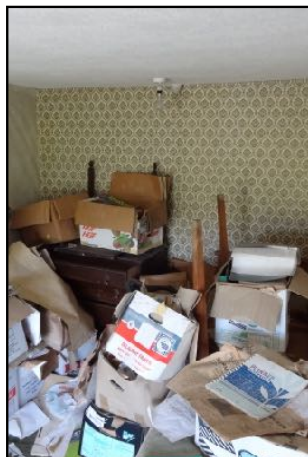
House, West corridor, South East bathroom and front Post office North room

<b>Condition:</b> corridor decorations to wall and ceiling poor; bathroom floor rotted out around wc and bath; decorations to bathroom poor; polystyrene ceiling tiles failing; bathroom window boarded up; Post office front northern bedroom decorations poor and wall appears painted with bitumen	C A C B C
<b>Repair Needs:</b> Redecorate corridor walls and ceiling; repair bathroom floor; strip decorations in bathroom and redecorate; insert new window into bathroom; strip decoration from front northern bedroom and remove bitumen coating from wall; redecorate

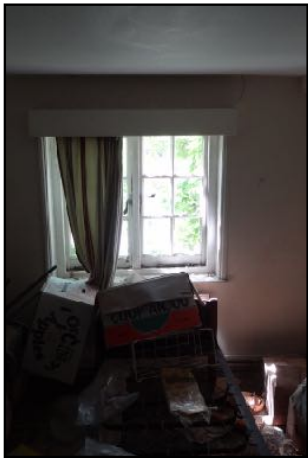
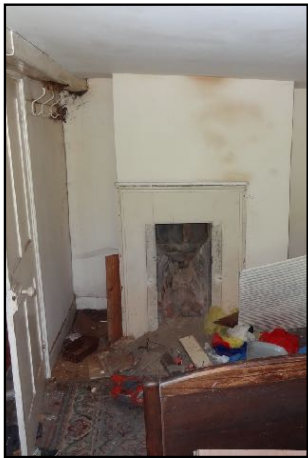
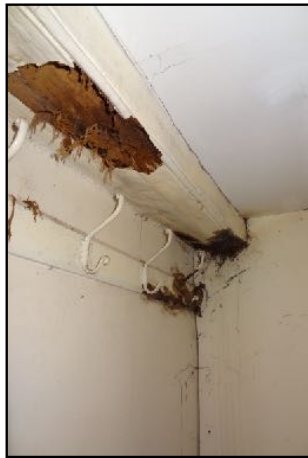
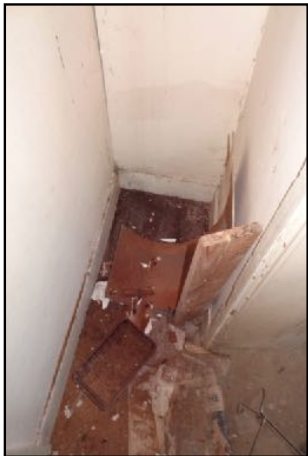
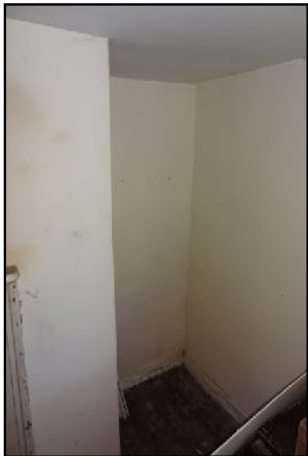
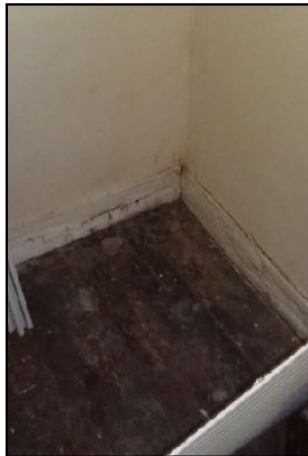
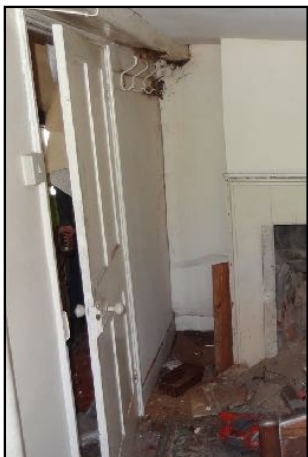
Post office, first floor, southern bedroom

<p><b>Condition:</b> Wet and dry rot to wall plate at North eastern end of bedroom, this supports roof timbers; dry rot to skirtings in South eastern corner; dap patch around chimney breast - chimney does not appear externally; 50mm diameter steel support column under wall plate mid span structurally dubious; decorations poor</p>	<p>A A A</p>
<p><b>Repair Needs:</b> Seek structural advice from a structural engineer on the suitability of the wall plate to carry roof loadings; carry out remedial works to prevent water ingress; remove damaged skirtings and replace; seek structural advice on the stability of the steel column; redecorate ceiling, walls and joinery</p>

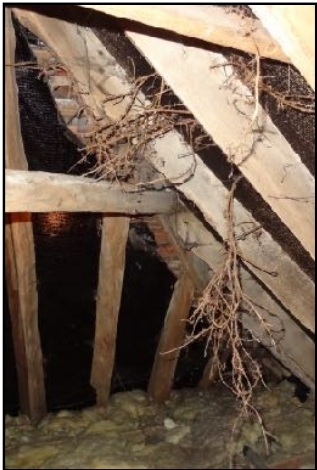
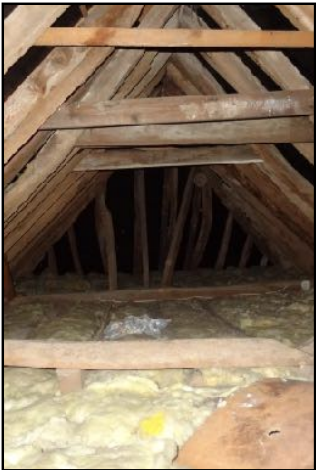
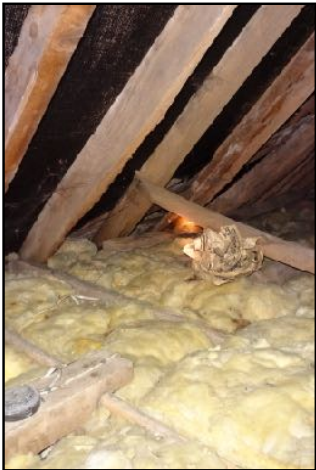
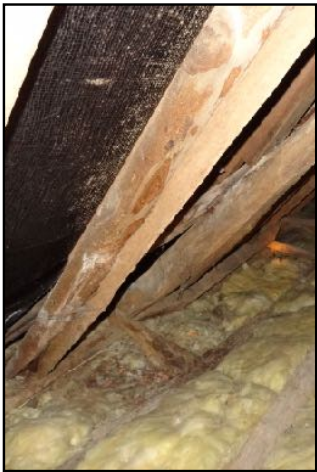
<b>Condition:</b> Cracked and broken rafters over house, some replacement rafter, inadequate cross ties, no purlins mis-aligned rafters; split ridge board; inadequate cross ties to roof over Post office, rotten wall plate, inadequate strapping to wall plate, no purlins and ceiling joists; inadequate ventilation to loft; inadequate insulation	A
	A
	A
<b>Repair Needs:</b> Repair rafters and introduce additional cross ties and collars to support roof loads; repair wall plate introducing additional, replacement strapping; improve ventilation ; add insulation

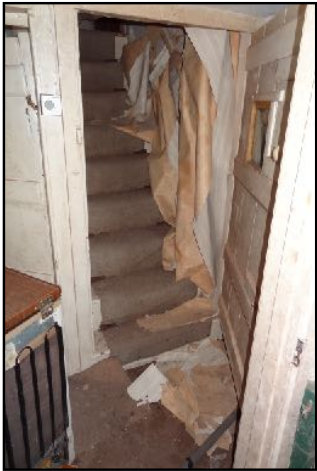
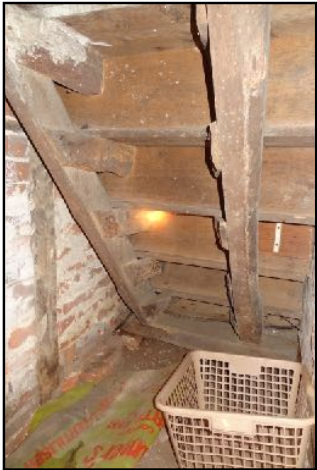
Post office staircase

<p><b>Condition:</b> Staircase treads and risers loose, weak and flexible; western stair string rotting at base; wall decorations poor</p>	<p>B</p>
<p><b>Repair Needs:</b> Lift stair and introduce damp proof membrane between string and masonry; repair string if necessary; add stiffening blocks to treads and riser; redecorate stair walls and ceiling</p>
