Shoreham Cement Works - Area Action Plan - Evidence Base

**Preliminary Building Condition,
Safety and Demolition Assessment**

Draft Report

September 2018

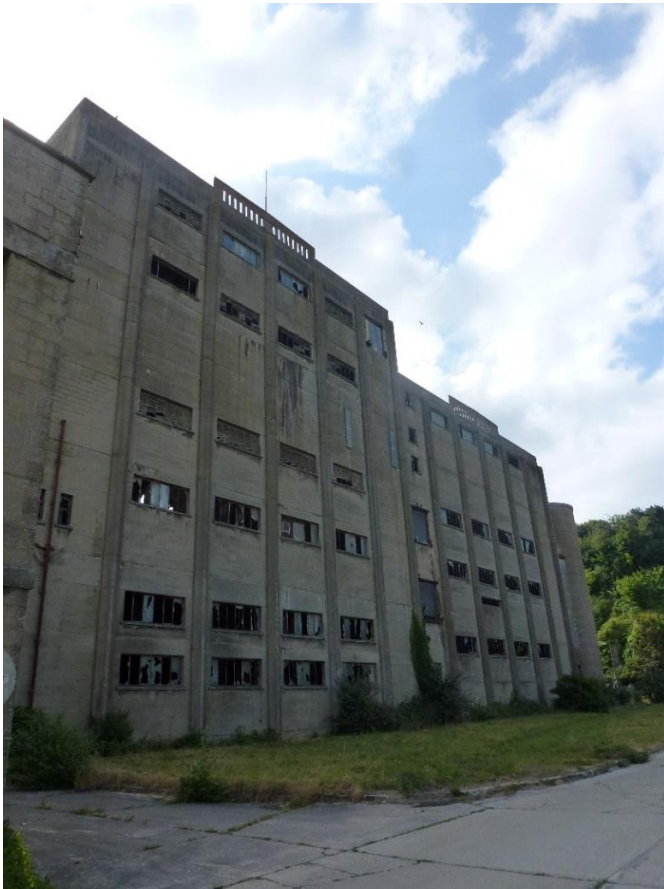
Horizontal cracking, rust staining and exposed reinforcement is visible on several of the reinforced concrete spandrel panels on the external walls (Photograph 2). This spalling is quite extensive at high level on the panels in front of the Kiln House.

Photograph 2 - Concrete framed structure at front of Kiln House.

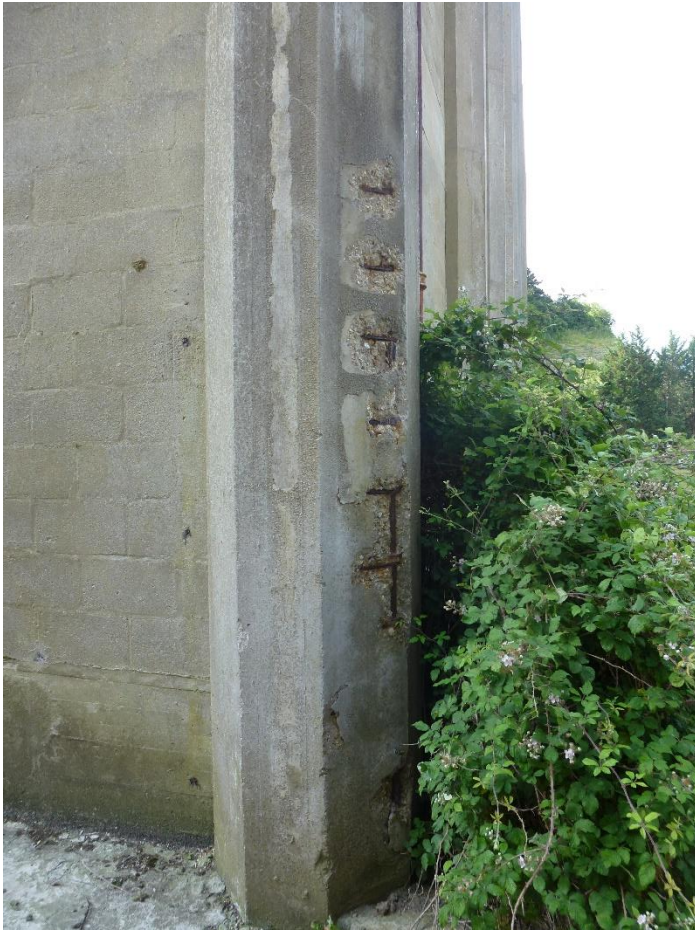
Corroded reinforcement is exposed where concrete has spalled from the external faces of the Kiln House external concrete columns.

Photograph 4 - Concrete framed structure at front of Kiln House, spalling concrete.

The precise cause of the corroded reinforcement where concrete has spalled from the outer faces of the Kiln House external concrete columns cannot be determined by a visual inspection alone. At the low levels where the defects are accessible, concrete cover to the reinforcing steel is as little as 20 mm, which is lower than would be specified nowadays. This could be due to a design fault (inadequate cover was routinely specified at that time) or poor workmanship. Intrusive investigations (dust samples and concrete cores) to facilitate laboratory testing of samples as part of more rigorous analysis of the buildings will be required to determine whether there are more endemic problems such as chemical attack. Feasibility of repair would be considered.

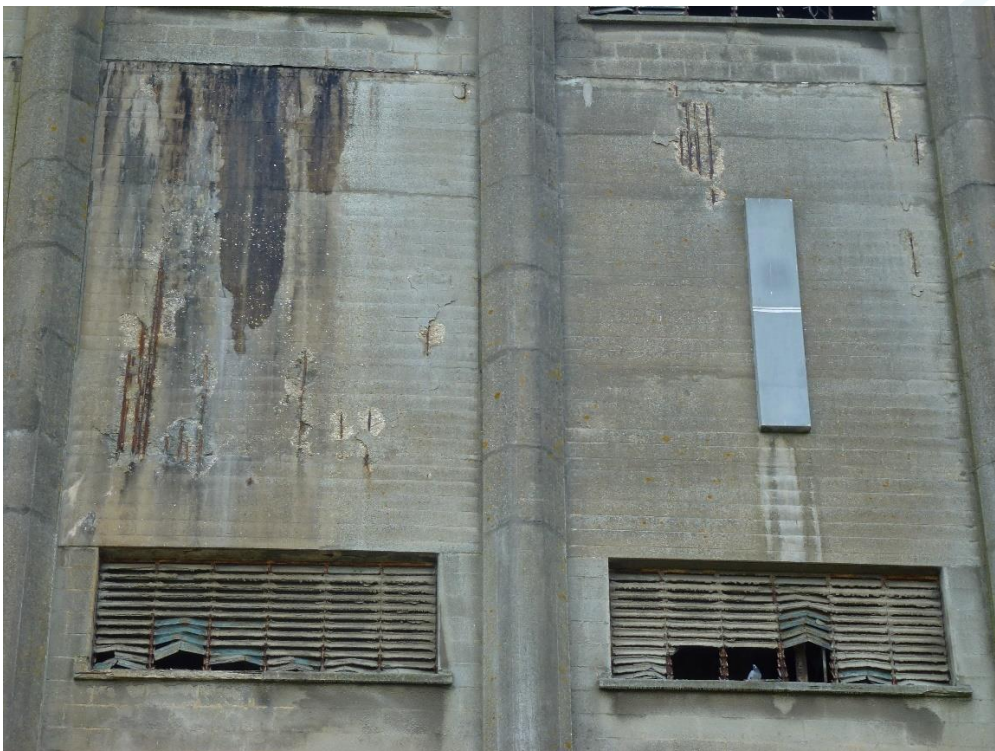
Photograph 5 - Concrete framed structure at front of Kiln House - spalling to spandrels.

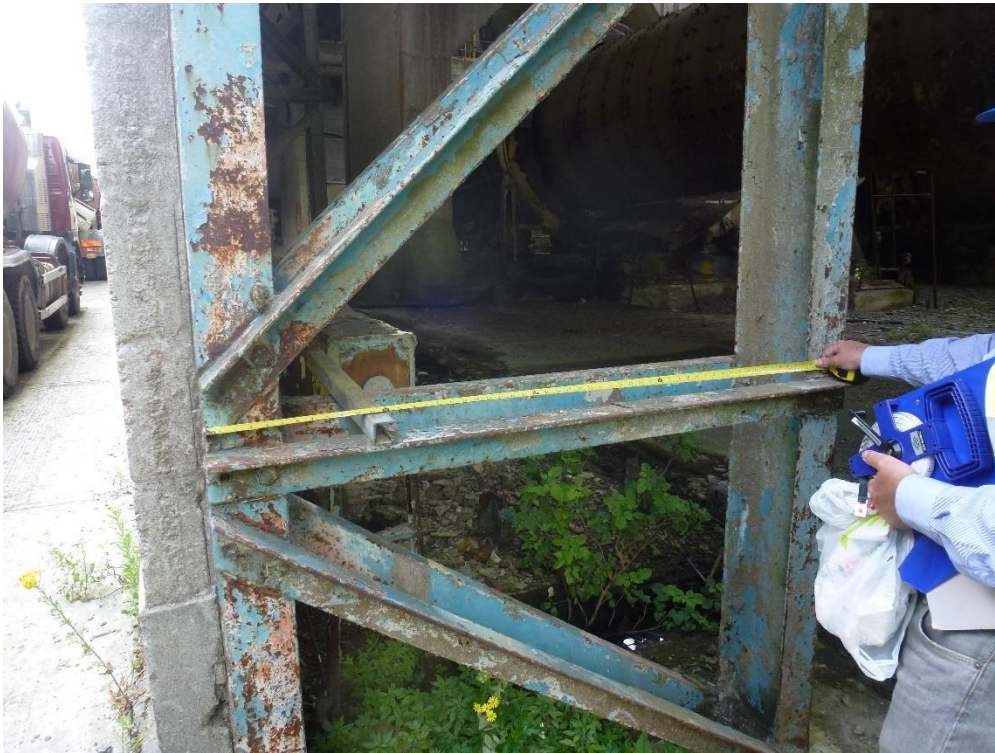
The areas of the main steel frames that were accessible for close inspection from low level had lost their corrosion protection paint but in the main appeared to have sustained only superficial corrosion.

Photograph 6 - Superficial corrosion of Kiln House stanchions.

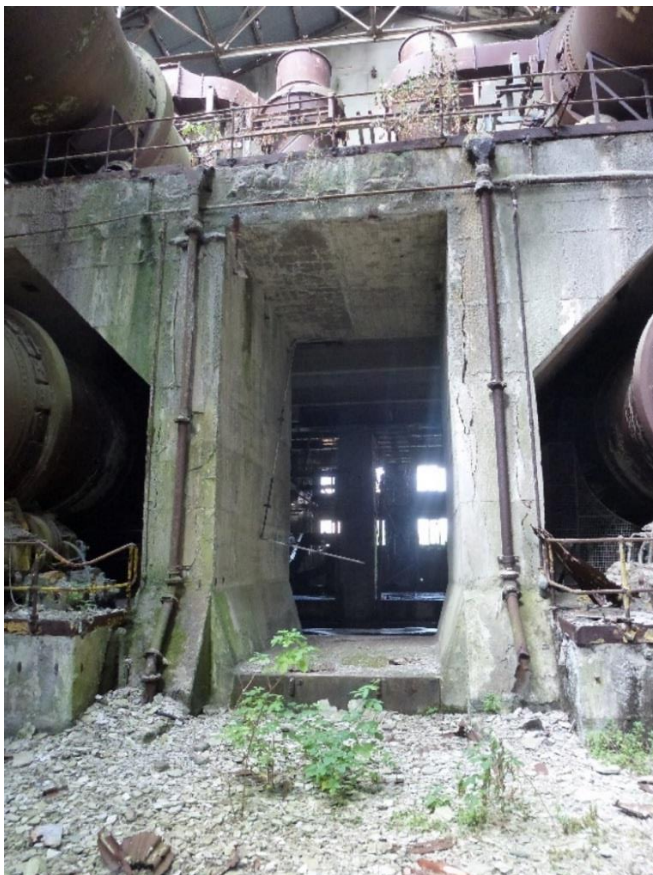
Photograph 7 - Cracking to concrete piers in the Kiln House.

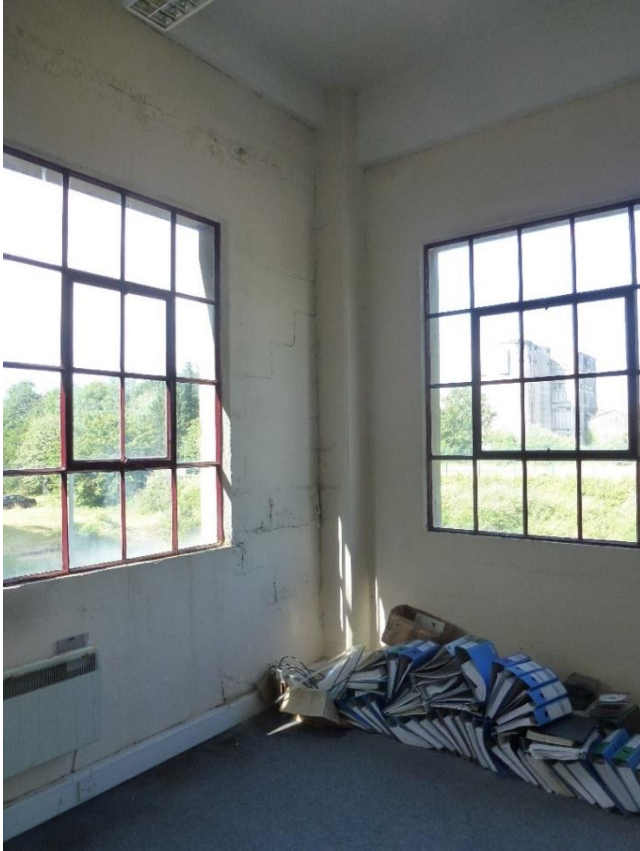
Damp staining was visible internally on the south facing first floor wall and around the roof light and roof access hatch.

Some hairline cracking was visible in the bed and perpend joints around the windows in the south facing first floor wall.

Photograph 8 - Cracking and dampness in Office blockwork.

The water ingress problems should be readily solved by investment in the building.

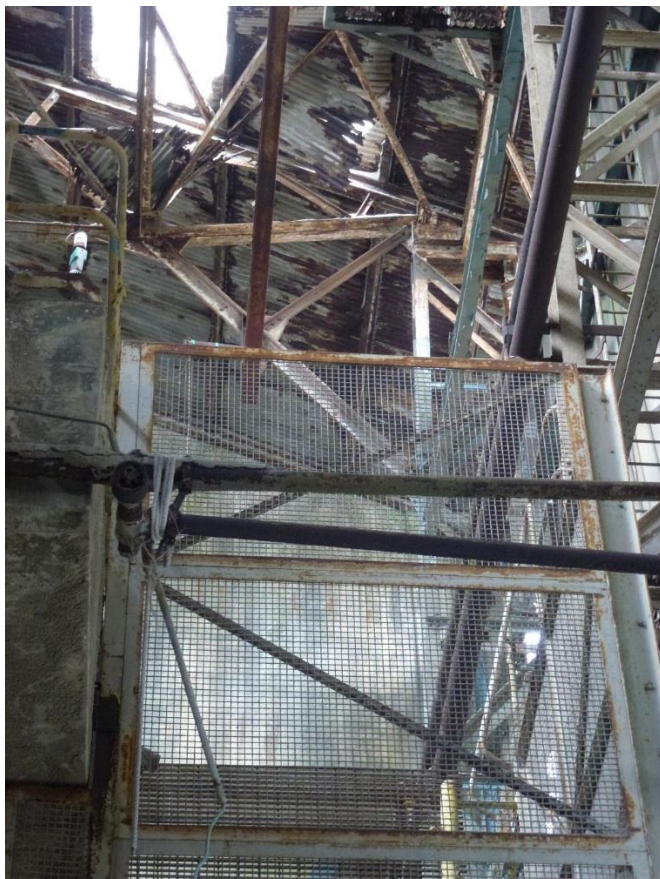
Photograph 9 - Superficial corrosion of Kiln House steelwork.

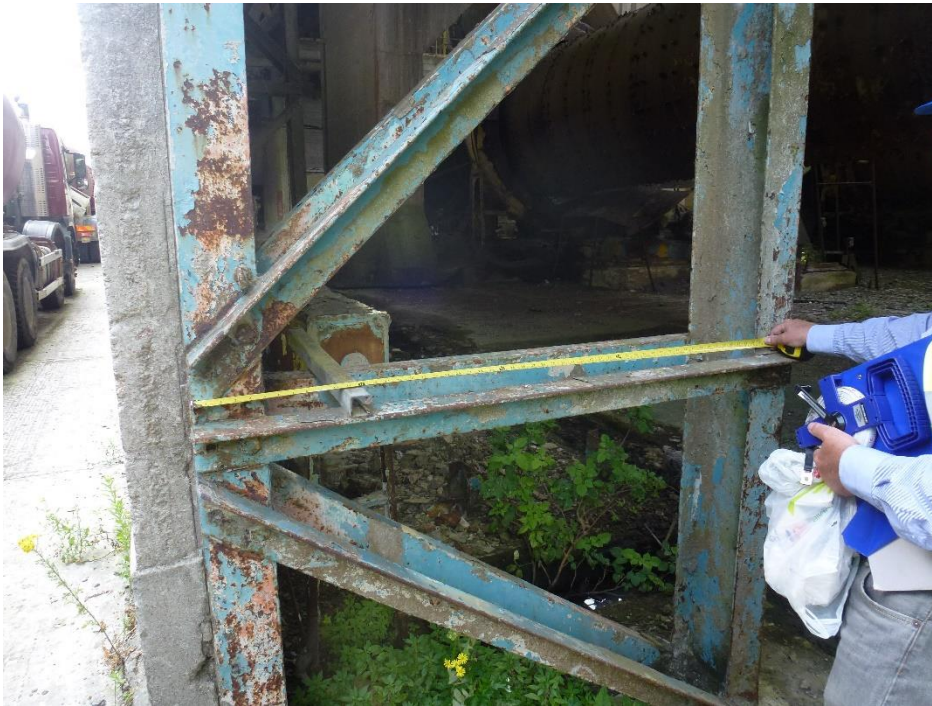
Photograph 10 - Superficial corrosion of Kiln House steelwork.

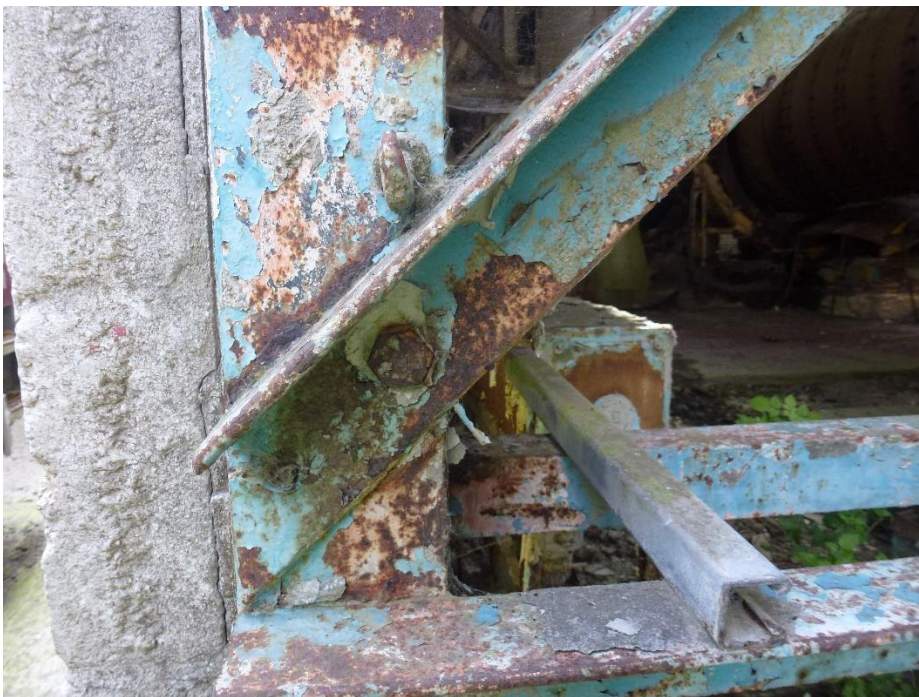
Photograph 11 - Superficial corrosion of Kiln House steelwork.

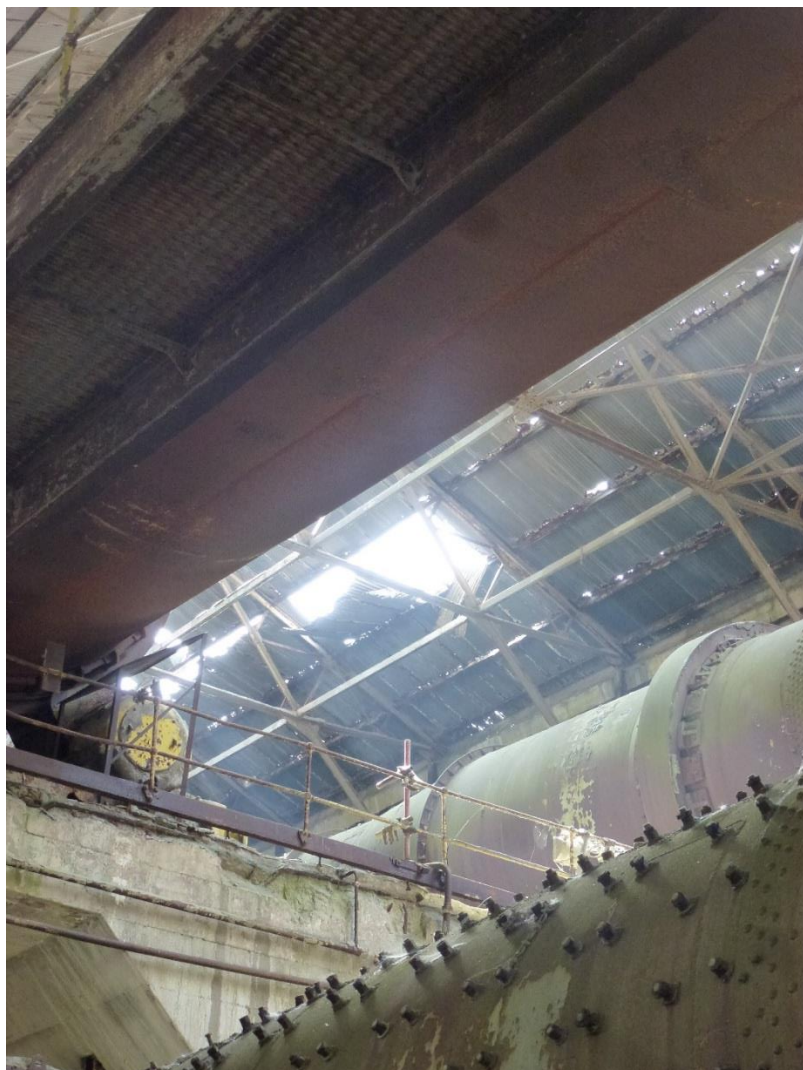
The roof sheeting, cladding and glazing to the Kiln House and Coal/Clinker Store complex have extensively failed. Large areas of standing water were observed at several locations, most notably in the Clinker Store. A continuous stream of running water was flowing from the higher levels of the Kiln House concrete structure during the duration of the inspection. It was not possible to investigate its source due to access restrictions. It is possible that large high level tanks have filled with water during wet weather and are leaking.

Photograph 12 - Failed Kiln House roofing.

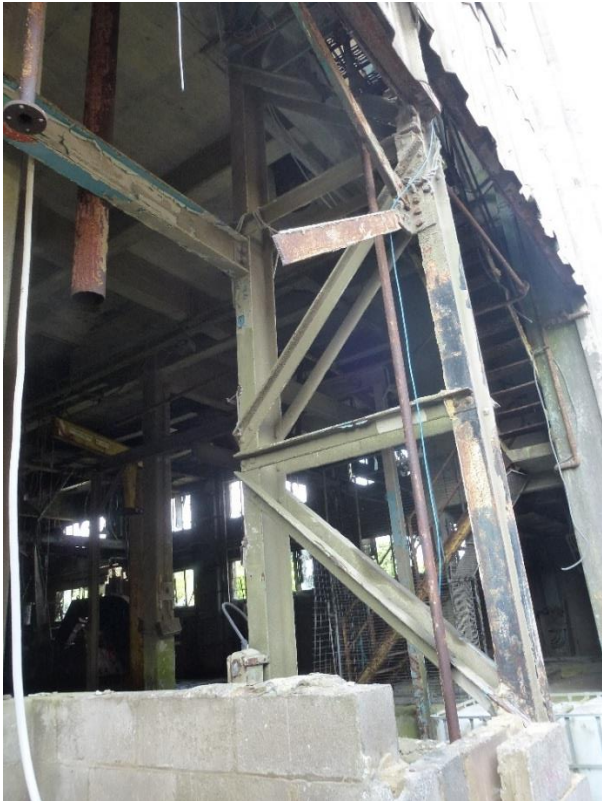
Diagonal wall bracing had been cut at low level in one of the Kiln House north wall bays (Photograph 11).

Photograph 13 - Severed Kiln House bracing.

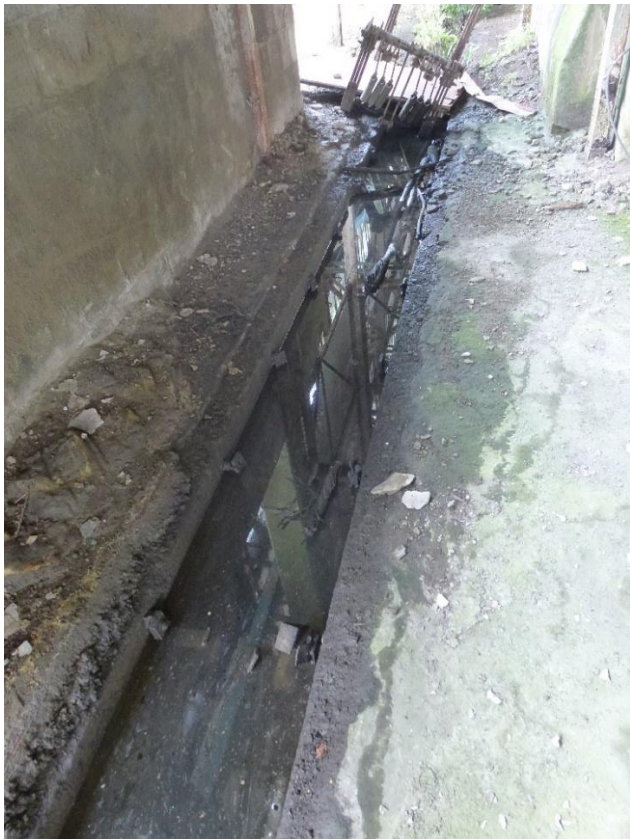
The ground floor concrete slabs have been heavily used and are extensively cracked and eroded.

Photograph 14 - Damaged Kiln House floor ducts.

The concrete floors to the working areas of the building are past economic repair and would need to be replaced in any refurbishment scheme.

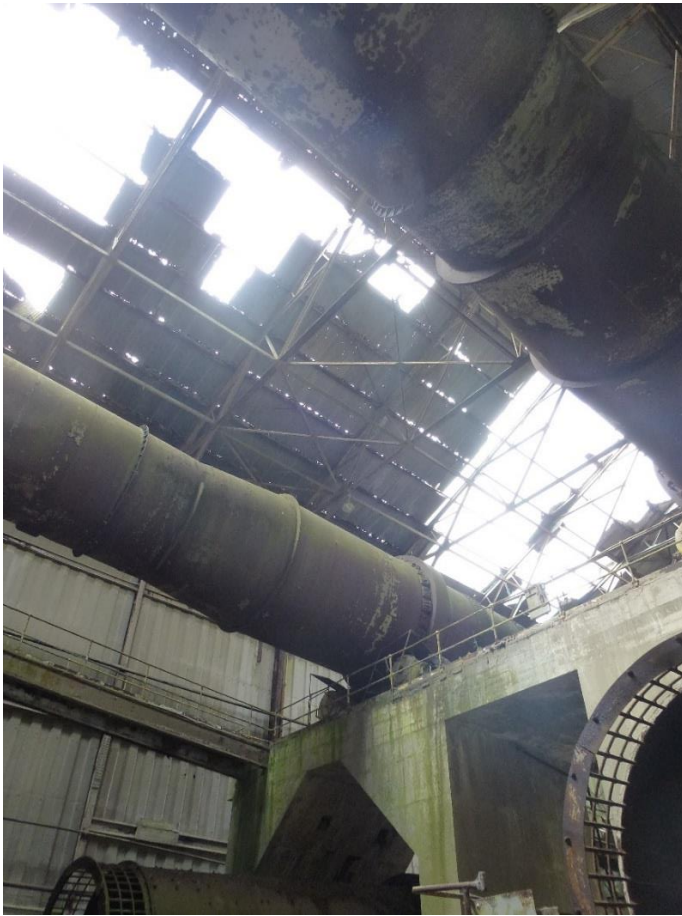
Photograph 15 - Damaged Kiln House roofing - rotary kilns and piers in foreground.

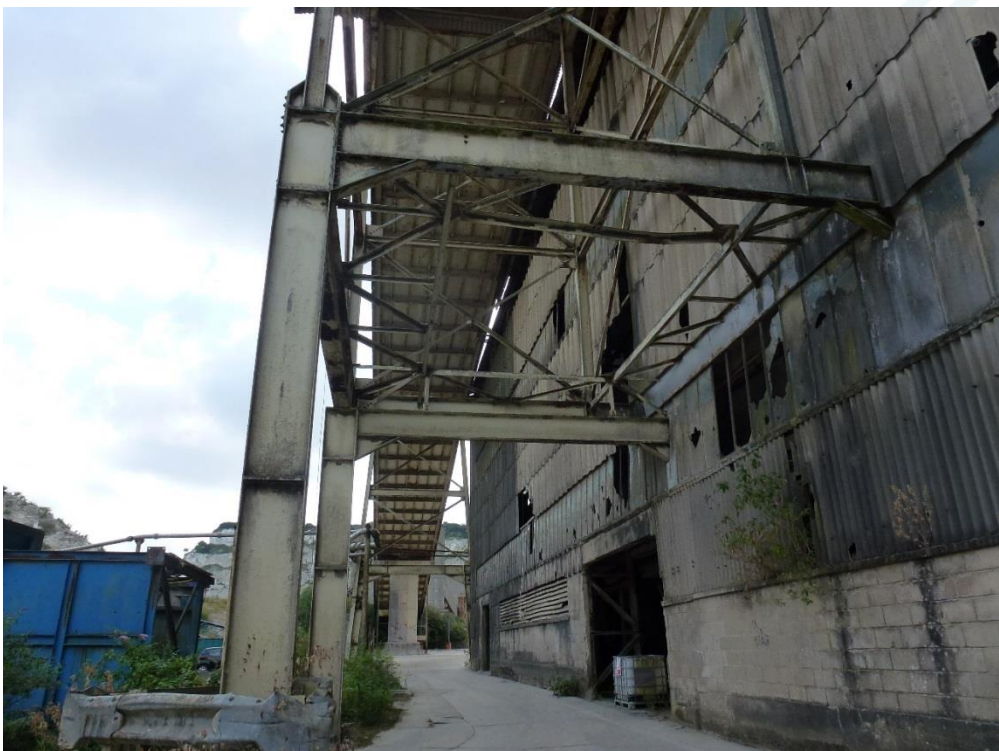
The concrete blockwork perimeter wall below cladding is in generally poor condition.

Photograph 16 - Failed Kiln House cladding - eroded blockwork, superficial external steelwork corrosion.

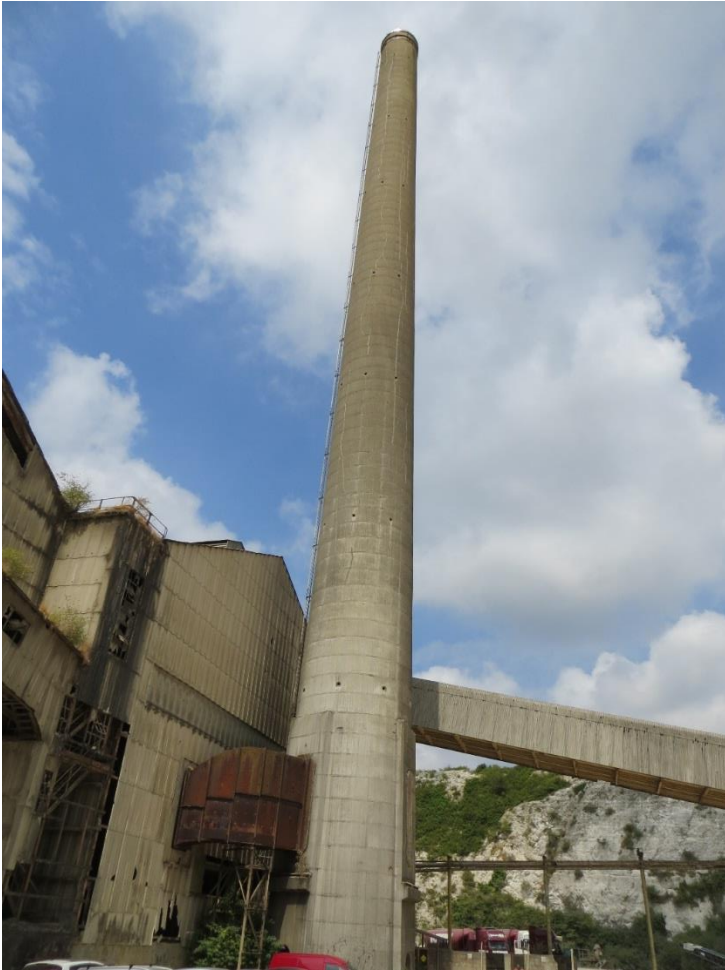
The reinforced concrete chimney located adjacent to the Kiln House east wall appeared to be plumb and in reasonable condition.

Photograph 17 - Chimney facing east gable of Kiln House

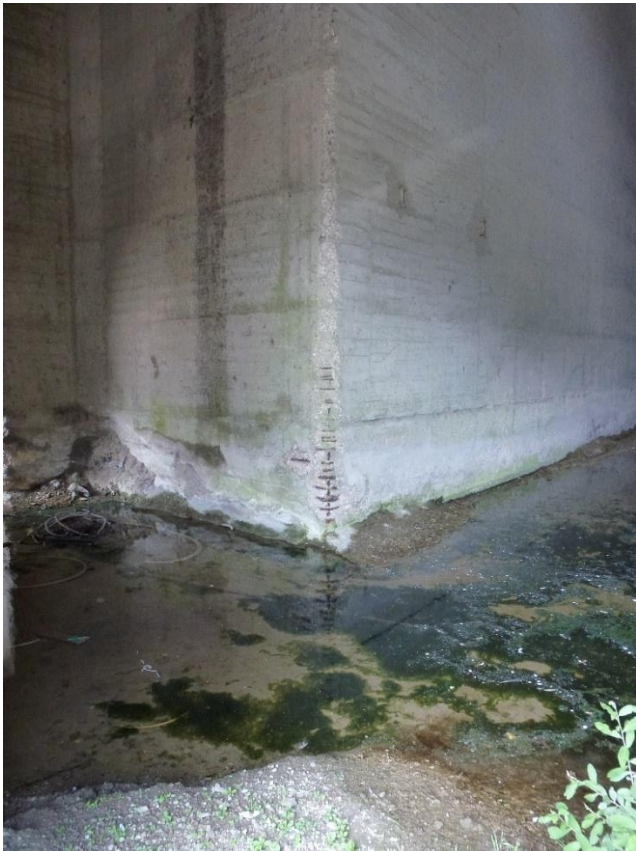
Photograph 19 - - Concrete spalled from Clinker Store wall.

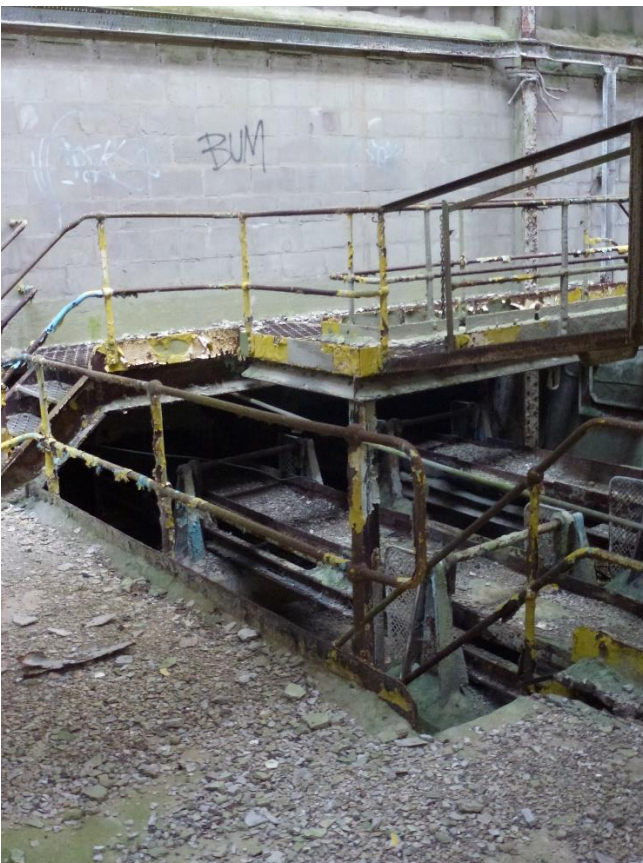
The Kiln House steel walkways, platforms, guard rails and stairs have sustained mainly superficial corrosion and some impact damage (Photograph 20).

Photograph 20 - - Corroded ancillary steelwork.

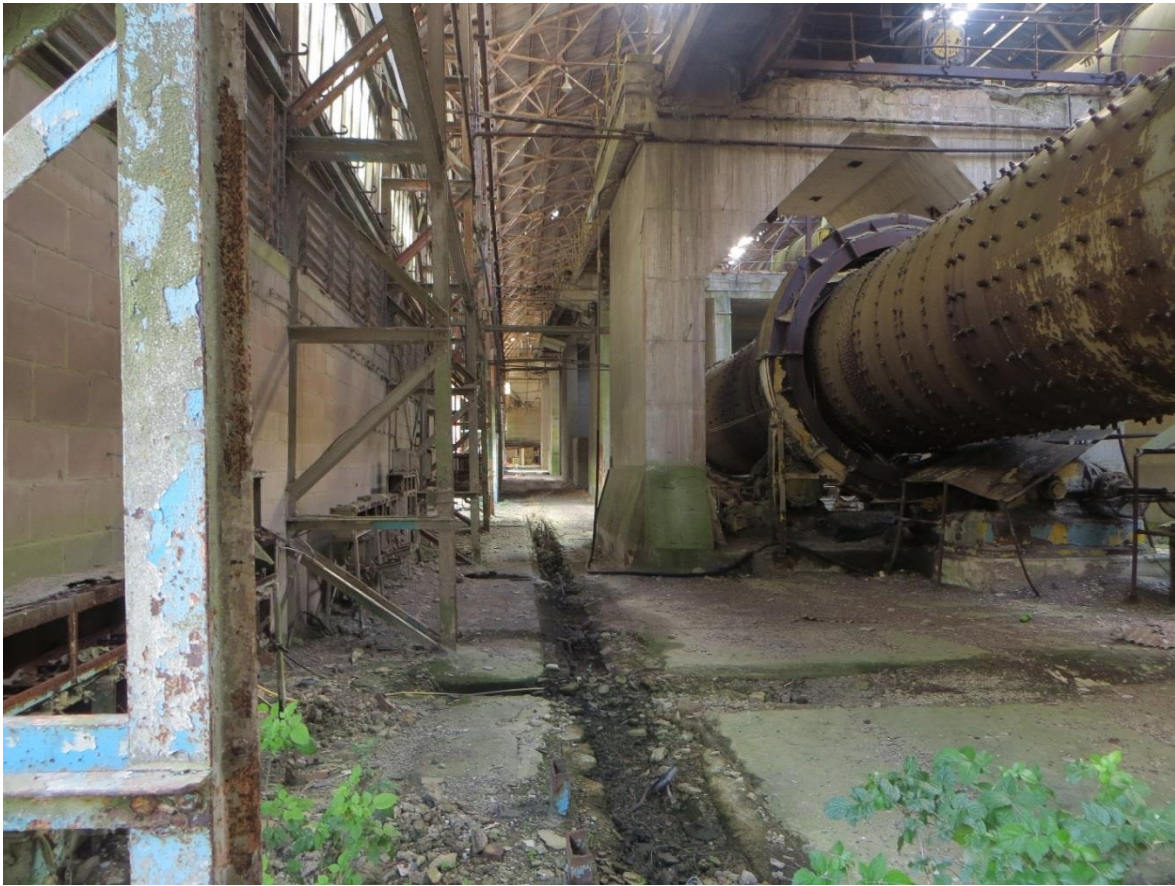
Photograph 21 - Kiln House, corroded steelwork, damaged floor slab.
