Surface condition report for the South Downs Way (Restricted Byway 2760) at Truleigh Hill, West Sussex.

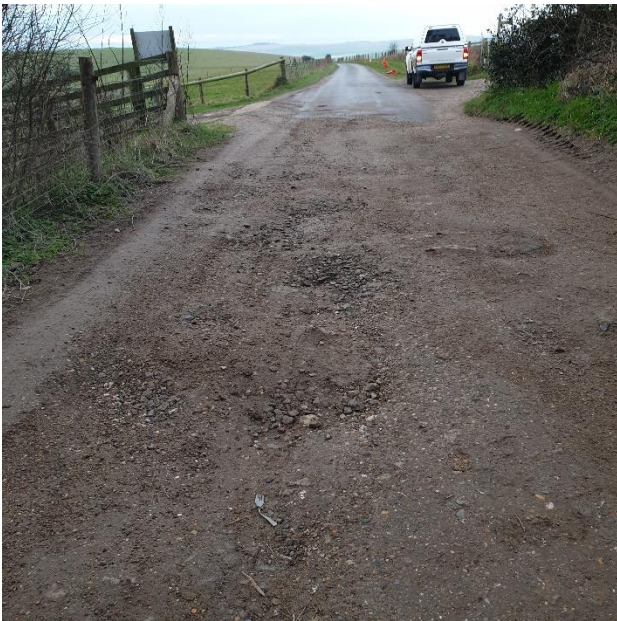
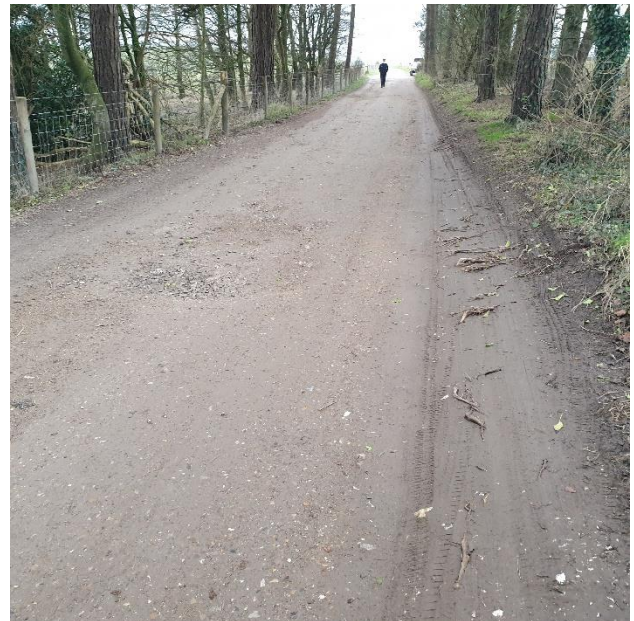
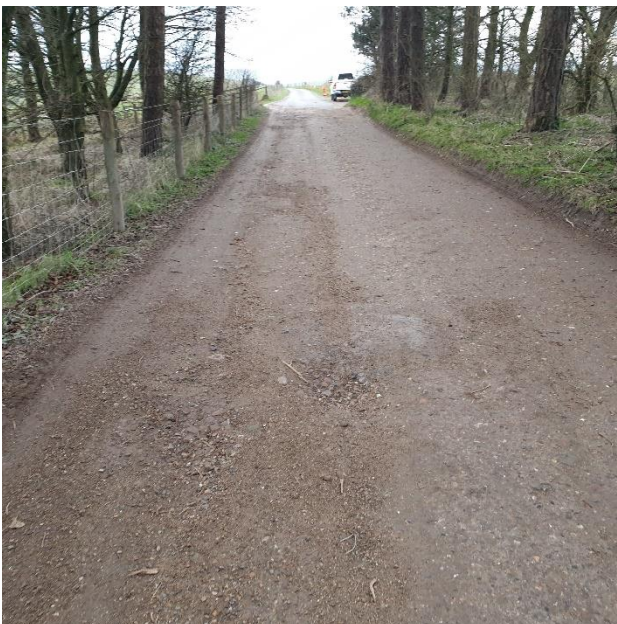
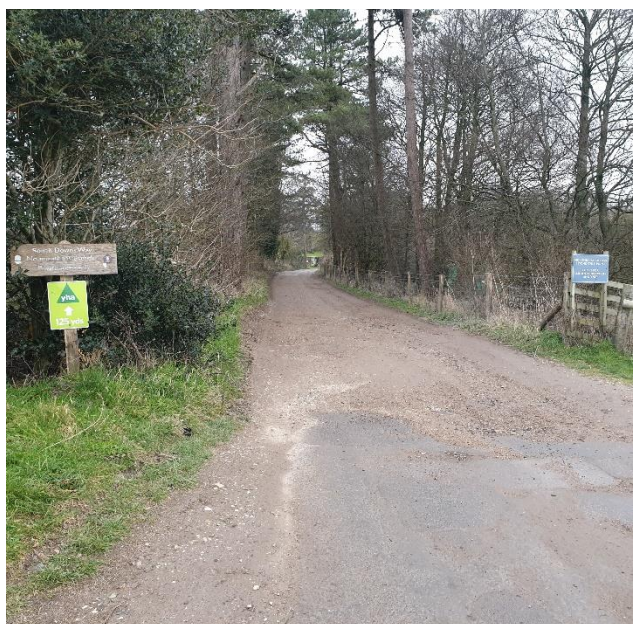
Current Condition: Section A

This section has several potholes and there is evidence that vehicles have been driving on the verge to avoid these, which has consequently caused tree roots to become exposed at the edges of the trackway (please see photos below). Despite the potholes, the general condition of the surface here does not impede public access and is suitable for public use.

Section A is regularly used by motorised vehicles and unsealed surfaces will start to degrade fairly quickly if frequently used by vehicles, especially heavy machinery/lorries. To improve private access the potholes should be filled and ideally addressed early on before they worsen.

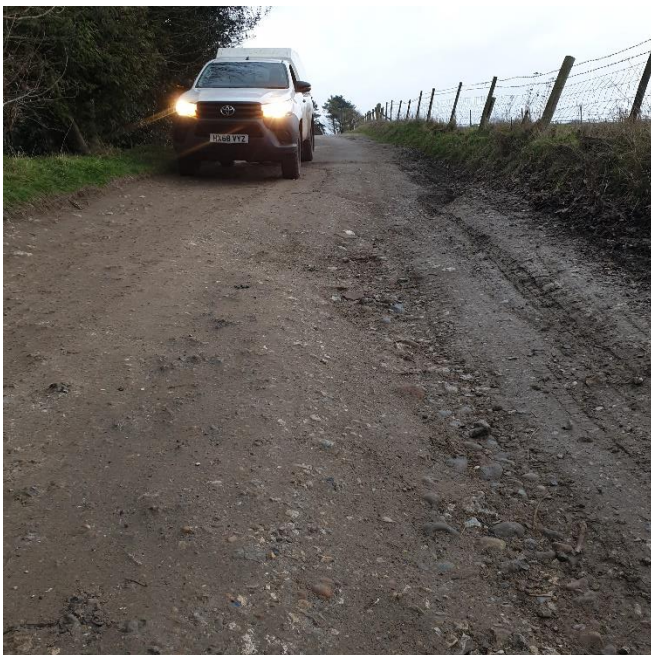
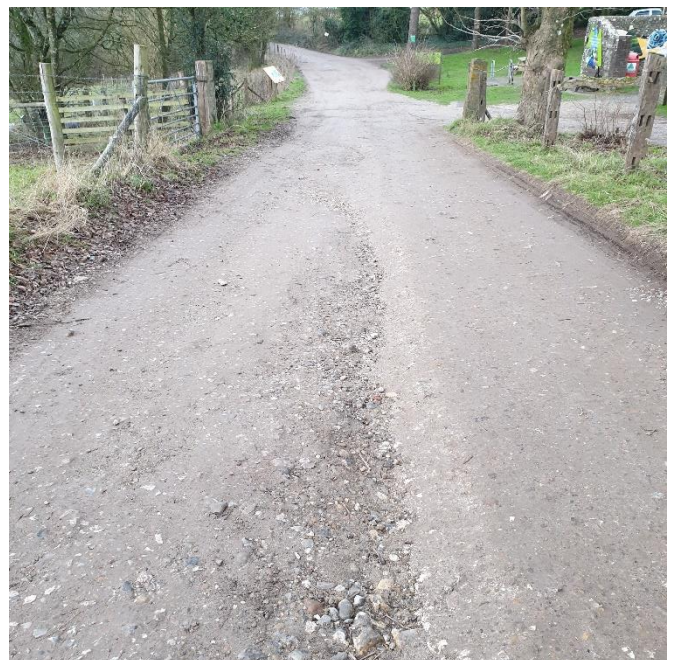
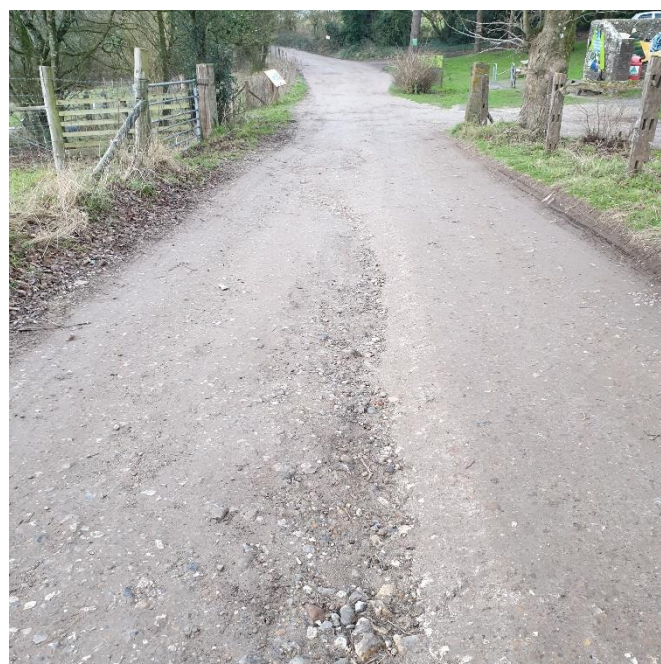
Current Condition: Section B

This section is showing signs of damage caused by surface water run-off, mainly on the southern edge of the track (please see photos below). As you approach the YHA entrance, a shallow gully is starting to form in the centre of the path where surface water is running from the southern edge. There is sufficient width for the public to use at present yet the gullies at the side and centre of the track are likely to worsen as time goes on.

Water management is key to the longevity of most path surfaces and it is evident here that drainage measures are required to prevent deterioration. Grips and/or humps installed at regular intervals should address this. Some re-profiling and potentially importing some stone would help to restore the original surface levels.

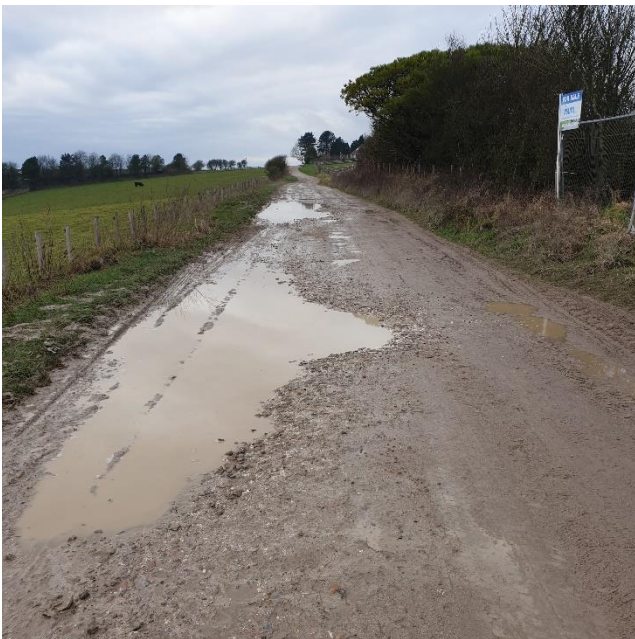
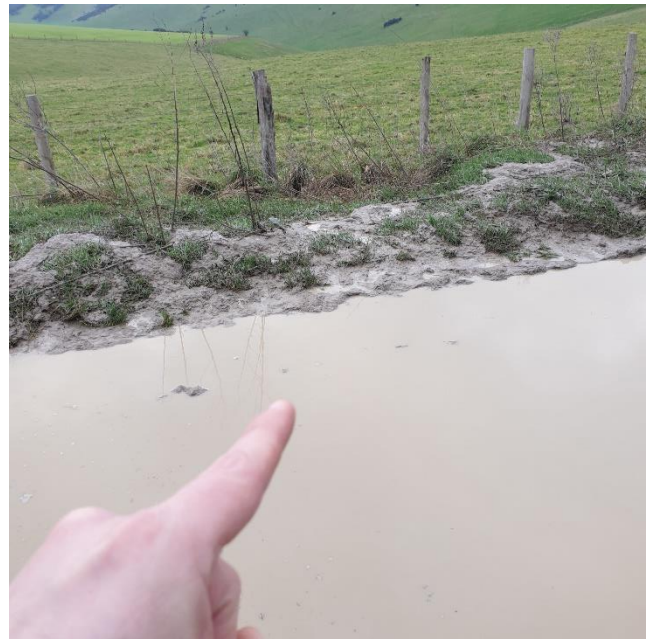
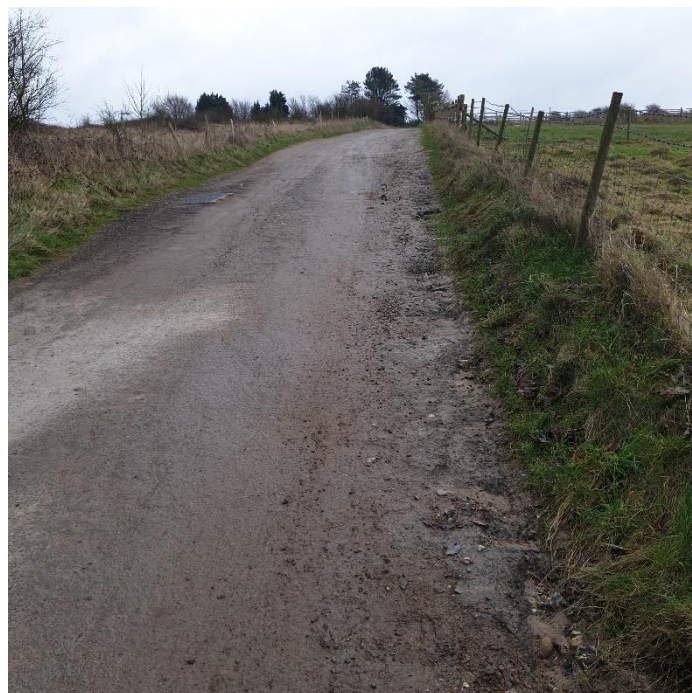
Current Condition: Section C

Pooling surface water is the main issue here (please see photos below) and is worse in winter. There is sufficient width for public use. The large tyre marks on the edge of the path would suggest that this section is used by large agricultural vehicles.

From the photos below one can see that the path verge is higher than the path surface and is preventing the water from draining away. A quick –fix solution here would be to scrape away the soft mud into the verge (on the southern side), creating drainage grips at regular intervals. Once the surface water has drained away, it will be easier to see how deep the puddles are and whether any infill is required. Apart from the surface water, this section is in good condition.

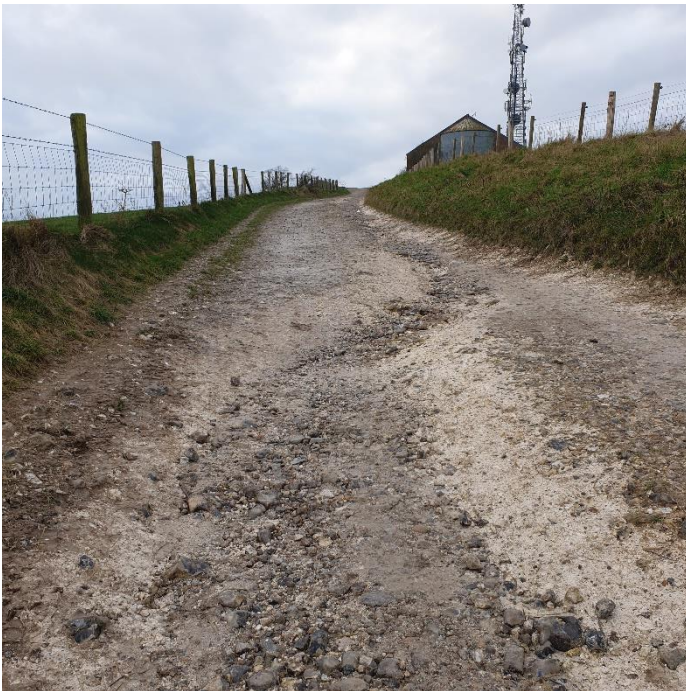
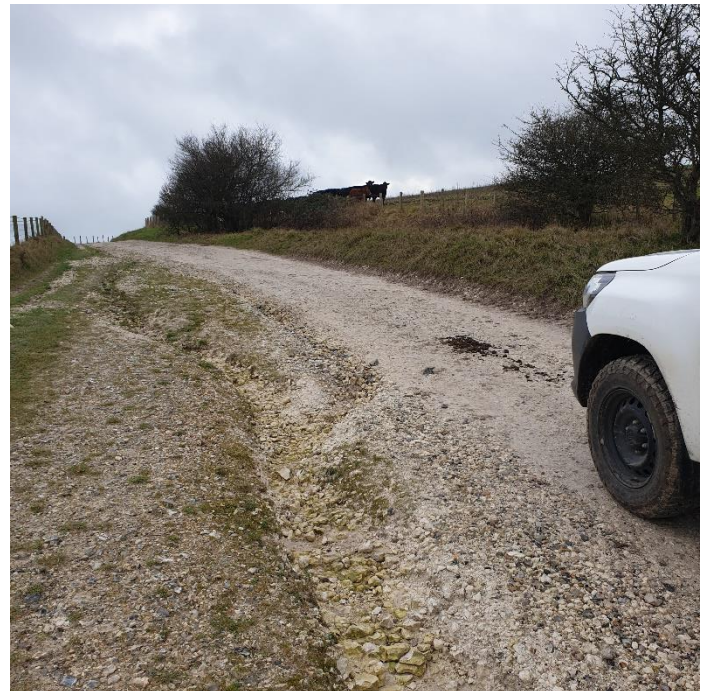
Current Condition: Section D

Surface water erosion has carved a gully down the southern side of the track and is starting to drift across the path at several points (see photos below). There is sufficient width for public use at present, yet the gully is likely to worsen and may start to drift further across the path. There are large tyre marks within the gully, which suggests that large farm machinery also use the track. If the gully is regularly driven in, it will deteriorate quickly, making the chalk looser and easier for the water to wash it away.

This section, out of the four, is of the highest priority to address in terms of improving public access.

From a public access perspective, the surface conditions of Sections A, B, and C are currently suitable for the intended public use. Section D will require some remedial work soon to prevent further deterioration.

Water management is key here which is more difficult when the track is sunken and lies below the verge or has banks on either side. It would require a huge volume of material (chalk) to build up the levels to make the path surface higher than the banks to facilitate drainage. It would be far simpler to re-grade the path giving it a sufficient cross-fall and to build humps to direct water off the path towards the verge. The verge/banks would need to be dug into to allow water to flow away from the path surface.

Our programme of surface repair work for next financial year (2022/23) has been prioritised and agreed. We recognise that Section D does require attention and therefore we have included this in the following year's work programme (2023/24). The list is subject to change depending on any unforeseen urgent work arising (e.g. landslips and coastal erosion).
