**STEDHAM WITH IPING PARISH COUNCIL AND MINSTED RESIDENTS GROUP
SUPPLEMENTARY STATEMENTS TO ROMP SUBMISSION DATED 20th September 2019.**

We are responding to the further information, Additional Information (4) dated September 2019, supplied by the applicant's agent and to other related matters. This representation should be read alongside all the comments that we have already submitted which remain valid.

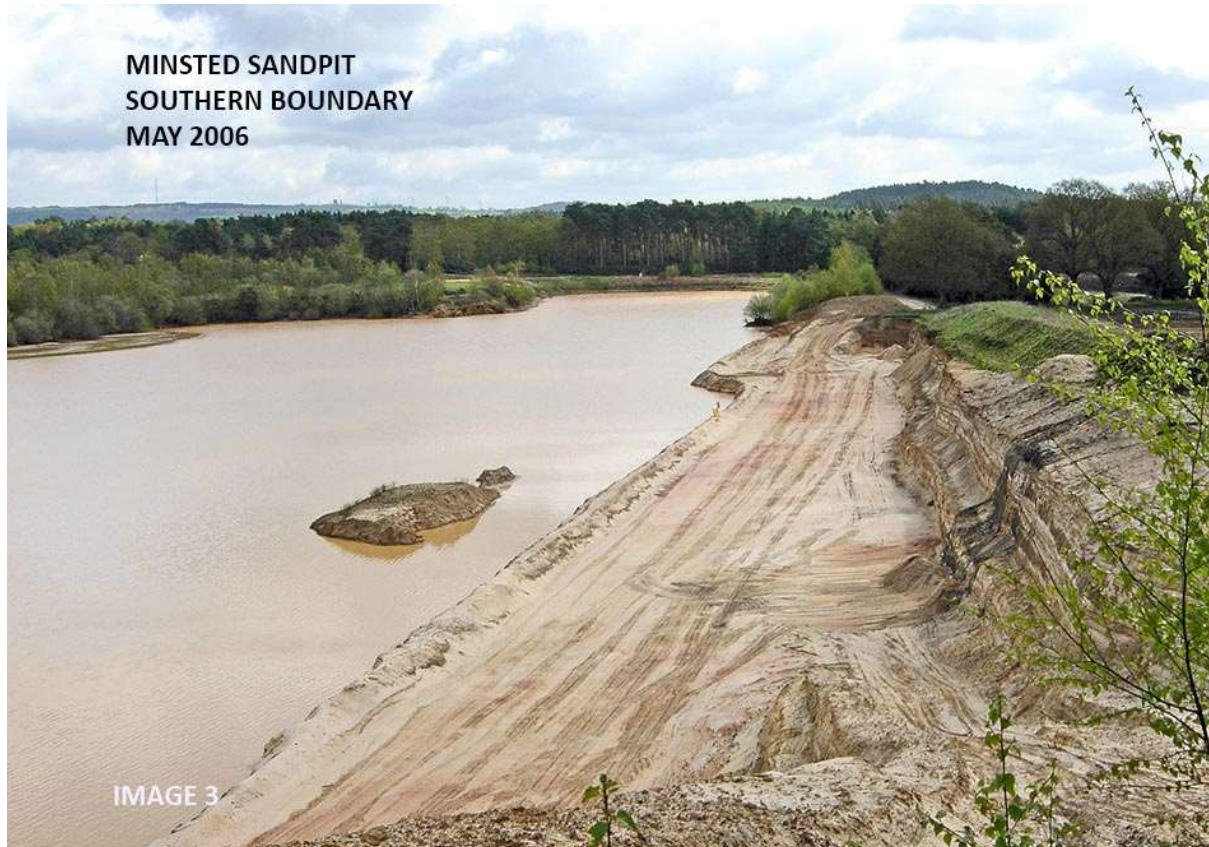
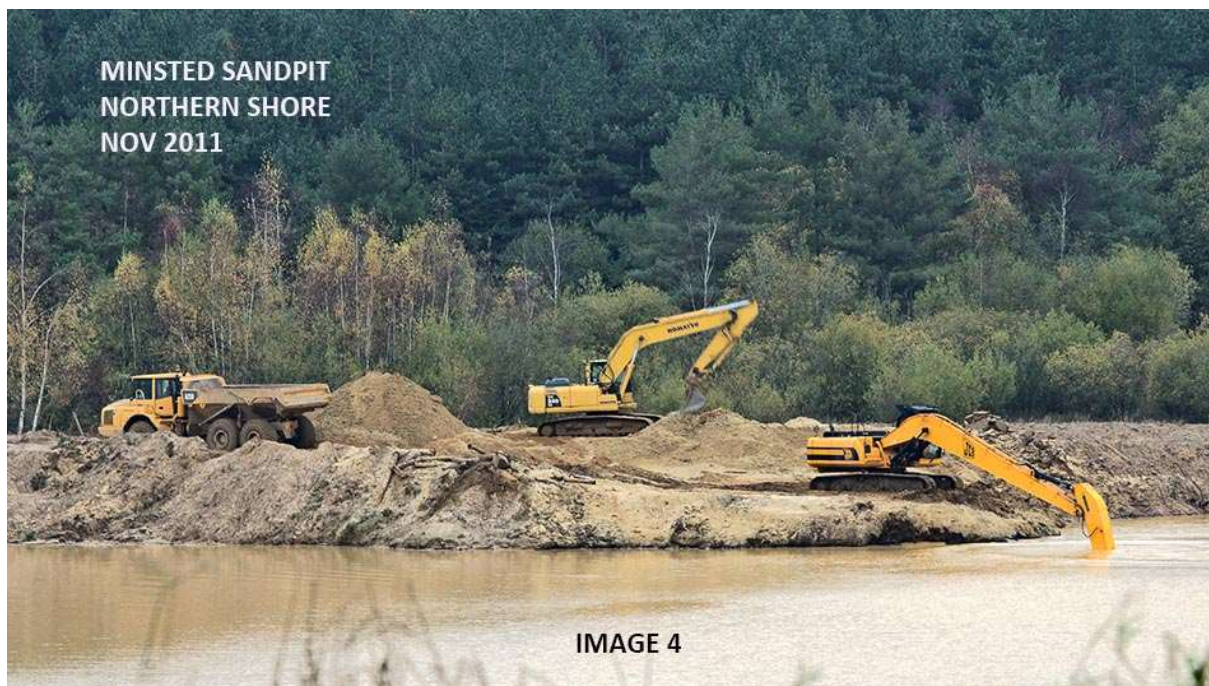
[Images 2 & 3](#) in Appendix V explain what has occurred here. Hansons left flat bunds on the south and west banks which marked the edges of cut. Since then, all the restoration has been taken out by the current operator leaving vertical cliffs of some 11m high and a bench effectively of some 15m wide. This will not allow restoration to the required 1:3 slope of 19 degrees and so the southern boundary cannot be restored to plan without substantial grading works extending back into the lake.

The underwater batters with their 30-degree slopes have also been dug out and will need to be replaced. This will be a difficult task as uncompacted sand will simply dissipate into the water and so substantial material will be needed to replace the batters and widen the over-excavated bench.

The sandstone in the northwest corner of the lake which was dumped there by Dudman is not suitable for this task, as has been suggested. There needs to be realistic proposals

made as to how restoration of the southern bank can be carried out to meet the terms of the current restoration requirements. No part of the ROMP submission includes any clarity on how the safe and permanent restored gradients will be formed, including the nature and type of plant and machinery that will be used to ensure a stable and permanent restoration.

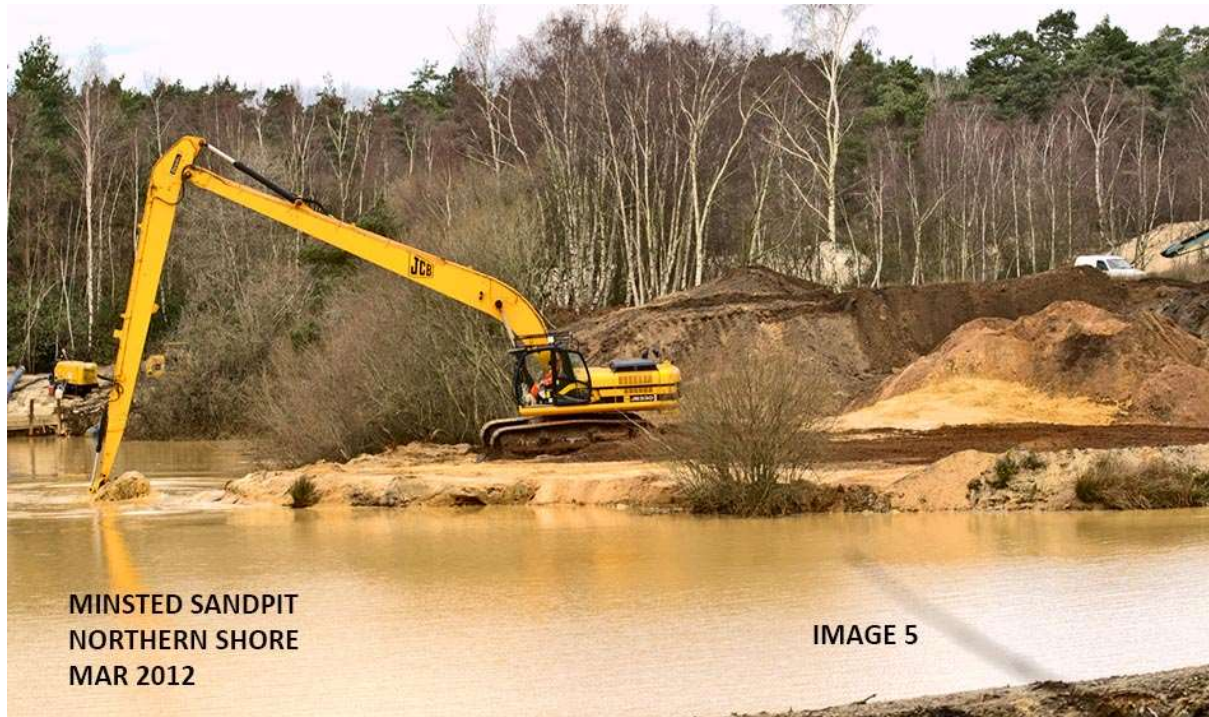
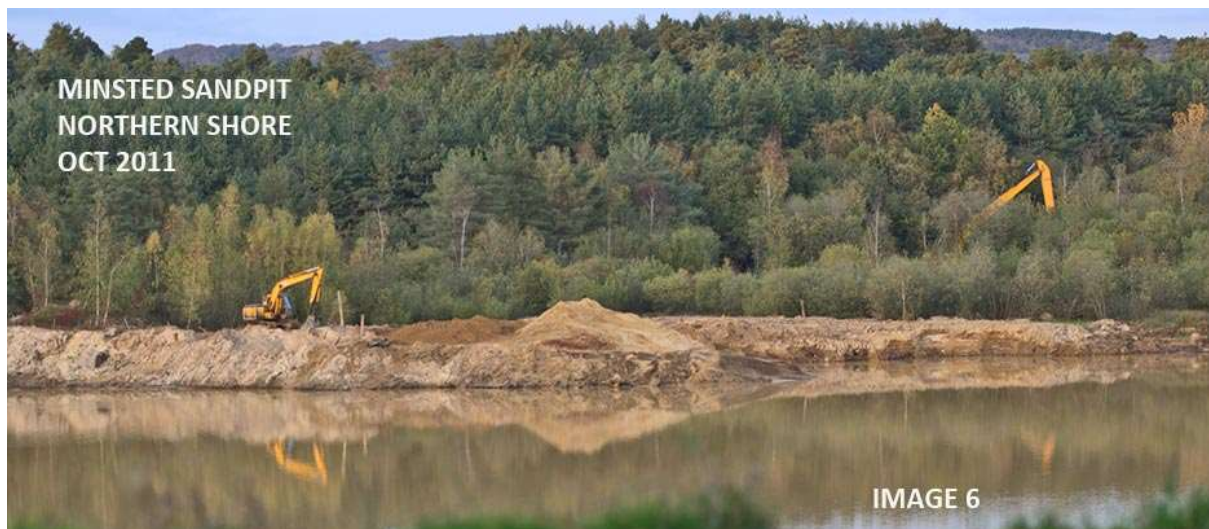
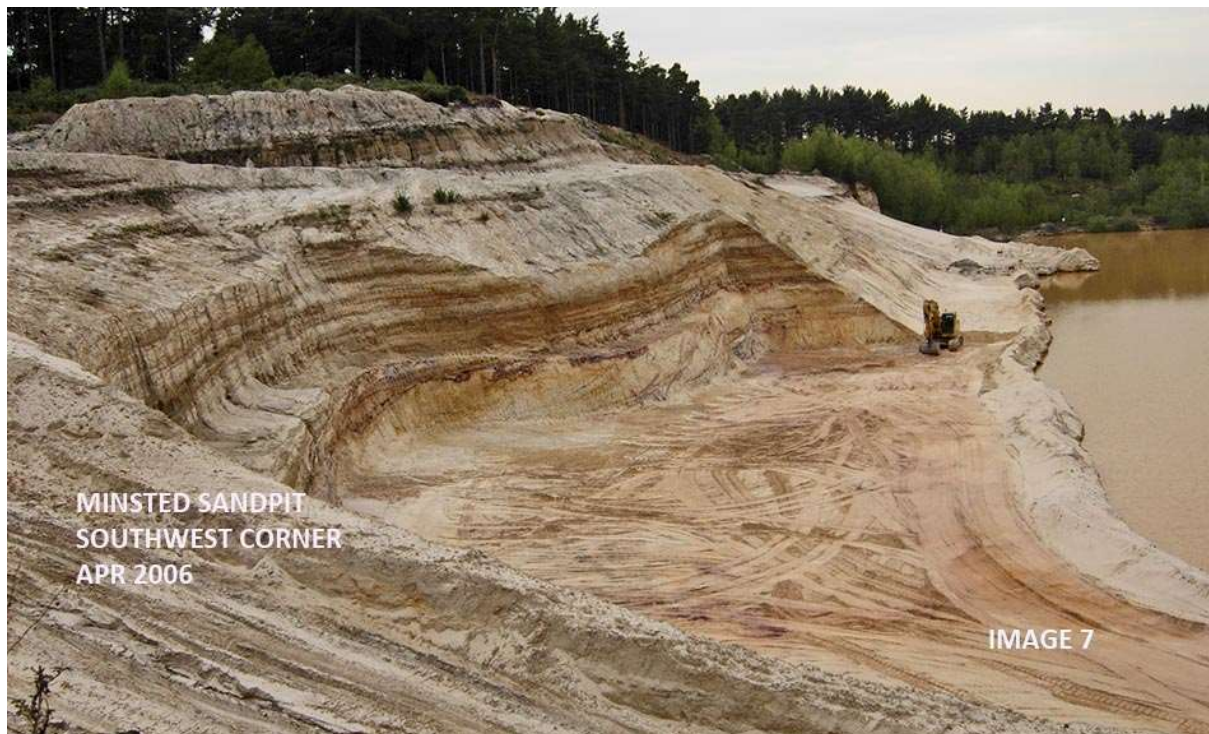
The north and northeast boundaries are outside the current Phase 1, Phase 2 & Phase 3 areas of the Working Plan. They had been restored by Hanson to form a varied shoreline, shallows and beaches. These, too, fell to Dudman's excavators but should be capable of restoration if all the sand taken out is put back. **Images 4, 5 & 6** in Appendix V illustrate these workings.

There was no permission either to excavate these areas or to use long-reach excavators, in itself a method of extraction that was not compliant with the operating conditions.

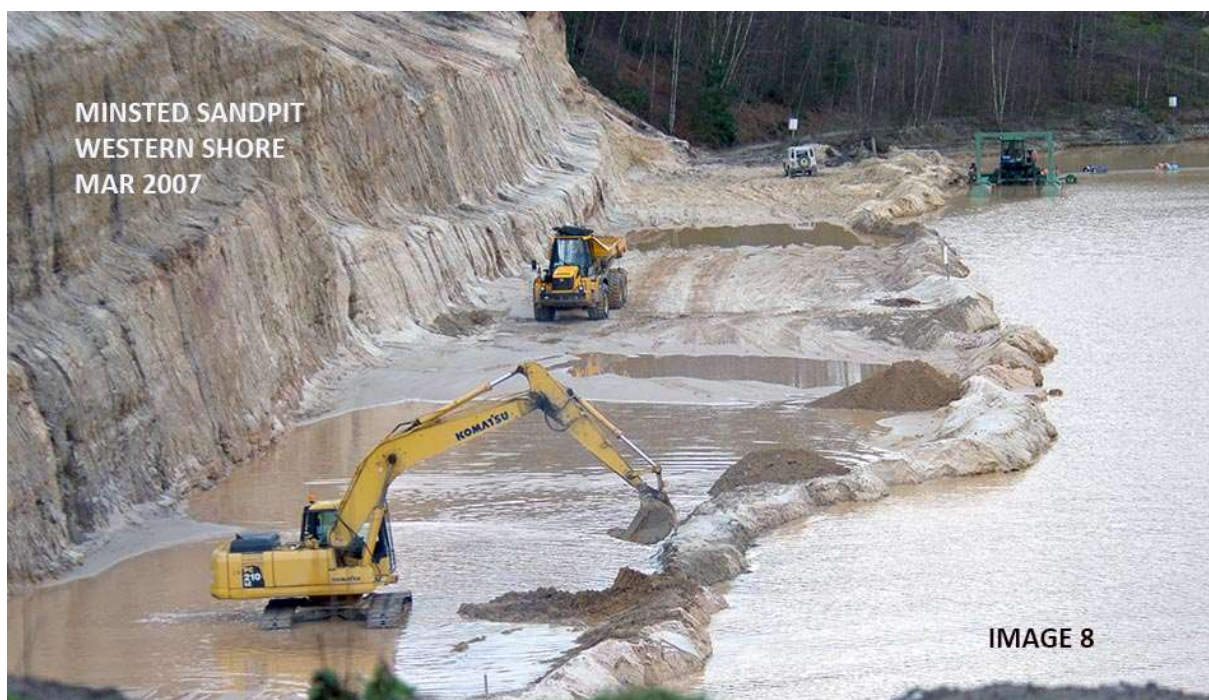
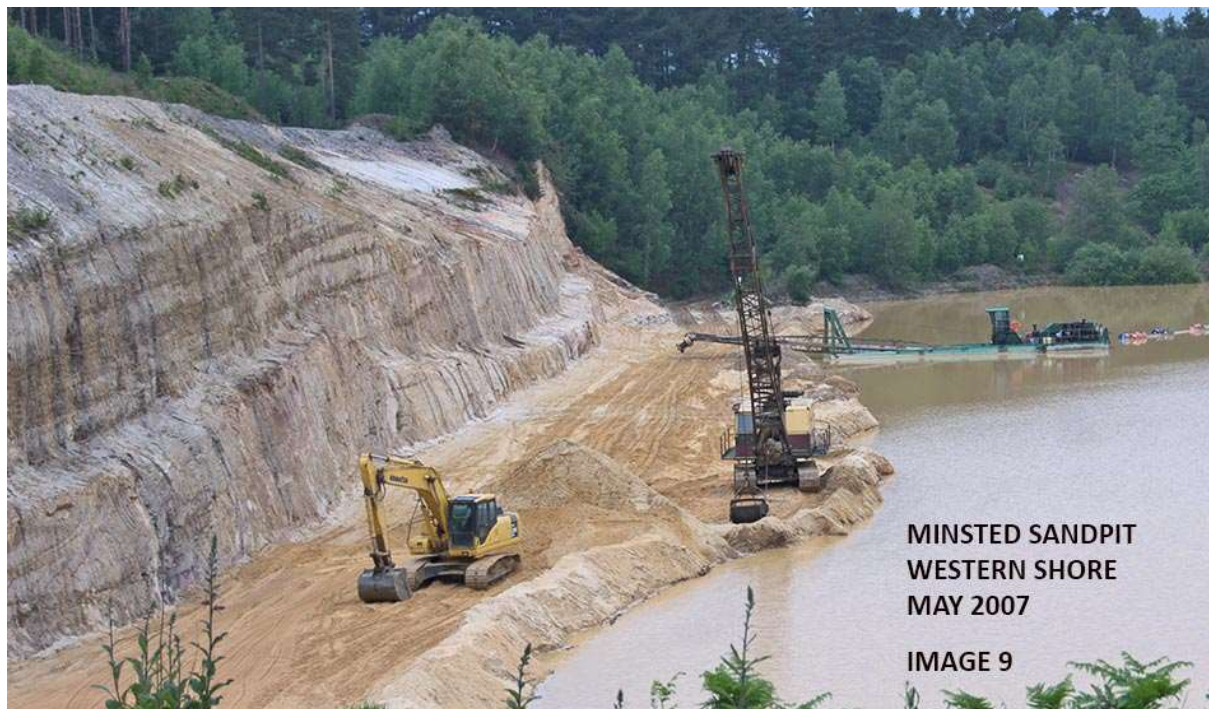
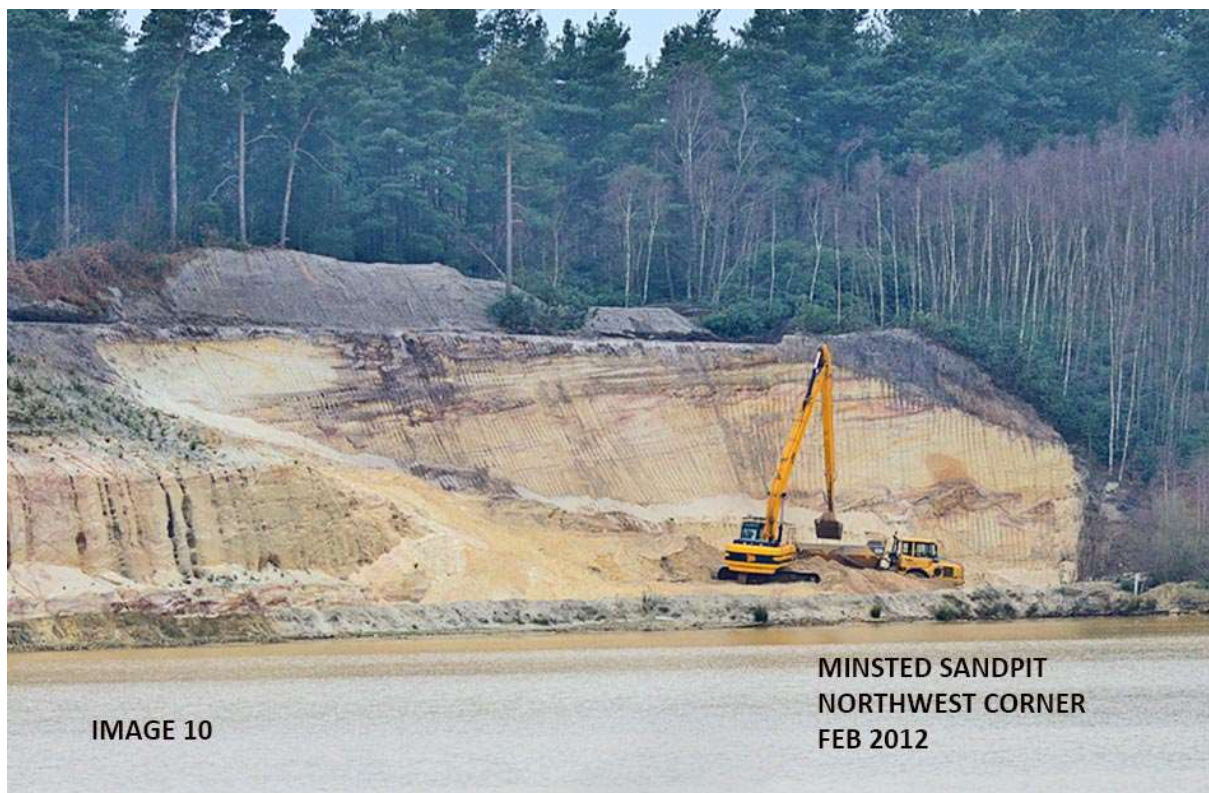
See **images 7, 8, 9, & 10** in Appendix V.

The western boundary is most significant in both its visual impact and the scale of over extraction. In 2005 the top of the ground extending north from the protected tumulus indicated approximately the beginning of the restored slope, shown in the plan 51m from the lake edge and following its contours. Excavation above and below the lake has allowed the lake to encroach closer to the site

boundary by 19m but leaving a level margin above the lake to the base of the cliffs, where the sand from the previous restoration has been removed, of average width 32m.

The previously restored level track margin around the lake has disappeared as sand has also been extracted from below the water. This leaves an area of extraction 32m wide along the worked length of the western boundary of 272m as it was in 2013 (238m in 2005). The average height of the cliffs is conservatively estimated at 20 metres, and allowing for the slope of the material remaining from the previous restoration this gives a triangular cross sectional area along the length of the working face of height \times base/2 = $20 \times 32/2 = 320\text{m}^2$. This area multiplied by the length of working of 272m gives $87,040\text{m}^3$ or 139,264 tonnes. This estimate is only for extraction visible above water level, and extraction that has taken place below the lake will significantly increase the volume of over extracted sand.

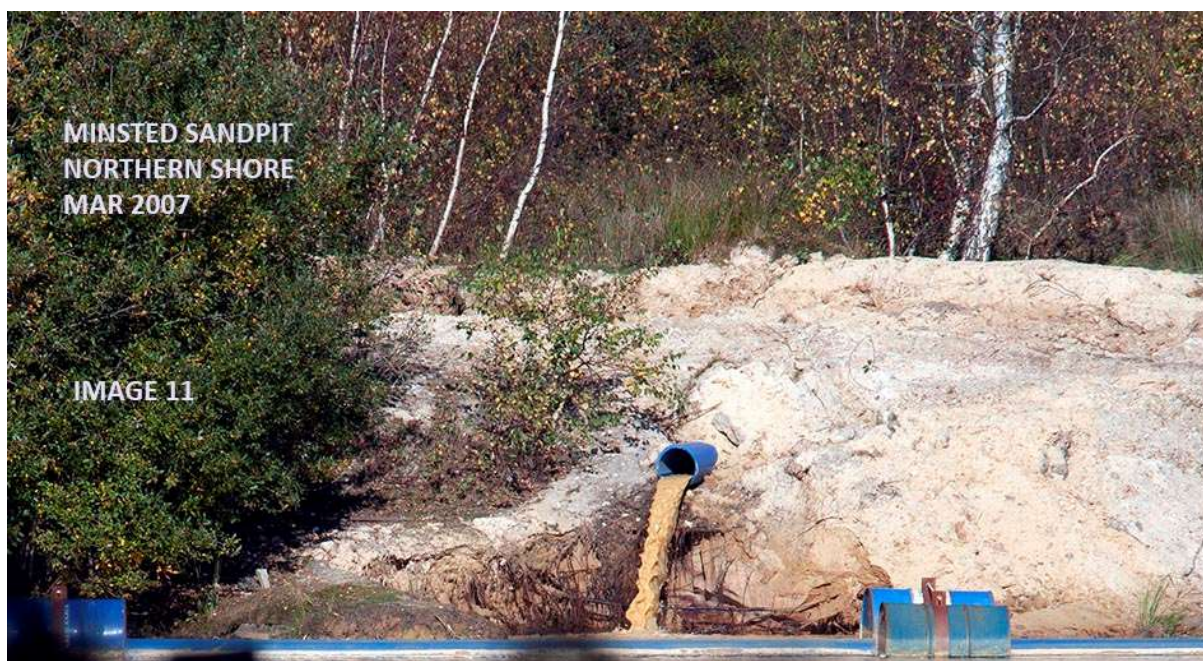
Image 11 In Appendix V shows unfiltered waste water from the processing plant emptying into the lake through a purpose-installed underground pipe, completely bypassing the filter beds. We estimate that this pipe had the capacity to feed dirty water into the lake at a rate of 30,000 gallons an hour. The fine grains of sand are harmful to the gills of fish which is why none are now left in the lake.

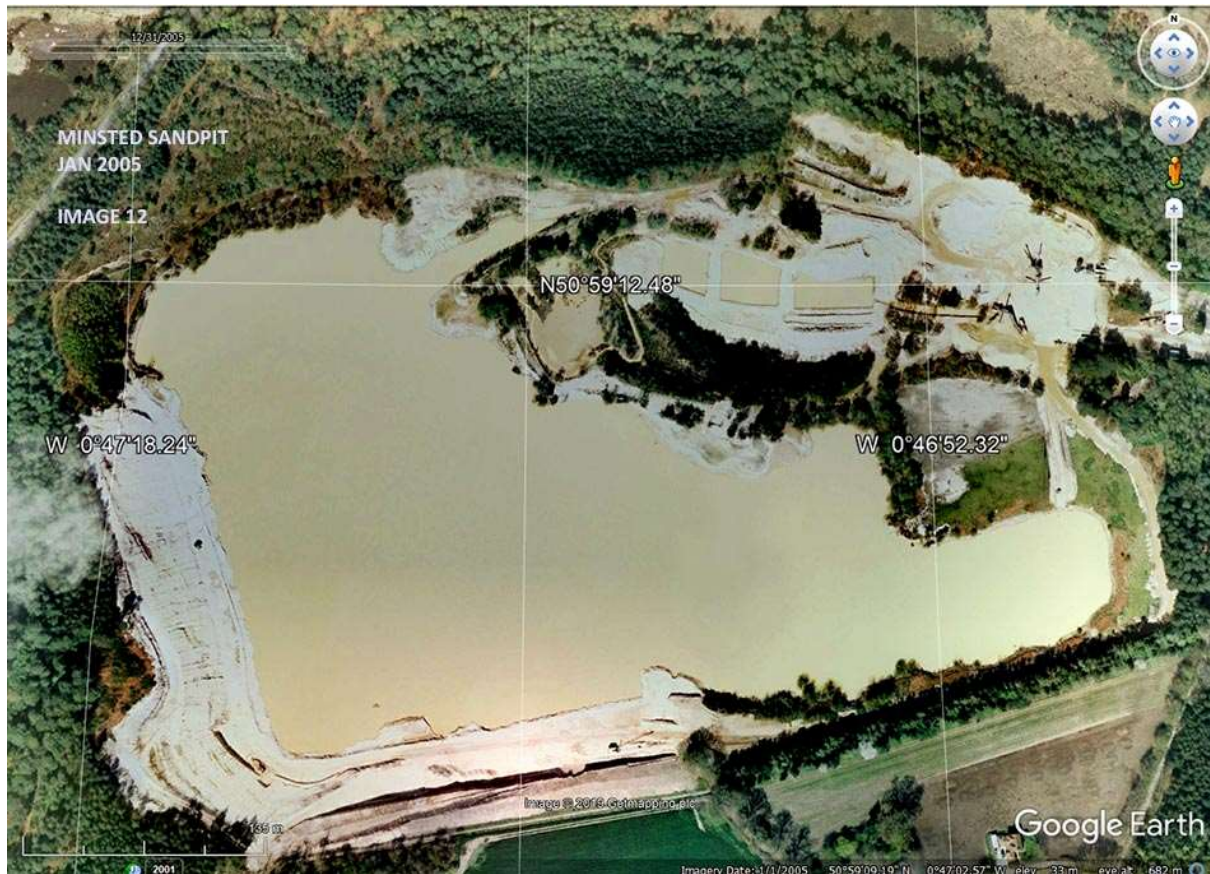
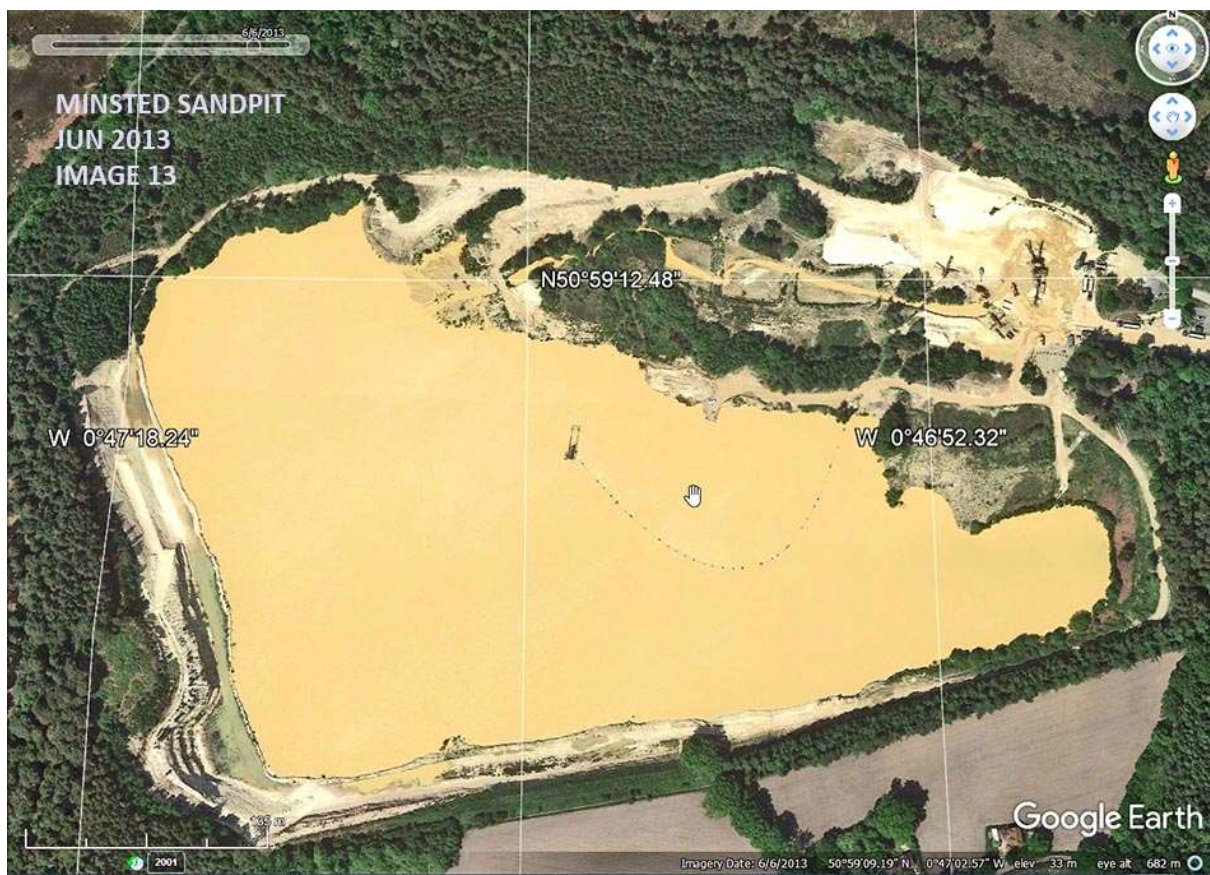
Given what can be seen through observation of the extensive photographic evidence and the use of Google Earth images from 2005 and 2013, images 12 & 13 in Appendix V the extent of Dudman's workings becomes clear and irrefutable. Photographs clearly show that Hanson's left the site in 2004 with restoration over 75% completed and the slopes and above water benches around the lake compliant with the 1998 restoration plan. Photographs are in Appendix V.

Google satellite images from 2005 (shortly after Dudman's taking over) and 2013 (one year before Dudman's suspension) have been used to measure changes in the lake dimensions, topography and the width of ledges around the lake. These images with reference to photographs show the full extent of sand removed above water level from the restored slopes to the west and south, which are now vertical cliffs. Estimates of volume removed are based on two-dimensional measurements, using accurate grids and scales on the Google images showing precisely the area of land taken, times the average depth removed, based on photographic evidence. Accurate reference points on both the Google images used provide a high degree of confidence in the dimensional changes we have measured. Weights are based on 1 cubic metre of dry sand weighing 1.6 tonnes.
