Conservation Area Character Appraisal and Management Plan

Alfriston

March 2014

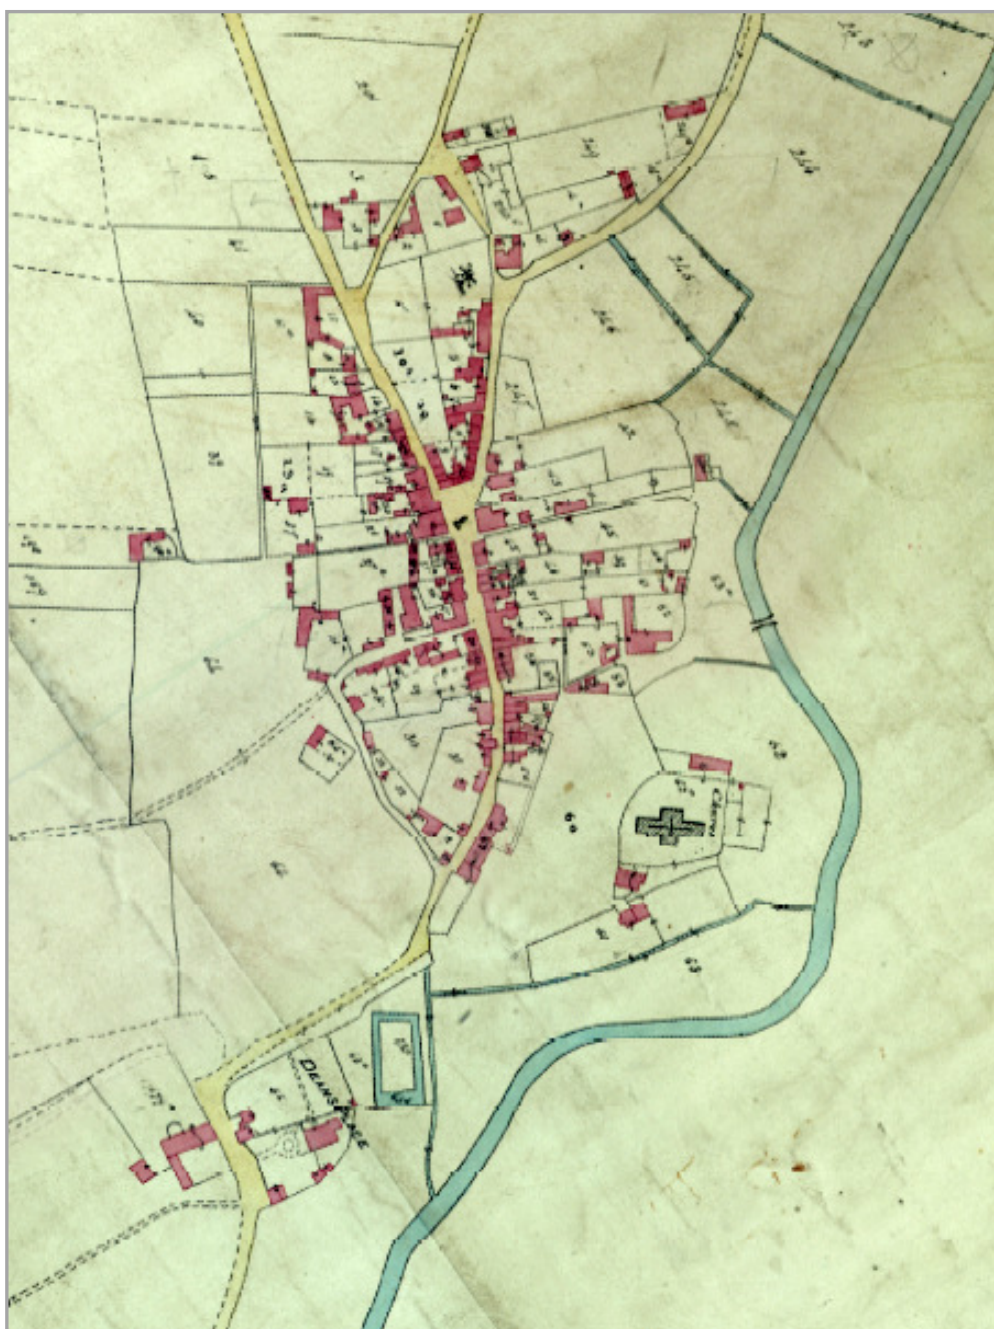
Figure 4: Alfriston Tithe Map of 1843

3.11 By 1600, the layout of Alfriston was very much as it survives today. Map regression using the tithe map (figure 4) and successive Ordnance Survey maps (figures 5 – 7) shown only a slow development through the 19th & early 20th centuries.

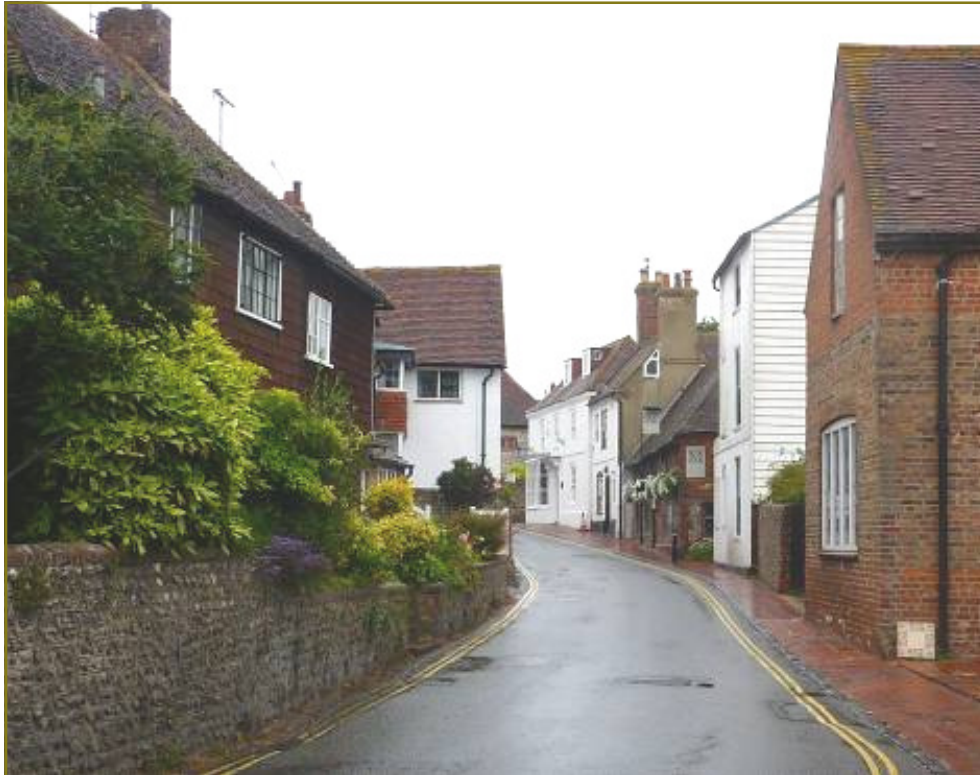
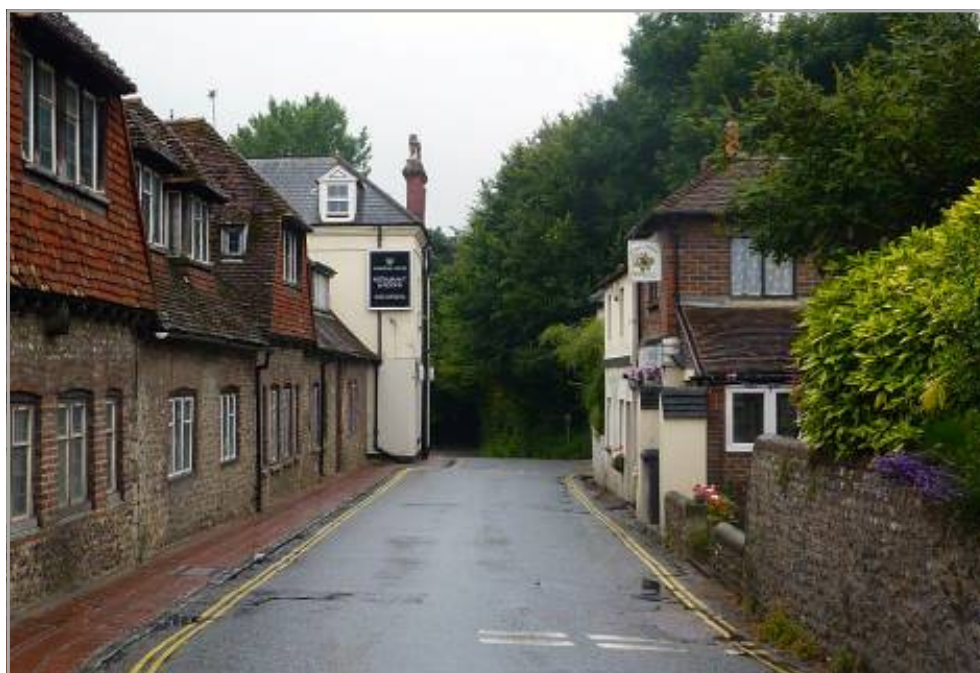
Figure 10: A pinch-point at the southern end of High Street, looking northwards (above) and southwards (below). The narrowness of the road and pavement, and the lack of view from one end to the other results in a potential for conflict between vehicles, pedestrians and the built fabric at this point, and care is required from all road users

5.4 There are a number of pinch points along the length of High Street (figure 10)

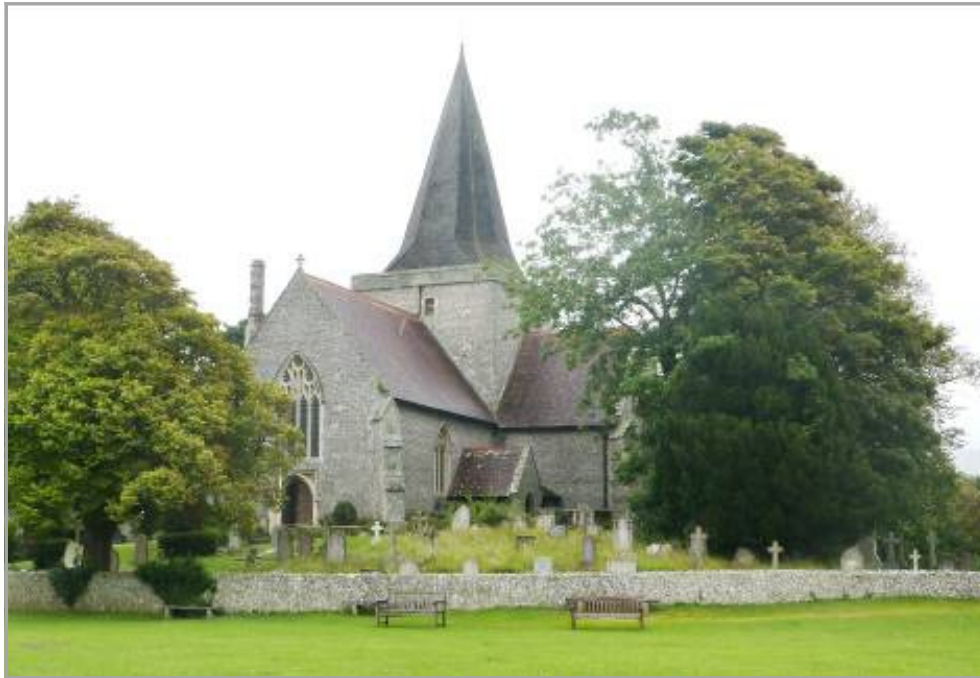
(Figure 18) The Parish Church of St Andrew's sits in an elevated position within The Tye. With the stone wall enclosing the graveyard and a number of significant trees, the whole makes a very attractive composition. The Church itself is mostly constructed of flint, as befits the 'Cathedral of the Downs', and is largely late 14th century in date. Nothing is known of its predecessor, which presumably stood on the same site. The Church is a Grade I listed building.

4.13 The Parish Church of St Andrew is the earliest surviving building within the village, being a large church mostly of late 14th century date (figure 18). It sits in an elevated position within The Tye (figure 19). With the stone wall enclosing the graveyard and a number of significant trees, the whole makes a very attractive composition. The Church itself is largely constructed of flint, as befits the 'Cathedral of the Downs'. Nothing is known of its predecessor, which presumably stood on the same site. The Church is a Grade I listed building.

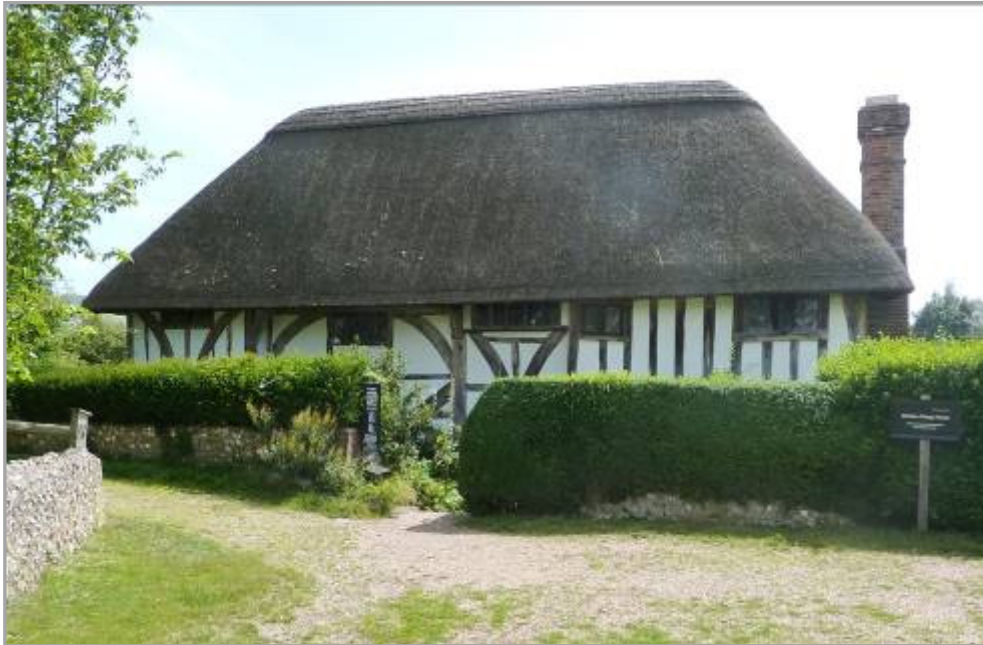
Figure 21: The Old Clergy House (Grade I) is a classic example of the “Wealden” house, a type of timber framed house that was popular in south east England, particularly Kent and eastern Sussex, in the 15th century.

An unaltered Wealden House is a two-storey building. In the central part is a large hall which is the full height of the building to the roof. At both ends of the building, on either side of the hall, there were ground and first floor rooms. These ends projected at first floor level from the main wall. The hall did not project, however, and the result was a recess in the middle of the building that is a typical characteristic of Wealden Houses

The Old Clergy House was the first building bought by the National Trust and, as such, has an important place in the history of the conservation movement as well as that of Alfriston.

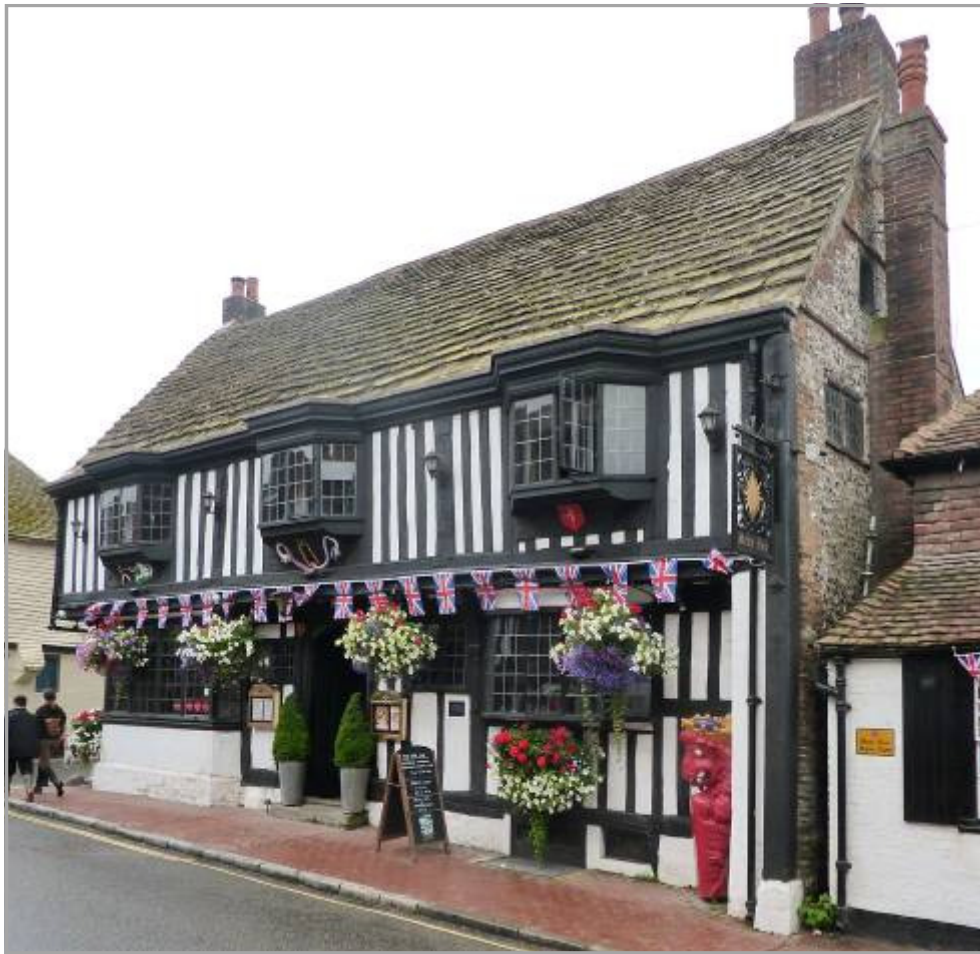
Figure 22: The Star Inn (Grade II* listed) is a good example of a 15th century timber-framed building. The closely spaced vertical timbers are called “studs” and when they are placed close to each other as on this building, it is called “close-studding”. The gaps between the studs are filled with plaster. The first floor projects over the ground floor supported by a large timber beam called a “bressumer”. This has carvings, including that of St George and the Dragon shown below.

The roof is covered with slabs of Horsham Stone.

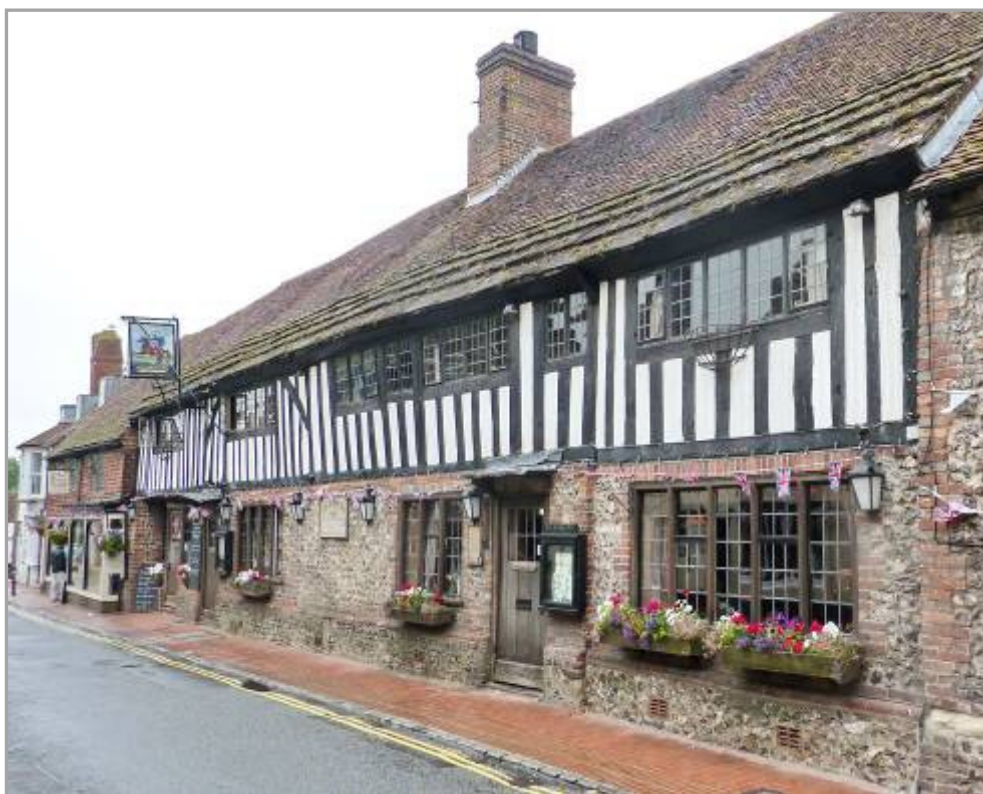
Figure 23: The George Inn (Grade II) is another building of 15th century origin but has seen much alteration and restoration over the succeeding centuries. In its original form, the building was a “Wealden House”. The late 16th century saw many changes, including the addition of the large chimney. In the late 18th and early 19th centuries, the flint and brick ground floor wall was built underneath a projecting jetty, giving a flush front wall. The close stud work was once covered with hanging tiles. An extensive restoration of the timber-frame after a fire in 1943 produced the building that is seen today. The combination of Horsham stone and clay plain tiles is an interesting feature of the building.

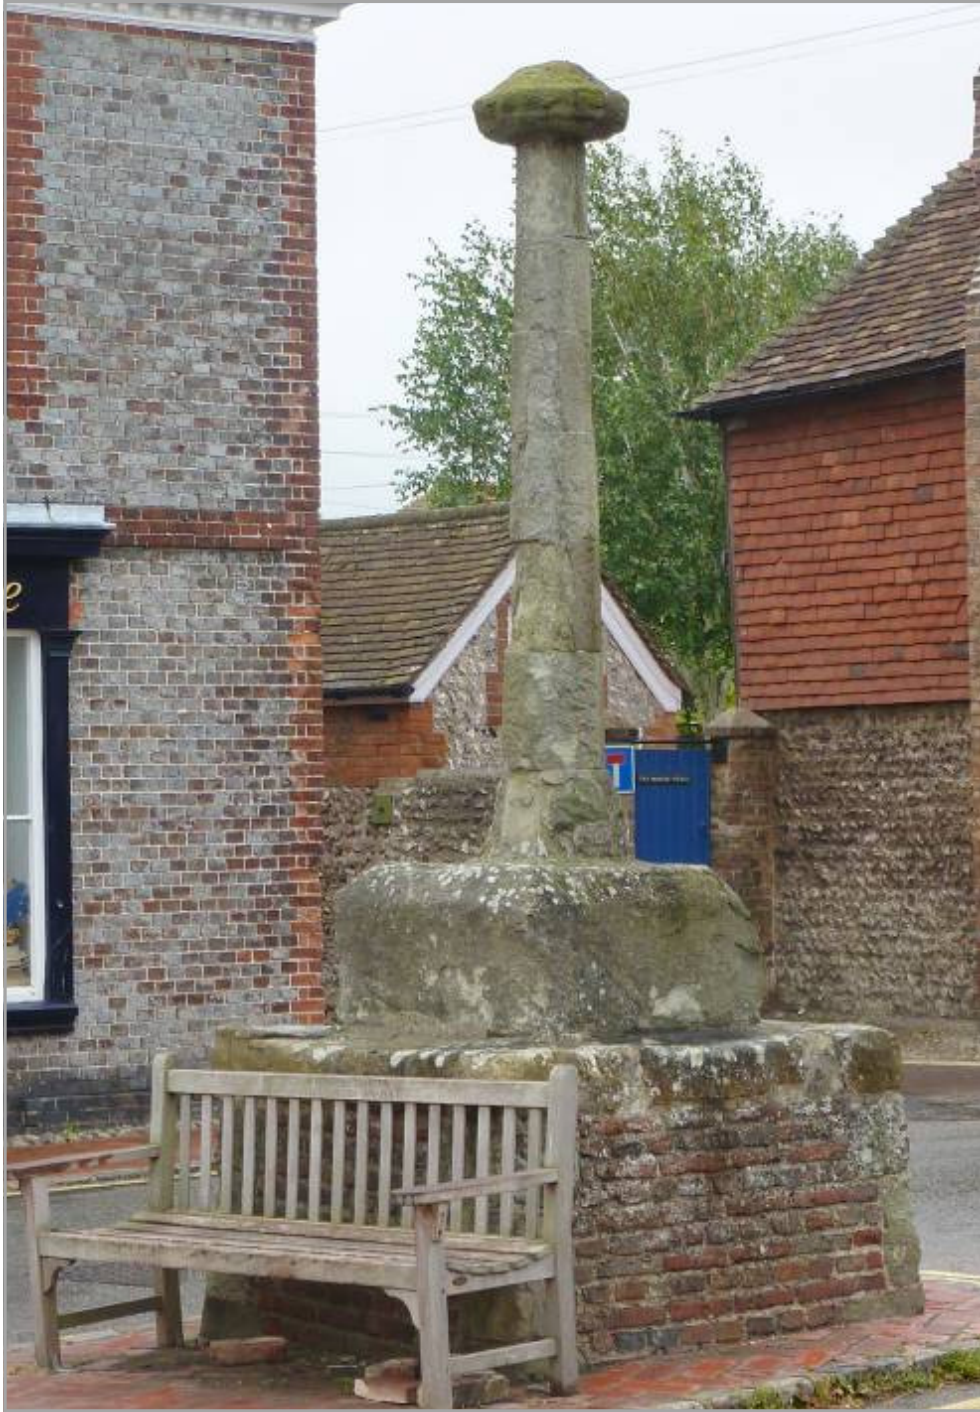
Figure 24: The Market Cross was probably first erected in 1406 when the market charter granted the right to hold a Tuesday market. The survivor is much altered, with the medieval stone base and truncated stone shaft, minus some of its length and the actual cross, standing on a modern brick plinth. Nevertheless, it is one of only two market crosses surviving in Sussex and it remains an important focal point within the village and significant testimony to the history of the place. It is a Grade I listed building

(Grade I). The only remaining market cross in Sussex, other than the great example at Chichester. Stone base and shaft of the medieval cross on a modern brick plinth. The cross itself is missing, but the cornice-like stone at the top was added in 1833, when the old steps were removed.

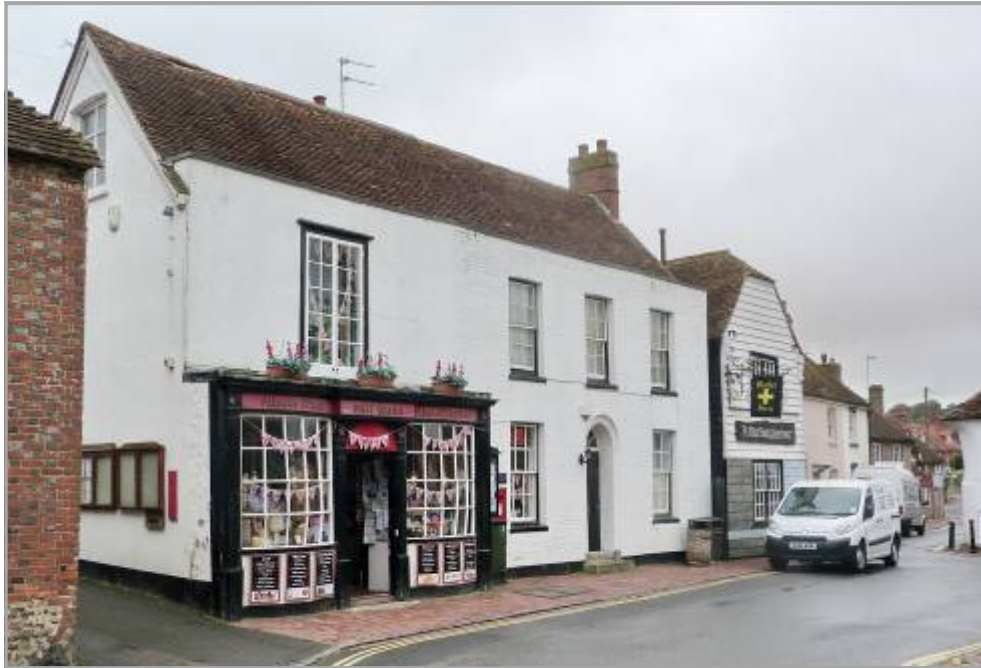
Figure 25: Described as “Alfriston Post Office (Phillips’ Stores) and the house attached” in its list entry, the building is 18th century in date and retains a fine 18th century shopfront.

Alfriston Post Office (Phillips' Stores) and the house attached, High Street, Alfriston. (Grade II).

C18. Two storeys. Four windows. Painted brick, southernmost window-bay stuccoed. Parapet. Tiled roof. Glazing bars intact. In south east corner is an C18 shop front of two curved windows with glazing bars, flanked by pilasters with a doorway between with fan ornamentation in the tympanum. In the centre of the remainder of the front is a round-headed doorway with semi-circular fanlight and six panel door. Grade II* for the shop front.

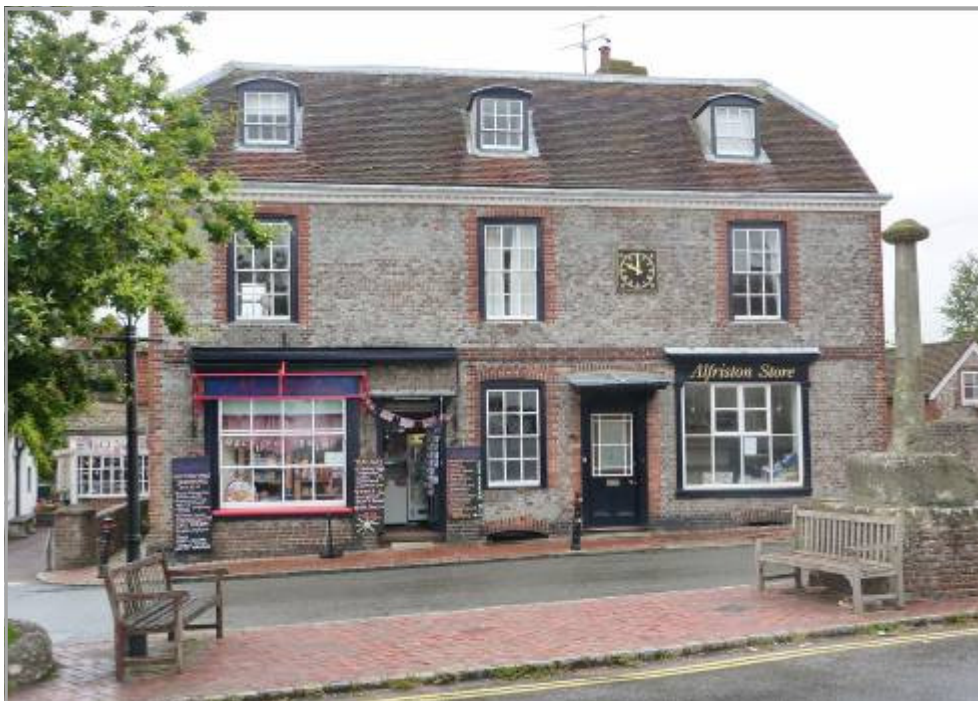
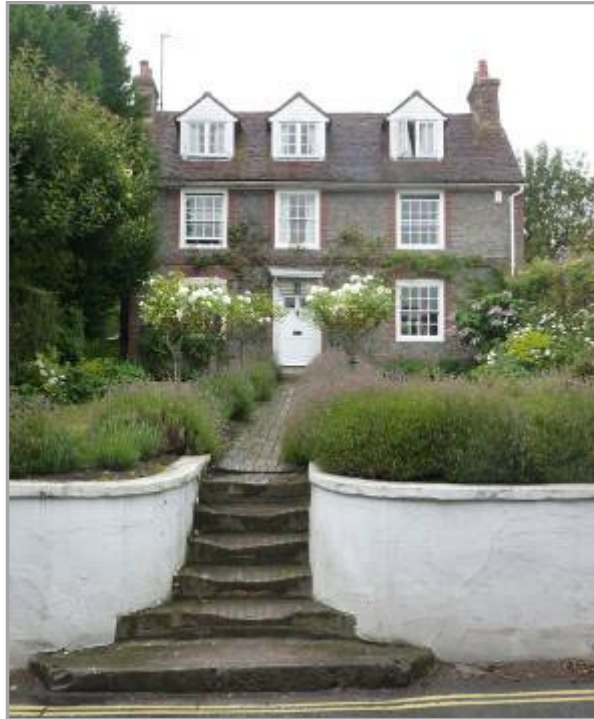
Figure 29: Southdown. The dormers were originally flat roofed, the usual 18th century form in the village

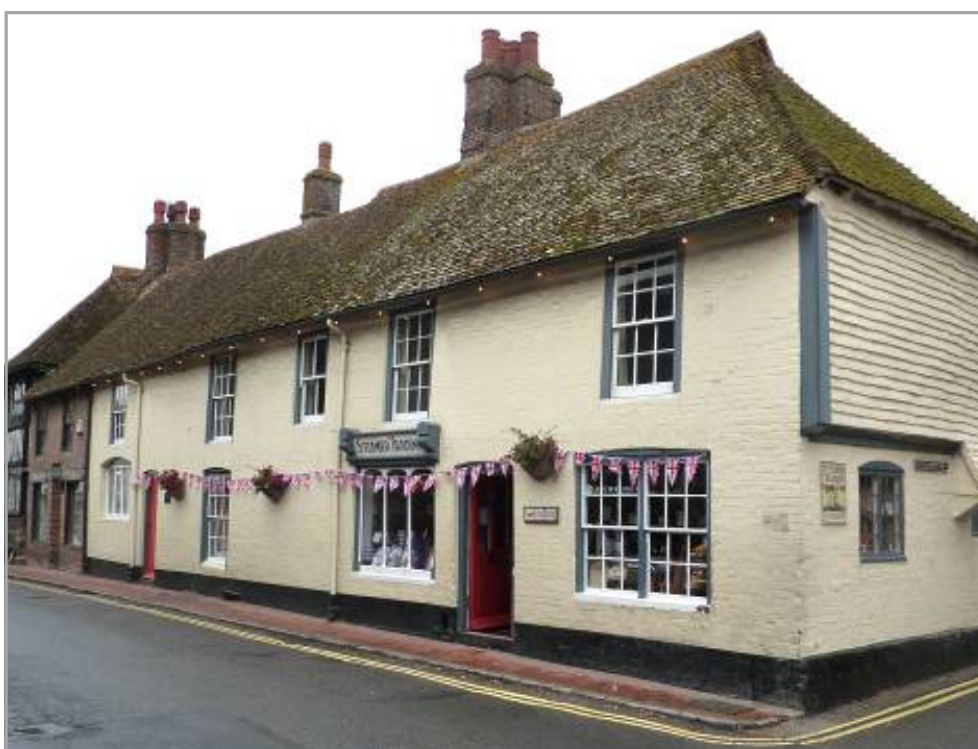
Figure 34: Rose Cottage, North Street, a grade II listed building of 18th century date

4.20 Rose Cottage (figure 34), which stands on North Street where it bends north-eastwards, is a prominent and very fine example of this but others include Brook Furlong on Sloe Lane, Southdown House on High Street, and Wood Butchers and the attached house, also on High Street.

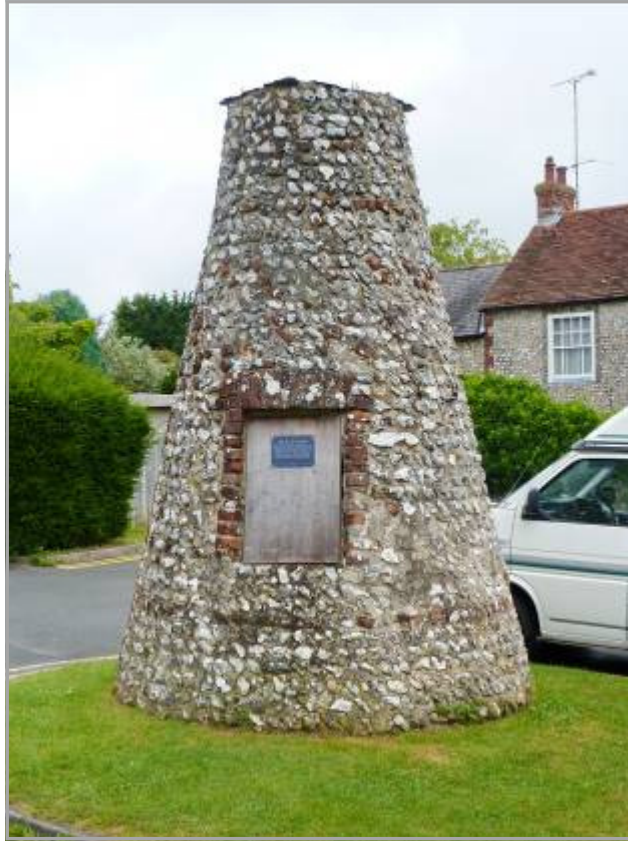
Figure 36: The Flint Tower. Built in the early 20th century as a play tower, perhaps with flints salvaged from an older building.

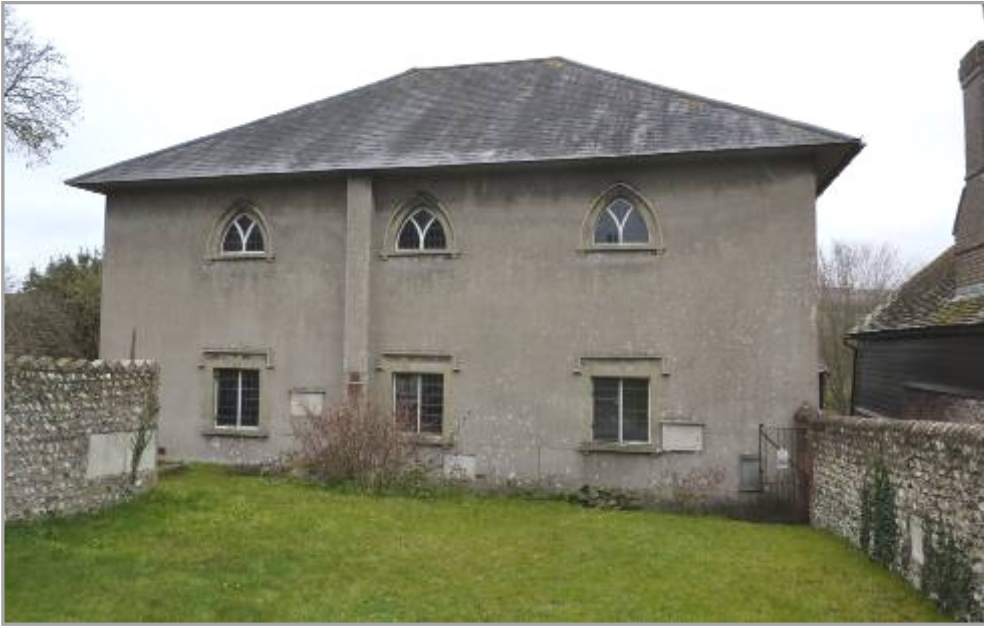
Figure 38: The Grade II listed chapel, now the United Reform Church, was originally built as a Congregational Church in 1801. The external rendering was probably added in the mid 19th century.

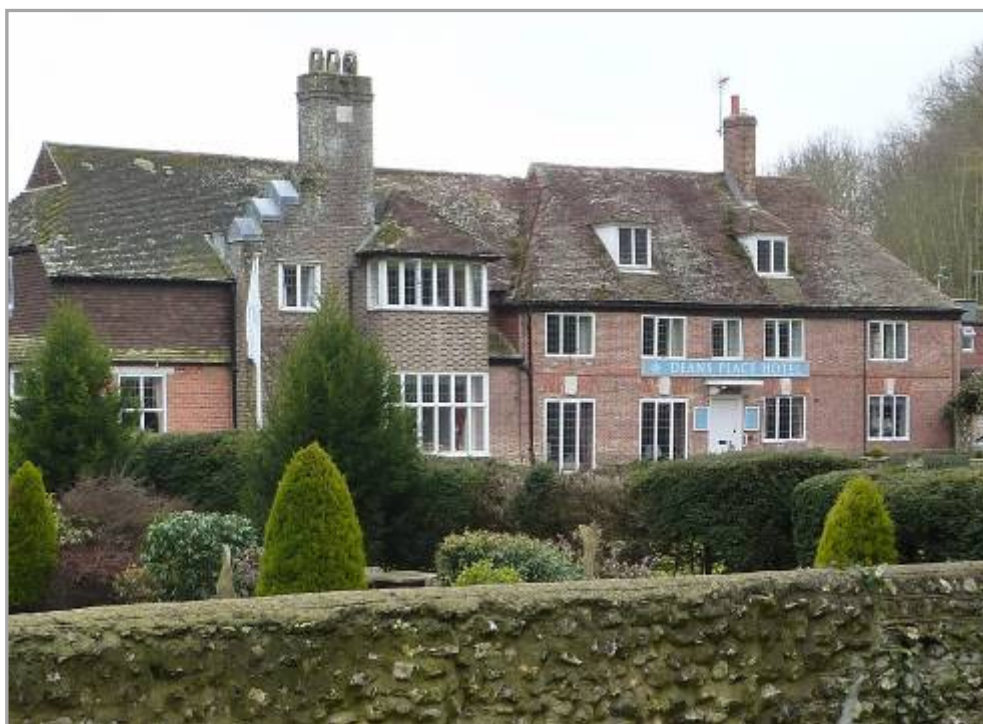
Figure 40: Dean's Place Hotel. The original portion of the building is an L-shaped 17th century (or earlier) timber-framed building which has been re-fronted with brickwork combining red bricks with grey headers

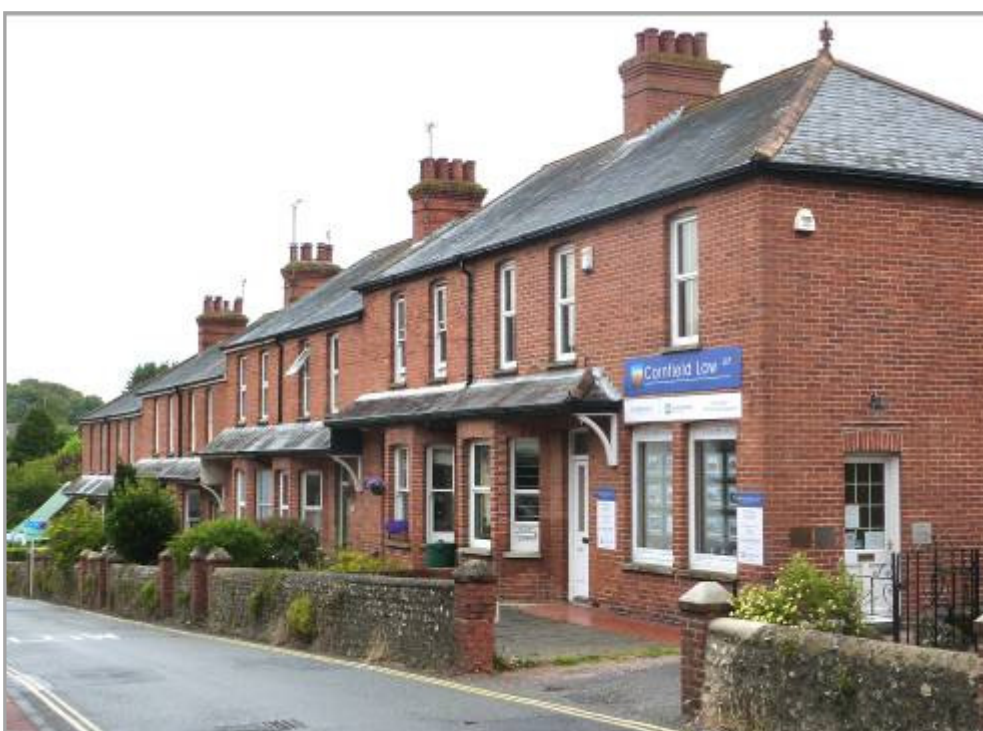
Figure 41: Early 20th century developments are more generic in design than the traditional and vernacular architecture of earlier centuries but still make a positive contribution to the Conservation Area.

4.22 Early 20th century development is represented by the terrace of eight houses on the east side of North Street (the end one now an office) and some larger semi-detached villas on the west side of West Street (figure 41). Both terrace and villas are typical of Victorian and Edwardian residential development through much of England and are not particularly distinctive to Sussex. Nevertheless, as buildings of traditional construction and materials, they do make a positive contribution to the Conservation Area.

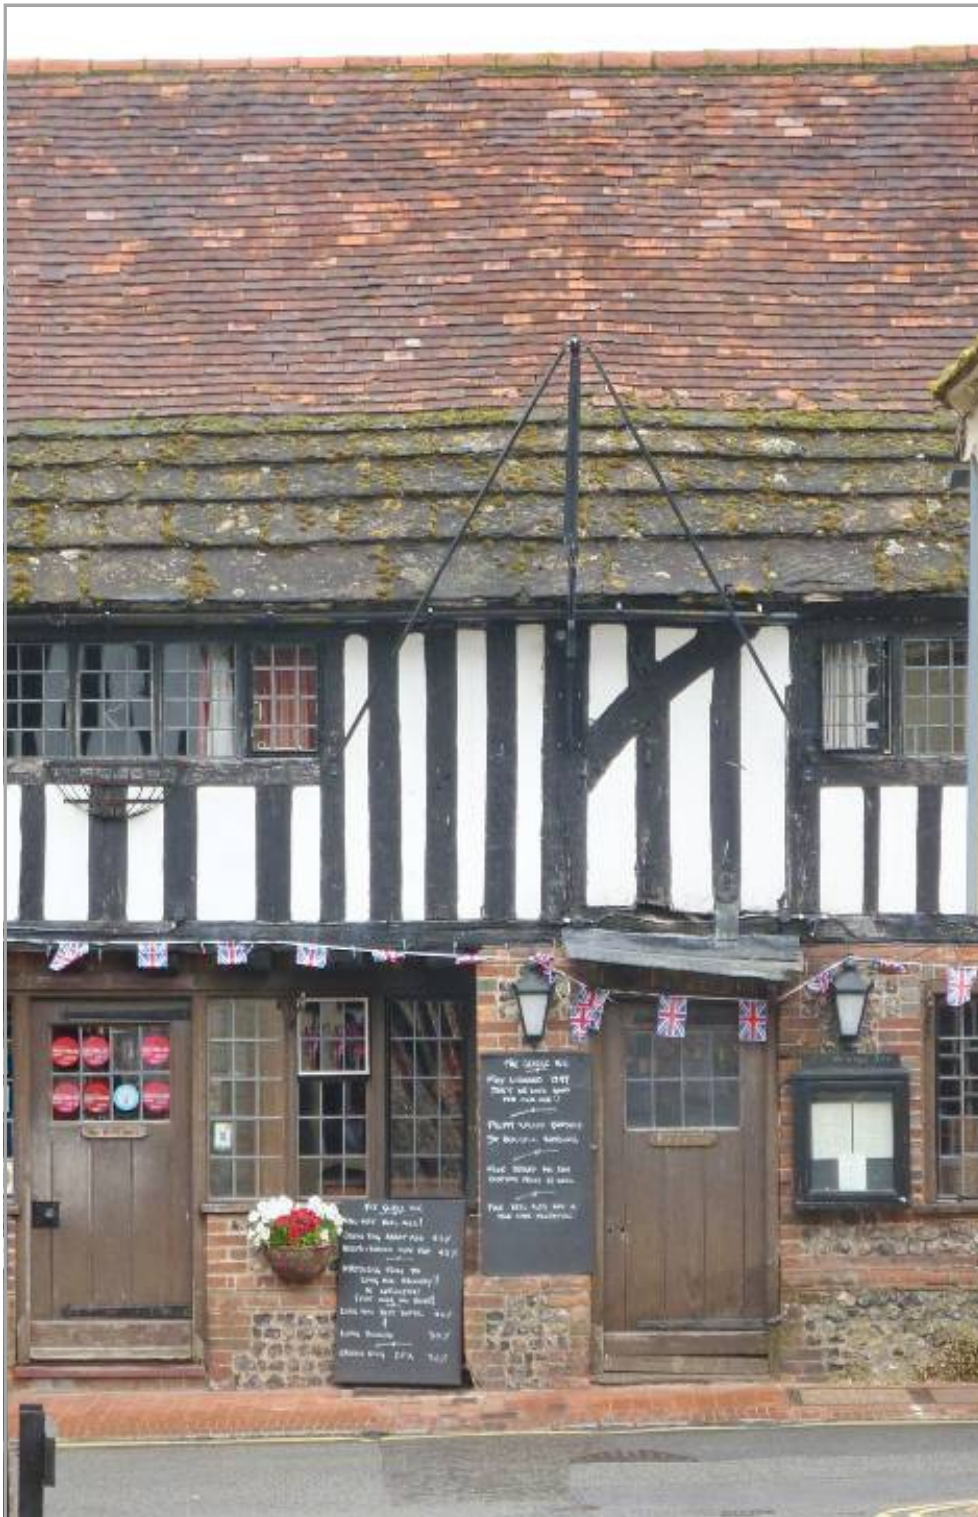
Figure 43: In one building, The George Inn illustrates most of the traditional materials used to build Alfriston – brick, flint and timber framing for the walls; Horsham stone and clay plain tiles for the roofs. The pavement of clay paviors in front of the building is also typical of the historic core of the village.
