## Conservation Area Character Appraisal and Management Plan

# Malling Deanery

March 2016

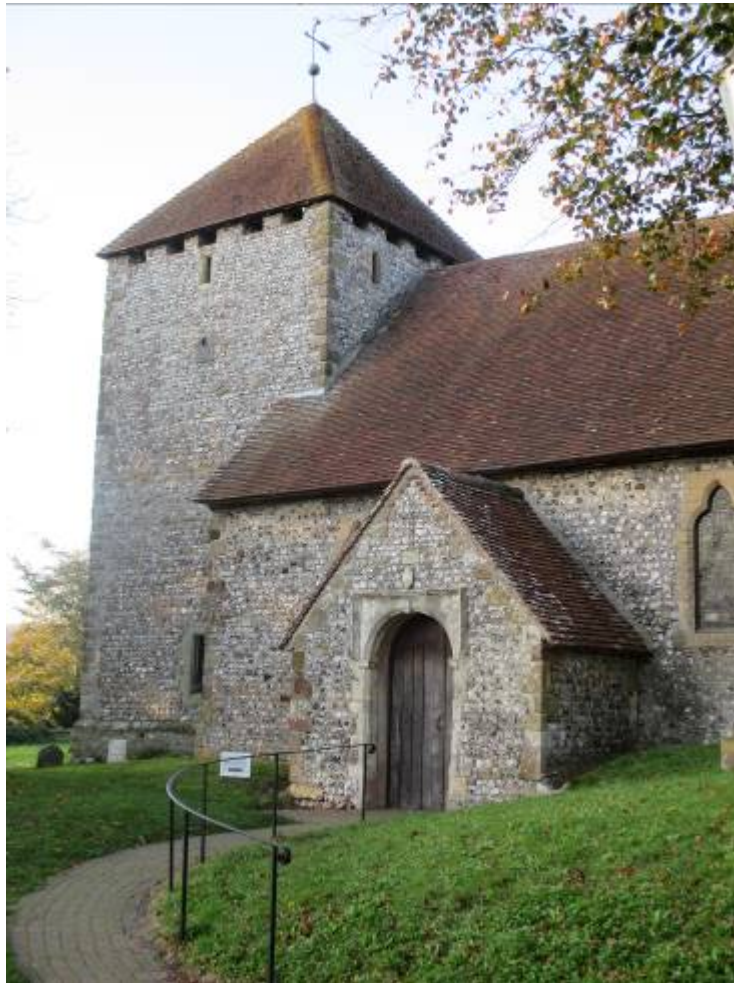
*Church of St Michael*

4.9 St Michael the Archangel, the parish church of South Malling is the notable exception to this residential context. Faced predominantly with field flints and rebuilt in the early Seventeenth Century, it is listed at Grade II\*. The porch is dated 1628. A vestry extension, of some subtlety, has been added to the north side.

Church, C13, C14, rebuilt 1626-28, the foundation stone being laid by John Evelyn, the future diarist and arboriculturalist. Restored 1874. Flint with stone quoins and dressings, plain tiled roofs. Low, two-stage west tower with west window, probably early C14 curvilinear. Pyramidal roof with weathervane. Nave of four bays with single bay chancel, all windows cusped lancets of 1874. South porch, gabled, with moulded round arch with key and impost blocks and hood mould over. Date stone over, marked 1628. North vestry.

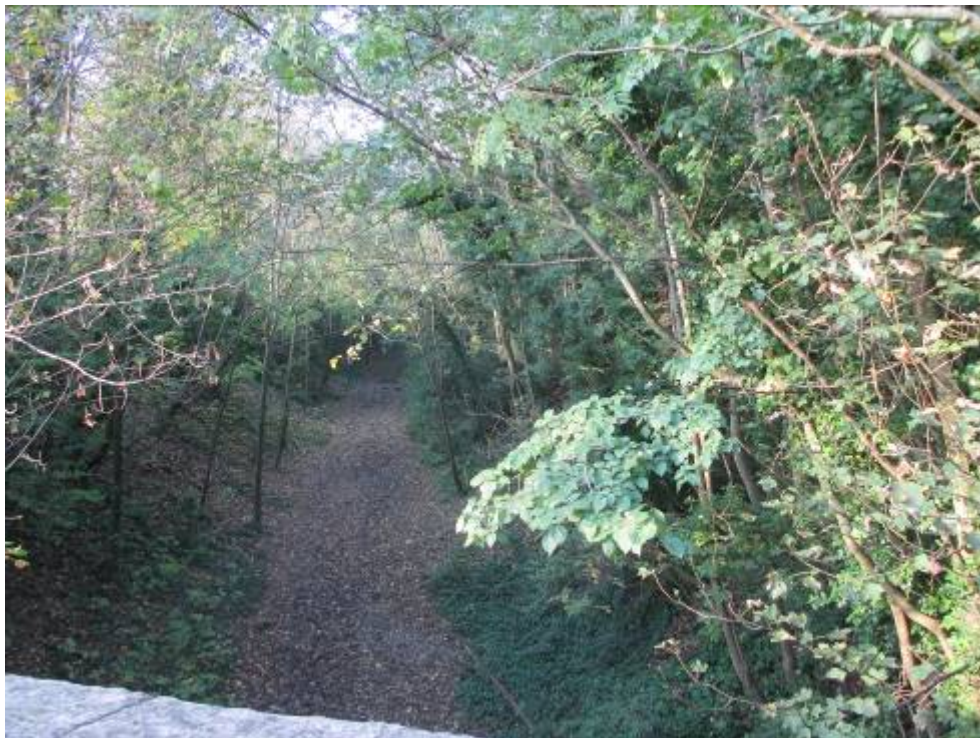
*View north along the former railway track bed from the road bridge*

2.7 The second barrier which constrained development was the former railway line which once connected Lewes with East Grinstead and Uckfield. This feature now consists of a deep railway cutting, at the bottom of which is a footpath enclosed by wooded banks. Church Lane is carried across the cutting by a Victorian bridge. The redundant railway line has been designated a Site of Nature Conservation Importance.

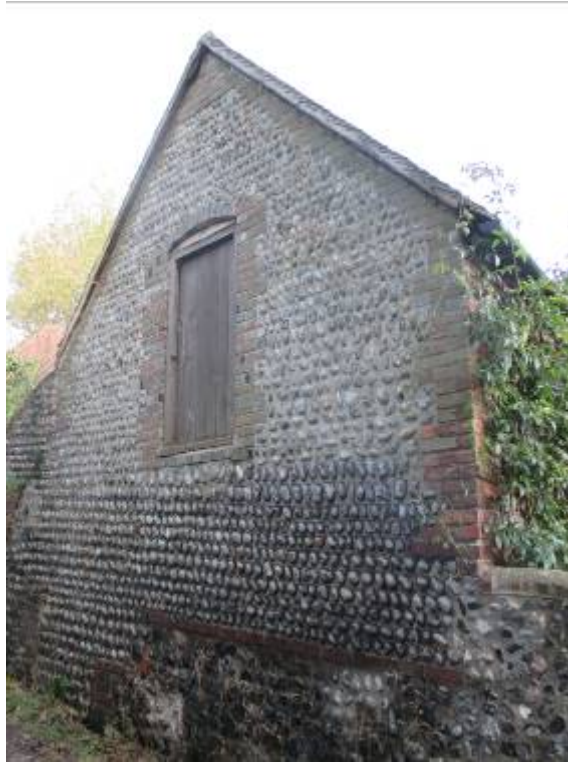
*Former coach house faced in coursed river cobbles beside Glebe Cottage*

4.15 *Glebe Cottage* has a complex evolution. The formal, red brick Georgian frontage facing south, complete with original, timber sliding-sash windows started life as a separate property of 1789. To the rear, stands the original house, an unusual slate-roofed cat-slide element with coursed, knapped flints and Caen stone quoins facing Church Lane. (Locally, Caen stone is known as Priory stone, as it was material salvaged during the demolition of Lewes Priory following the dissolution of the monasteries in 1538). The reported survival of medieval framed elements in the roof of this part of the building may also indicate early origins. The small detached outbuilding within the curtilage of *Glebe Cottage*, constructed

of flint cobbles with red brick dressings, was originally a coach house and stable with hayloft above.

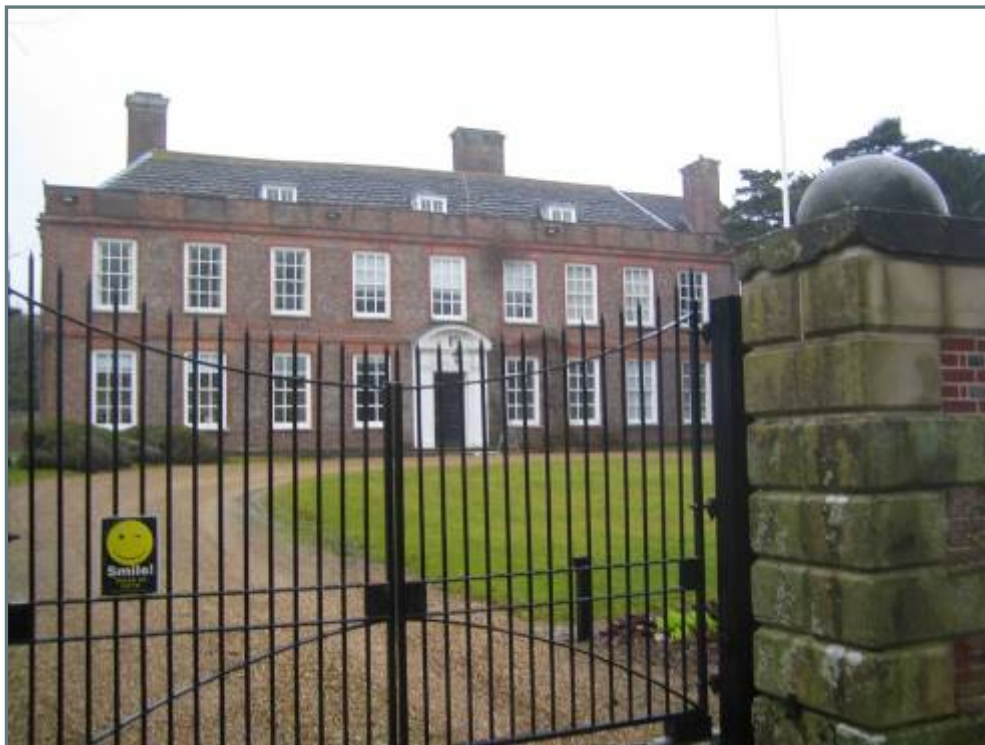
*Malling House, the Sussex Police HQ*

5.9 The one important heritage asset which lies very close to the current conservation area boundary is *Malling House*, a fine building now used as the Headquarters of the Sussex Police. However, as the house is Grade I listed, it is not clear what additional benefits conservation area designation would bring for its protection. For this reason, no boundary alterations are recommended.

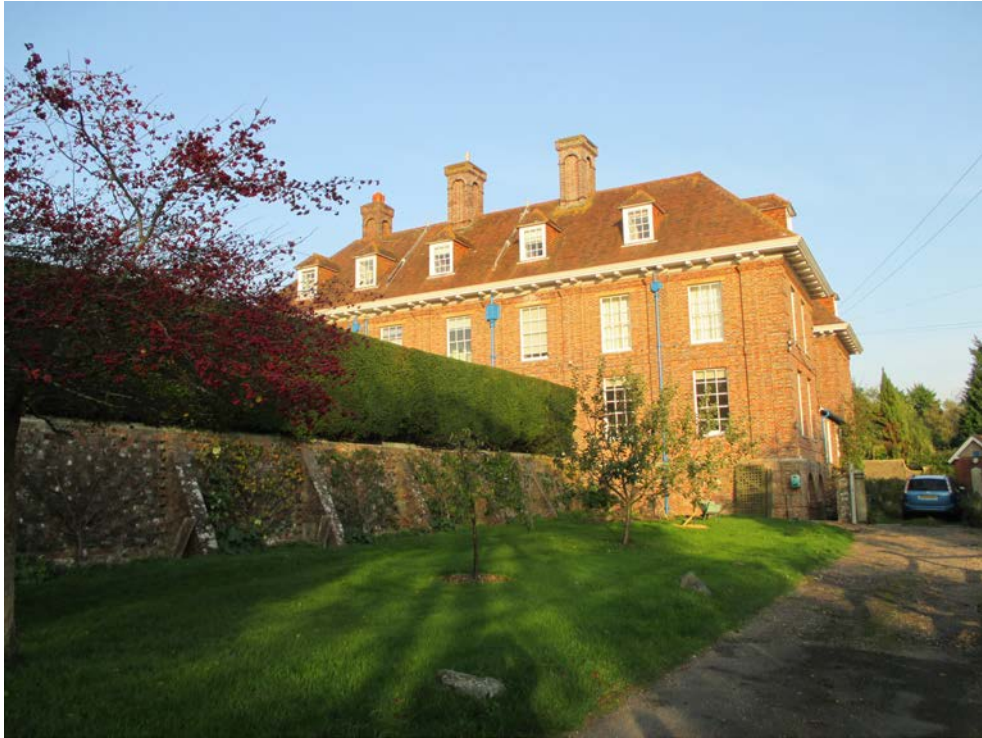
*Malling Deanery is the largest building within the settlement*

4.11 The Conservation Area is dominated by *Malling Deanery*, which has Elizabethan origins but now dates from the mid-Seventeenth Century, with some Eighteenth Century and early Twentieth Century modifications. Listed, at Grade II\*, it is built on a U-plan, of two tall storeys, constructed of red brick under a hipped, clay plain-tile roof. The prominent, well-proportioned sliding sash windows date from the Eighteenth Century. The house has been subdivided into three dwellings, *East Wing*, *West Wing* and *North Wing*, set within generous, mature gardens, themselves subdivided in a reasonably sensitive manner. Glimpsed views of these gardens and the Deanery from Church Lane, through the

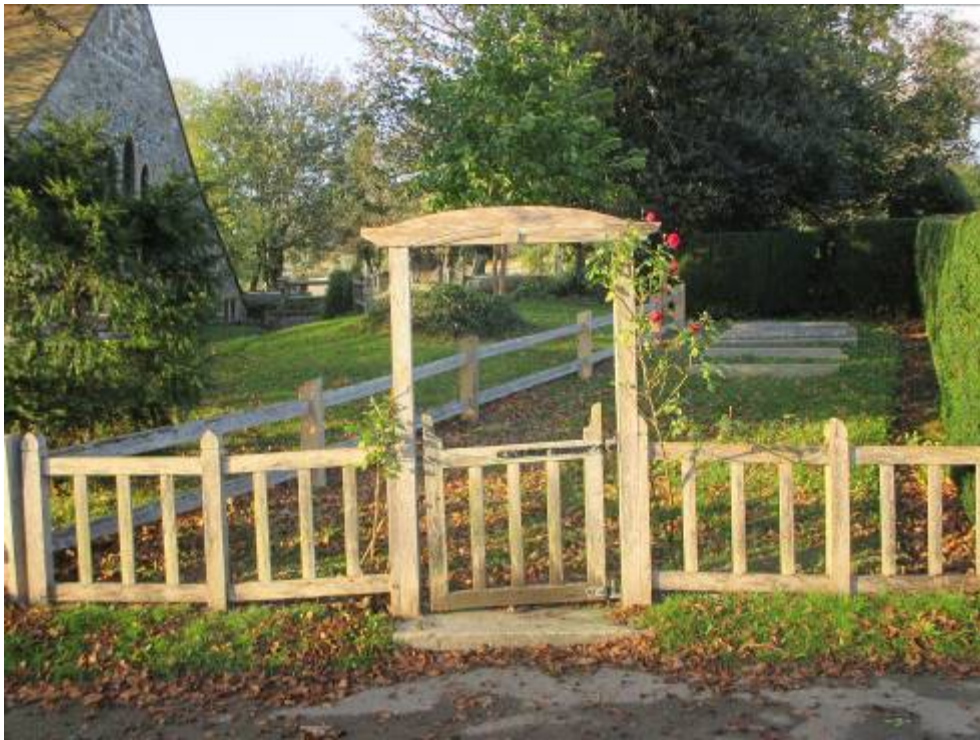
*Sanderson family plots at the eastern end of the Churchyard*

enclosure with a rustic timber gate facing Church Lane, for interments of the Sanderson family, owners of the Deanery in the middle years of the last century.

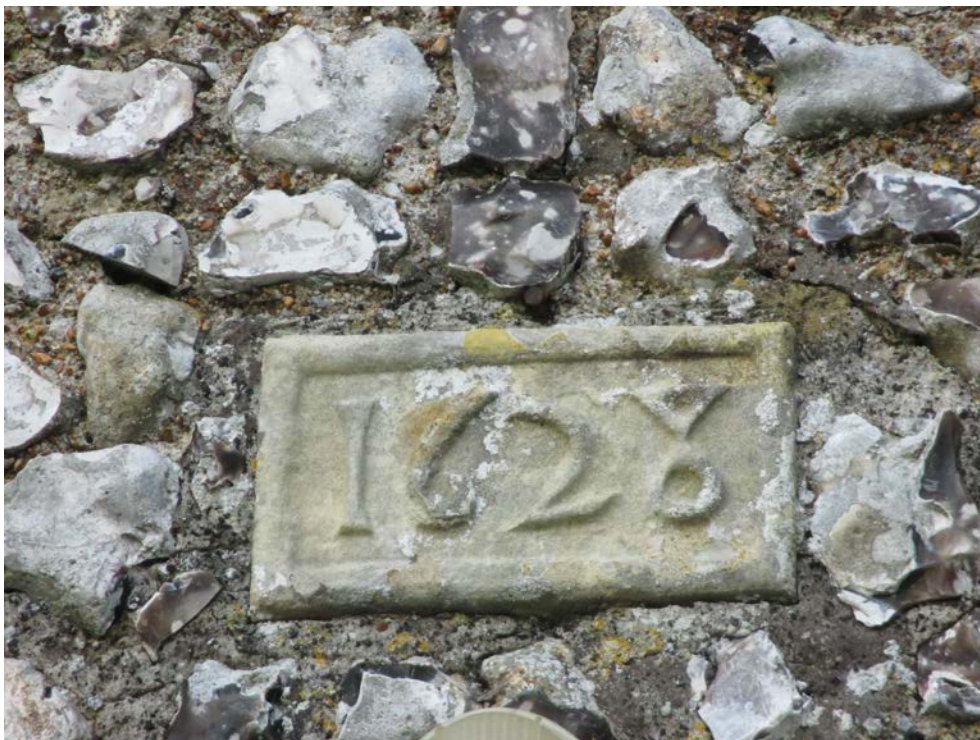
*Date stone on the Church Porch*

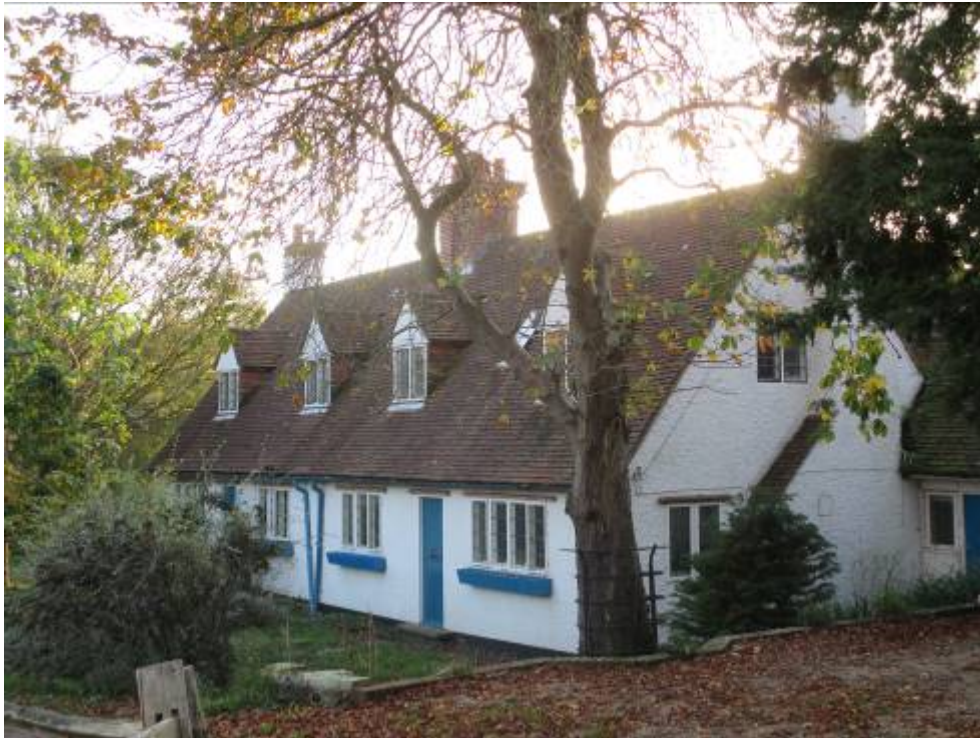
*1 and 2 Deanery Cottages – Arts and Crafts houses of the Edwardian years*

4.17 *1-2 Deanery Cottages* were built by Andrew Duncan Macneill, a former owner of the Deanery, between 1906 and 1910. They display an Arts and Crafts influence, with their wide casement windows and facing of roughcast render. Roughcast is also a feature of ancillary buildings of the Deanery, notably the stables opposite which date from the same period.

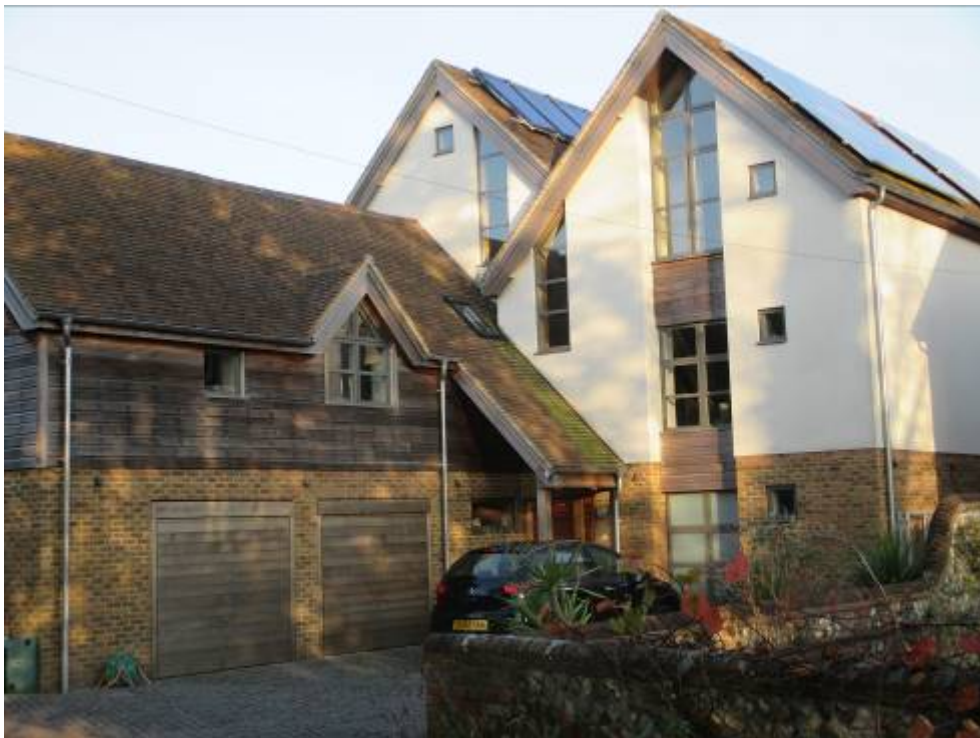
*River House displays considerable alteration to window openings over time*

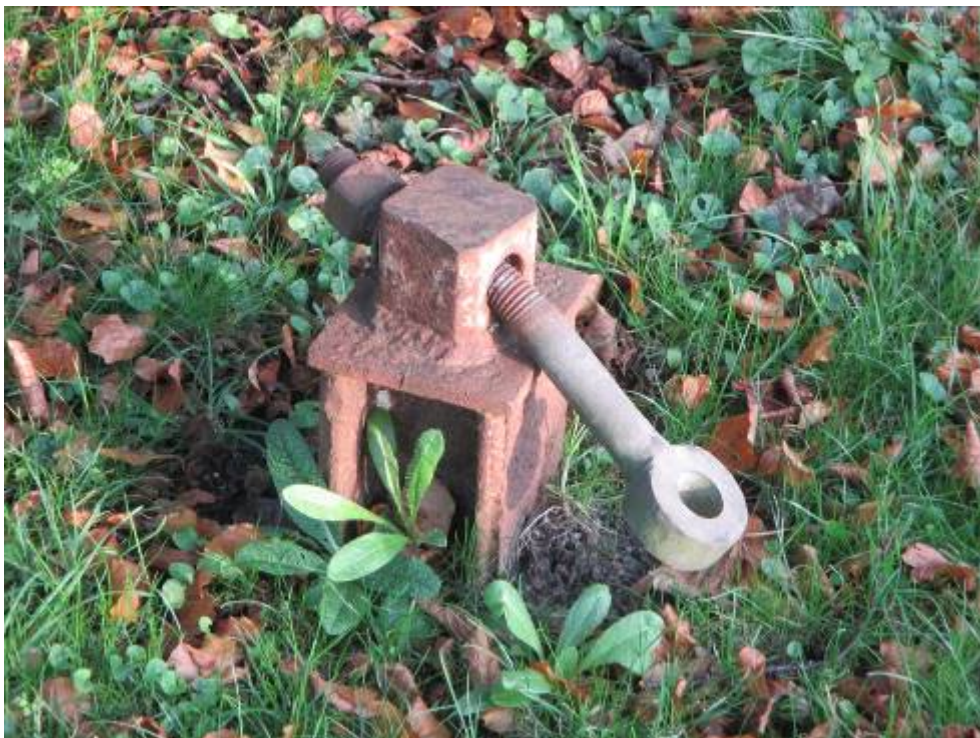
*This surviving anchor point is one of two which once restrained the cables of a pre-war suspension bridge across the River Ouse. The white-painted bridge only carried private foot traffic and was dismantled in the 1970s.*

3.9 Twin anchor points beside the river survive to testify to the existence of a private suspension footbridge of 1934 which once linked the settlement with the south bank. This elegant bridge, built for Sir Frank Sanderson and designed by the architects Wratten & Godfrey, replaced a tall Victorian timber bridge of 1868, constructed for Edmund Currey and in perilous condition by the early 'thirties. The inter-war bridge was eventually removed in the mid-1970s.

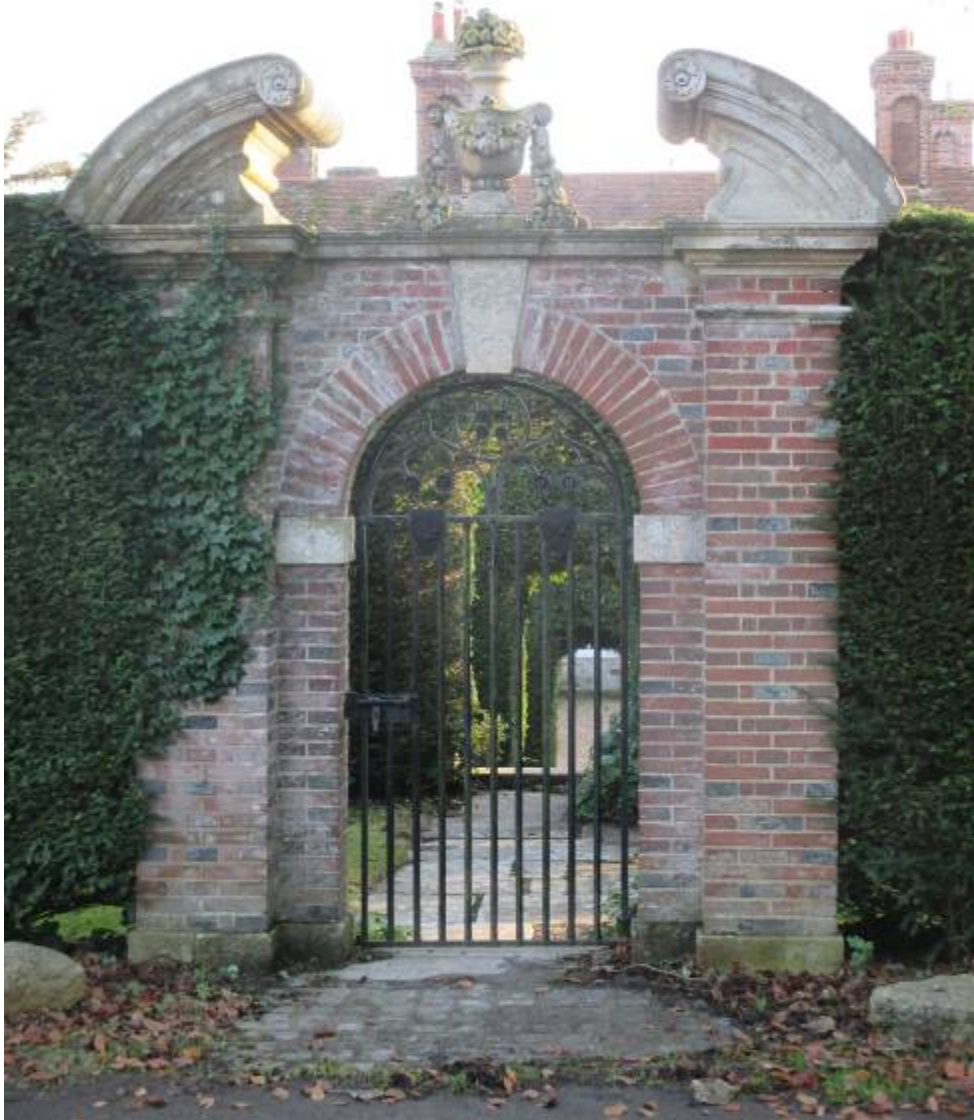
*The north gateway to Mallory Deanery is an elaborate Baroque statement built as an adornment to the house in the Edwardian period*

Gateway. Early C20. Red brick with stone dressings. Central arch with gauged head and stone imposts. Outer piers with entablatures carrying pieces of broken segmental pediment. Urn on bracket over arch in centre. Included for group value.

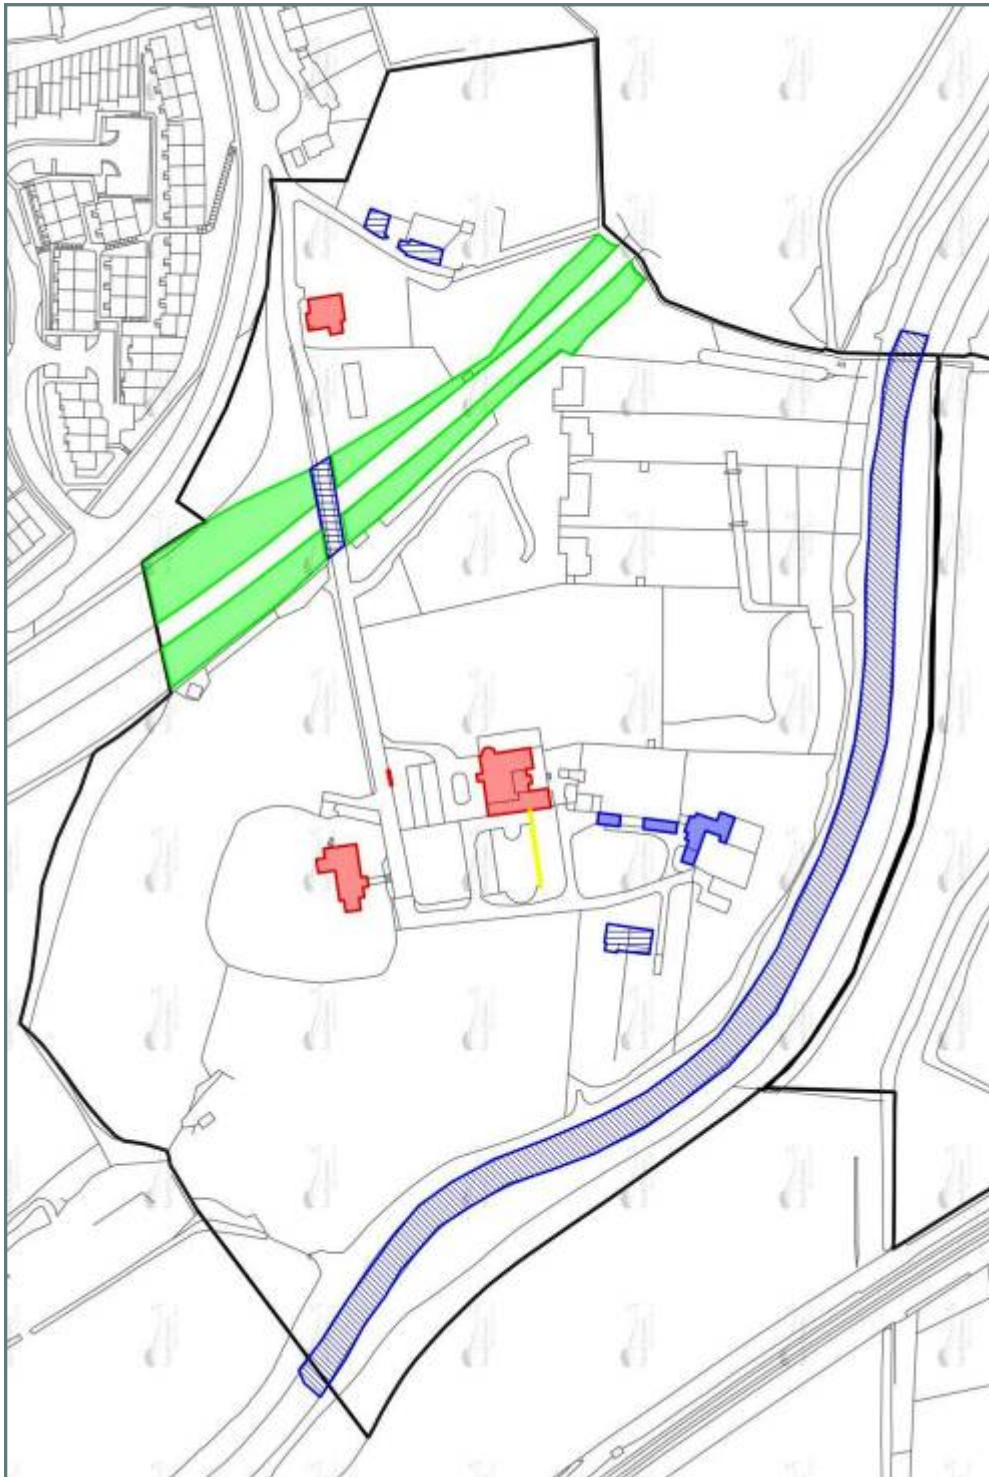
### ***Analysis Map of the Conservation Area***

*Red.....Listed Buildings*

*Blue.....Buildings of Townscape Merit*

*Hatched Blue.....Buildings of sufficient quality to justify future Local listing*

*Green....Wooded former railway cutting*
