## Conservation Area Character Appraisal and Management Plan

# Southease

June 2017

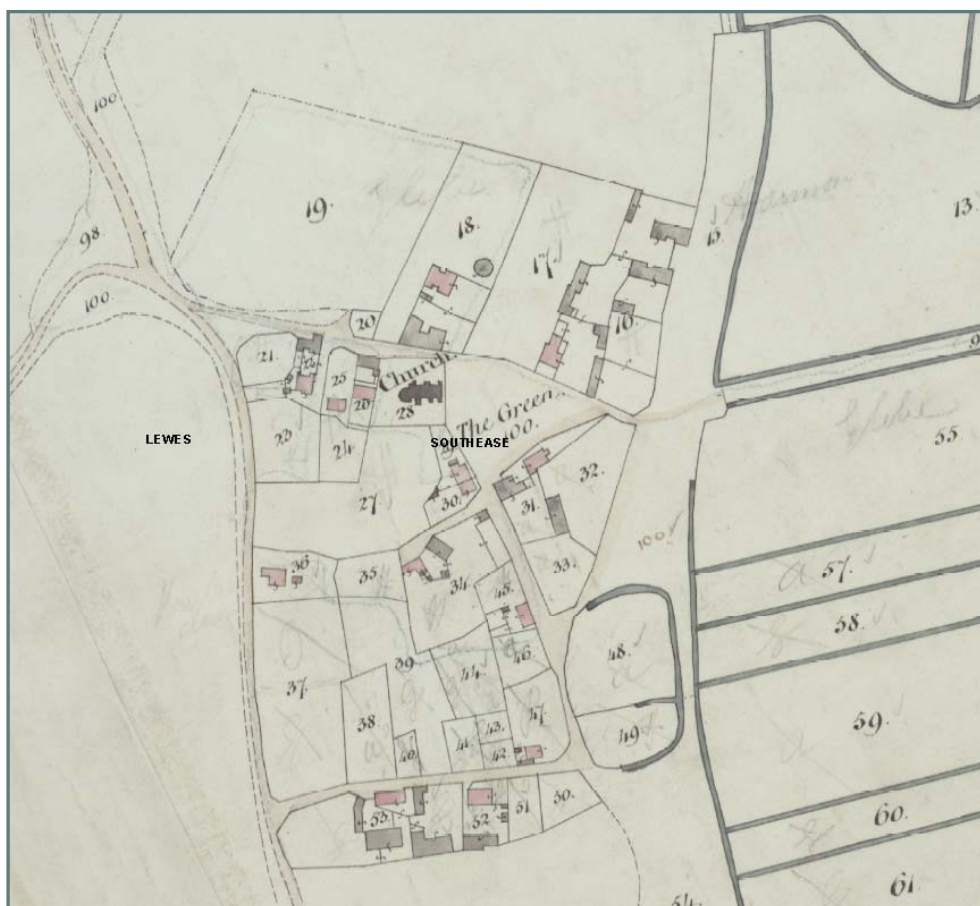
**Figure 3: Southease Tithe Map**  
(courtesy of East Sussex Historic Environment Record)

3.13 The Tithe Map (Figure 3) and Ordnance Survey maps (Figure 4) show the form and extent of the village in the nineteenth century. It survives in much the same form today.

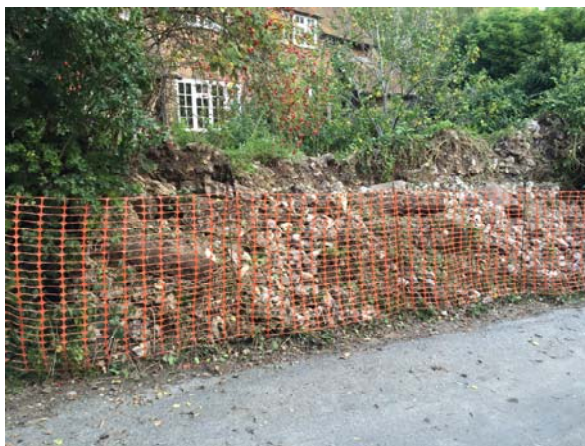
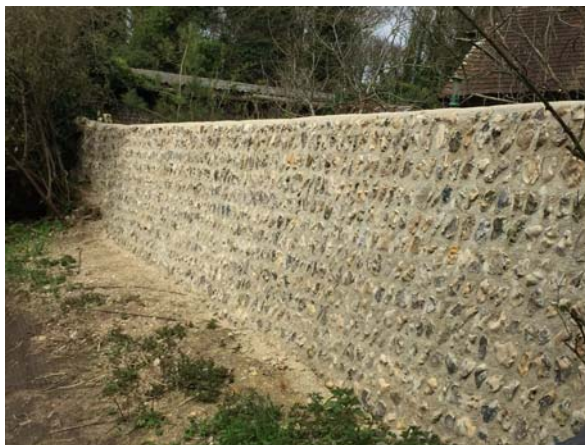
5.2 Possibly the most significant issue which is threatening the qualities of the village is the lack of maintenance to the boundary flint walls throughout the settlement. Old photographs demonstrate how prominent these walls once were in the village and their significance in defining the character of the settlement as a downland village.

5.3 In recent decades, the walls have been allowed to largely disappear beneath various forms of greenery. This has both much reduced the visual impact of the walls and their contribution to the character of the village, whilst also contributing to their long-term decay. If the process is allowed to continue unchecked, this vital element in the villagescape could completely disappear. The one example in which a collapsed wall has been rebuilt by the owner, in this instance the Glyndebourne Estate, serves to demonstrate the impact that repair of the flint walls can achieve.

6.10 A rather more significant issue, and quite possibly the main threat to the conservation area, is the disappearance of the flint boundary walls under greenery of various sorts due to lack of maintenance and decay that follows.

**ACTION 3 – that the National Park Authority seeks to secure repair of the traditional farmsteads, flint walls, and pill boxes by working in co-operation with the owner and wider community.**

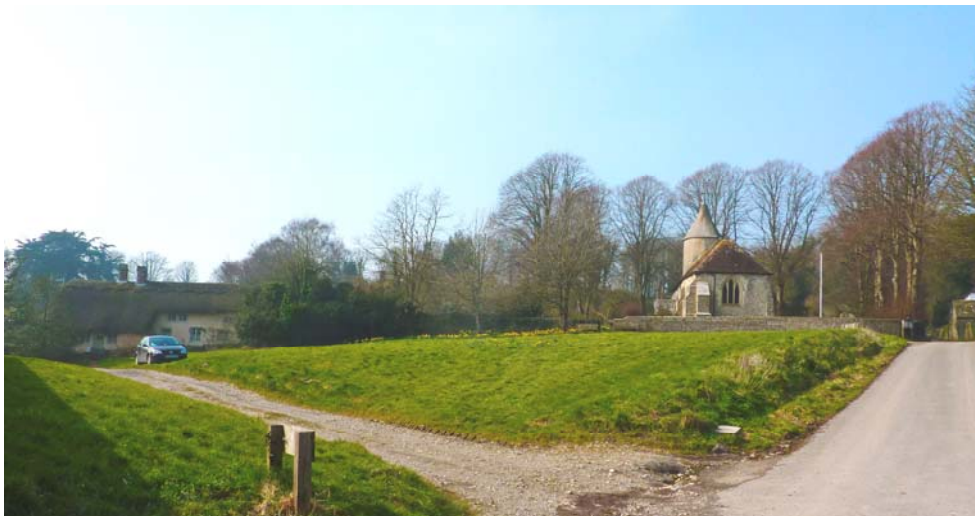
Figure 5: The village green lies at the heart of Southease.

4.6 The village is centred around the open space of the Village Green which provides the immediate setting for the Parish Church (Figures 5 & 6), Southease Place, and Thatched Cottage. From this central point several roads and tracks lead off to other residences and farm yard areas. This public space is the most significant in a village that is generally characterised by private land and dwellings screened by flint walls and trees.

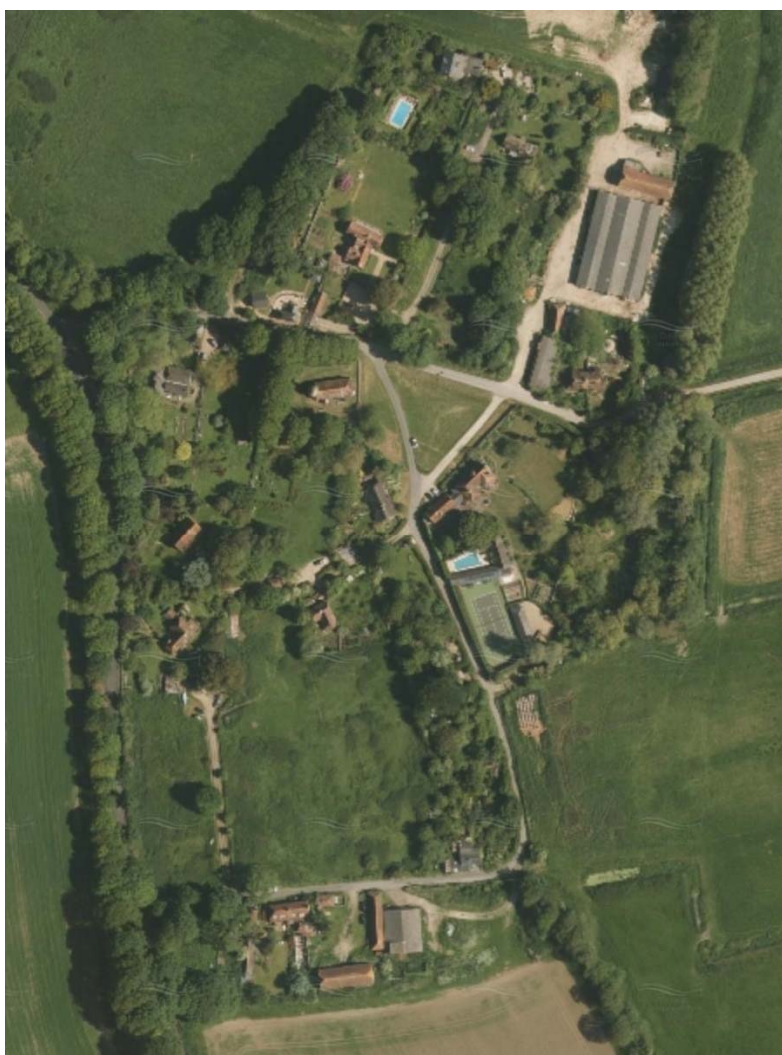
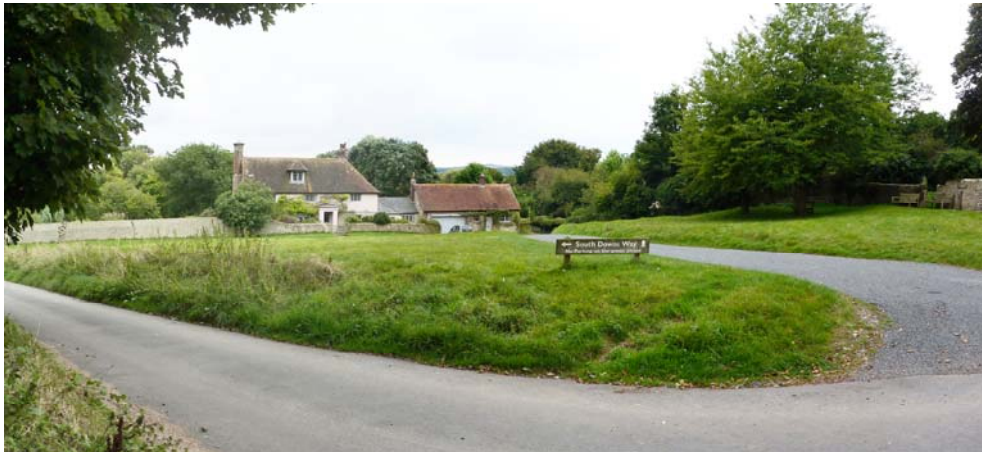
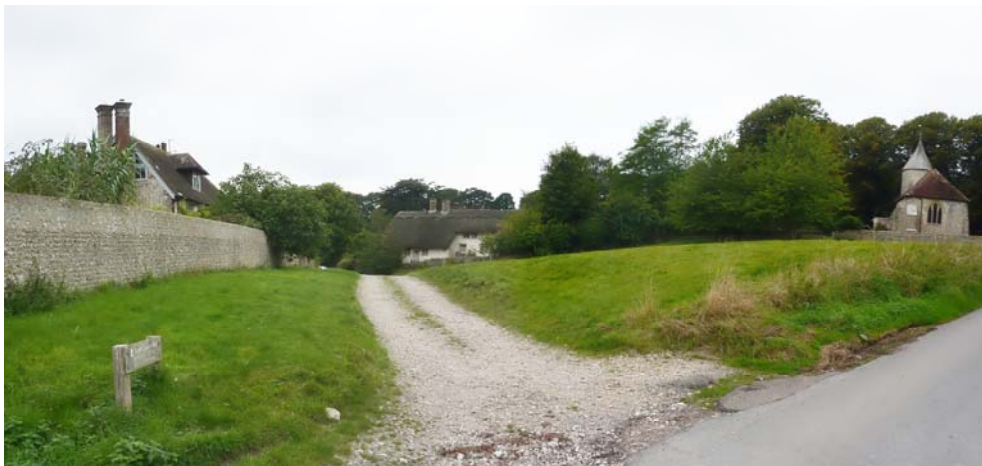
Figure 6: Views across The Green. The daffodils make a pretty sight and were planted in honour of Non Humphryes, a nationally famous daffodil grower and breeder who lived in The Thatched Cottage.

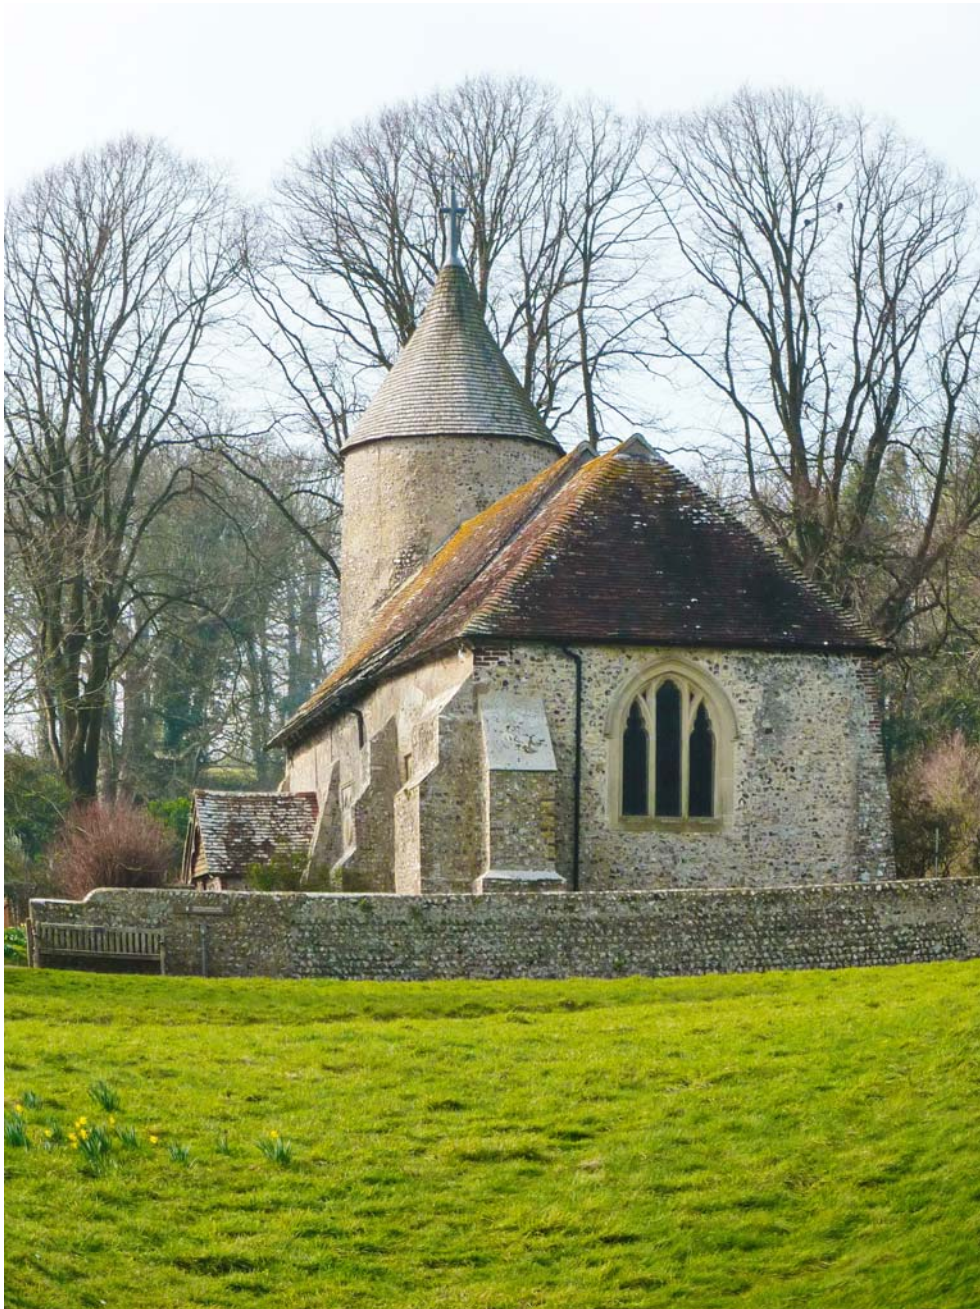
Figure 7: The Parish Church.

4.15 The Grade I listed Parish Church, of Saxon or early Norman origin, is one of only three churches in Sussex with a circular tower (Figures 7 & 8). The church tower was probably built in this way due to the abundance of flint and the relative scarcity of ashlar stone, which would have been needed for quoins and dressings. This is the most important building in the Conservation Area, both historically and architecturally, and is suitably situated on a prominence in the centre of the village.

This is one of the 3 churches in Sussex with a circular C12 tower (the others being in Lewes and Piddinghoe). Chancel, nave and west tower with shingled spire. The chancel and nave C11. Together they form the nave of the original building, of which the chancel and the transepts were demolished in the C14, and have only been divided by the insertion of a modern pointed wooden chancel arch. Remains of mural paintings of 1280 circa on north and west walls.

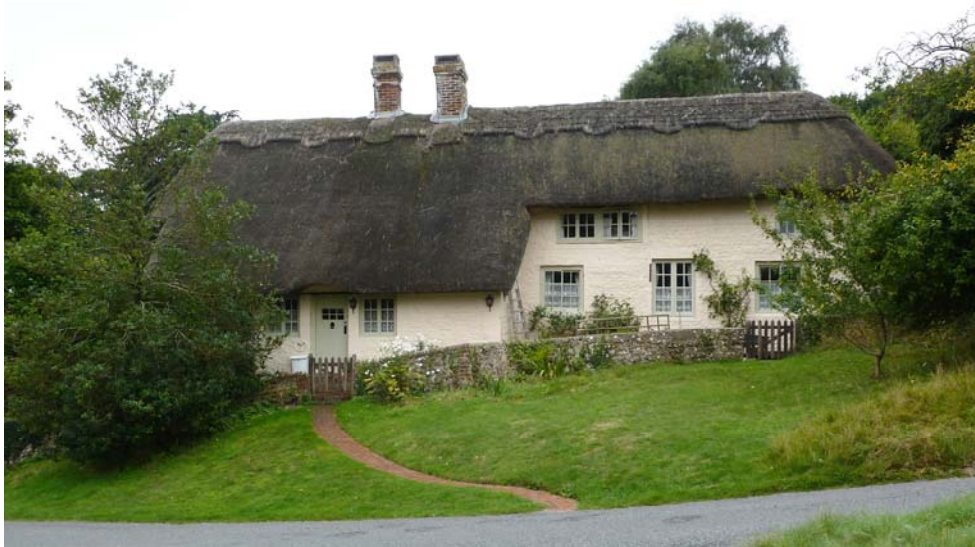
Figure 9: Thatched Cottage:

4.16 The 'Thatched Cottage' fronts onto the Green to the south of the Church (Figure 9). Probably built in the eighteenth century or earlier, it was formerly two cottages. It is faced with flints with red brick dressings and quoins, all now painted, has a thatched hipped roof and horizontal sliding sash windows. It is one of the first buildings to be seen on entry to the village and the only surviving thatched building. It is, therefore, an important surviving example of this once common roof covering.

A Grade II listed buildings with 18<sup>th</sup> century. Once 2 cottages. C18 or earlier. Two storeys. Four windows. Faced with flints with red brick dressings and quoins, all now painted. Hipped thatched roof. Horizontally-sliding sash windows. Ground floor portion with pentice roof built out at south end.

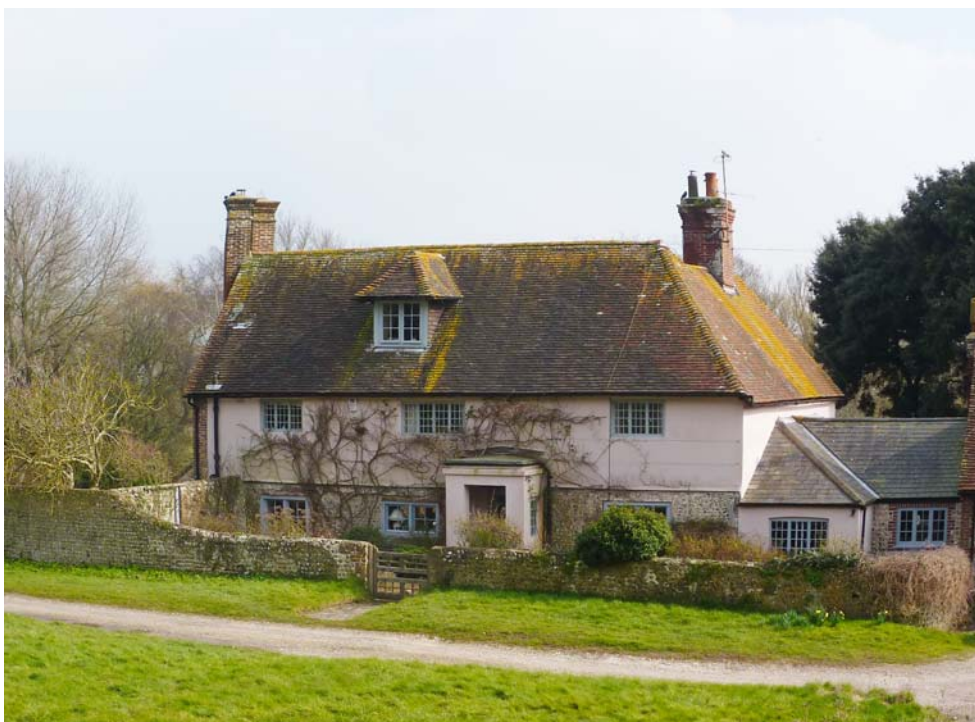
Figure 10: Southease Place:

4.17 Southease Place fronts onto the south eastern side of the Green (Figure 10). Built in the seventeenth century, it has been refaced on the ground floor with flints, and above with stucco. The hipped roof has traditional handmade clay tiles. This building is seen immediately on entry to the village, indicating its high status. Its generous grounds are bounded by fine flint walls and incorporate the village pond, a wonderful surviving feature hidden away behind the house at the very edge of the Conservation Area (Figure 20 - bottom).

A Grade II listed building with origins in the 17<sup>th</sup> century, refaced on ground floor with flints, above with stucco. Hipped tiled roof. Casement windows. Modern porch. Two storeys. Three windows. Brick chimney breast with offsets on north wall. Until sold by the Glyndebourne Estate in the 1930s, the house was known as 'Southease Farm house'.

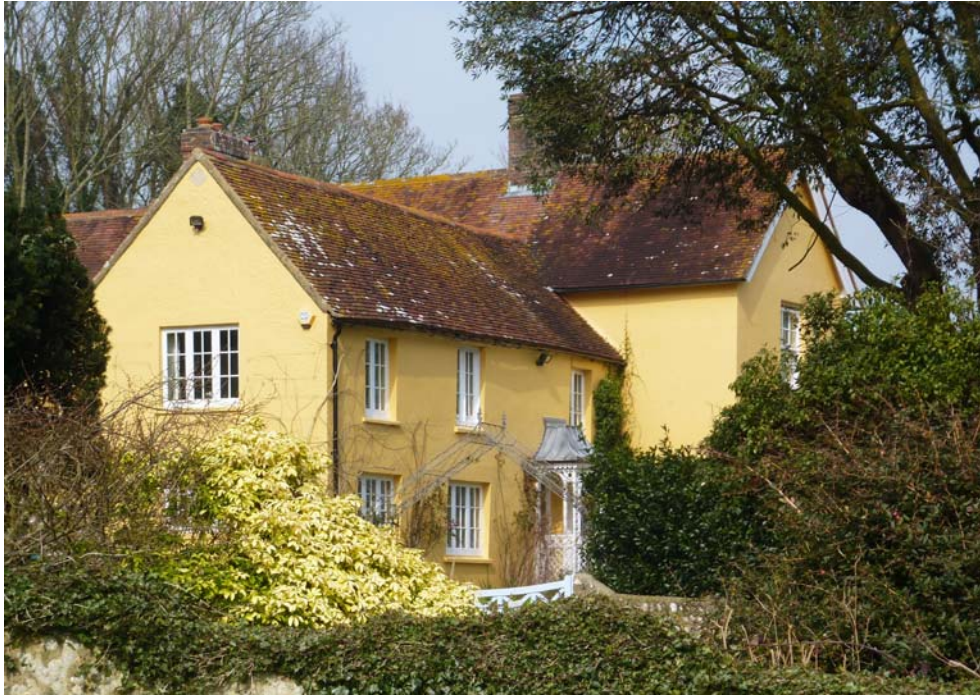
4.18 The Old Rectory and its large, landscaped garden is found within a wooded area to the north of the green (Figure 11). The south wing of this L-shaped building is a sixteenth century timber framed structure which has been

refaced with stucco. A gable facing west at its north end has the date 1604 and the monogram of John Rivers. The east-west wing is a nineteenth century addition, also stuccoed.

Figure 11: The Rectory: The south wing is a 16<sup>th</sup> century timber-framed building refaced with stucco and bearing the date 1604. The east-west wing at its northern end is a 19<sup>th</sup> century addition.

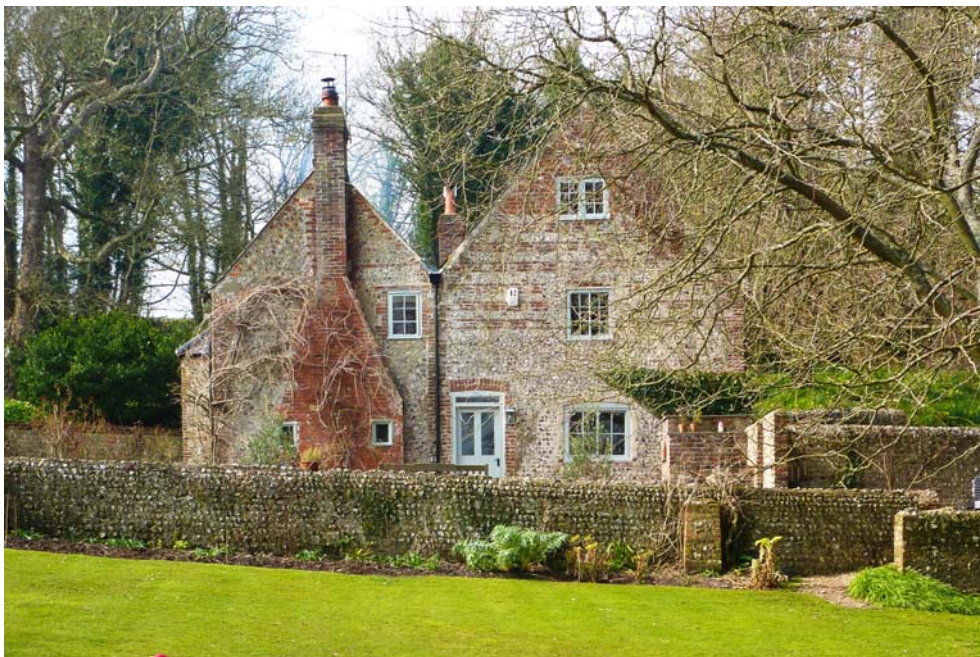
Figure 12: The Black Lamb (listed as “The Rest”). A Grade II listed building dating to the 18<sup>th</sup> century.

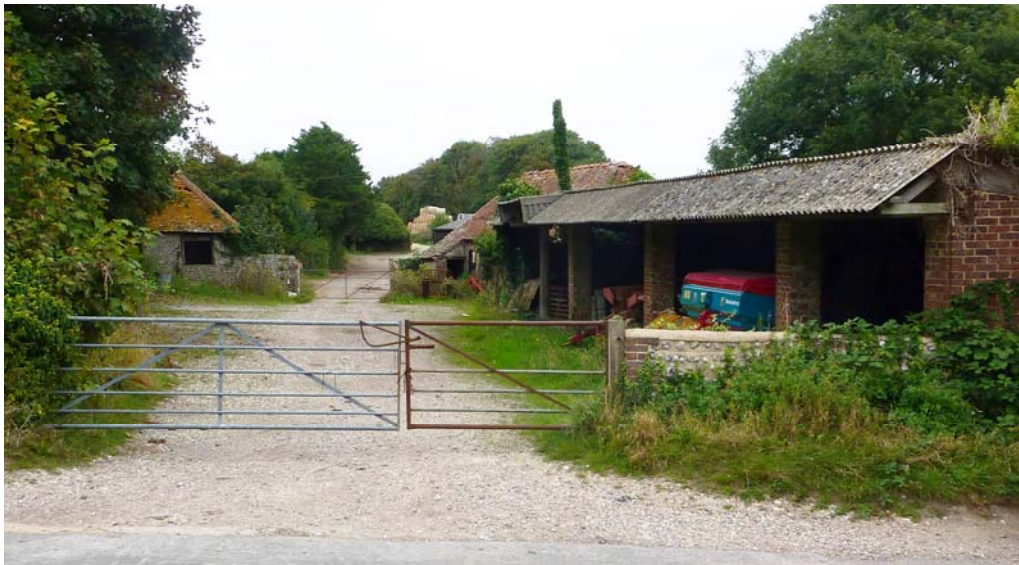
Figure 13: The northern farmstead.

4.22 The other farmstead within the village, and the one that remains in use, lies to the east of the Rectory (Figure 13). This is formed of a rectangular courtyard with multiple yards dating to the 19<sup>th</sup> century. Over half of the original buildings have been lost and some of those which survive are in poor condition. The site also has a number of large, modern agricultural buildings which do not make a positive contribution, but which must be expected in the context of a working farm.

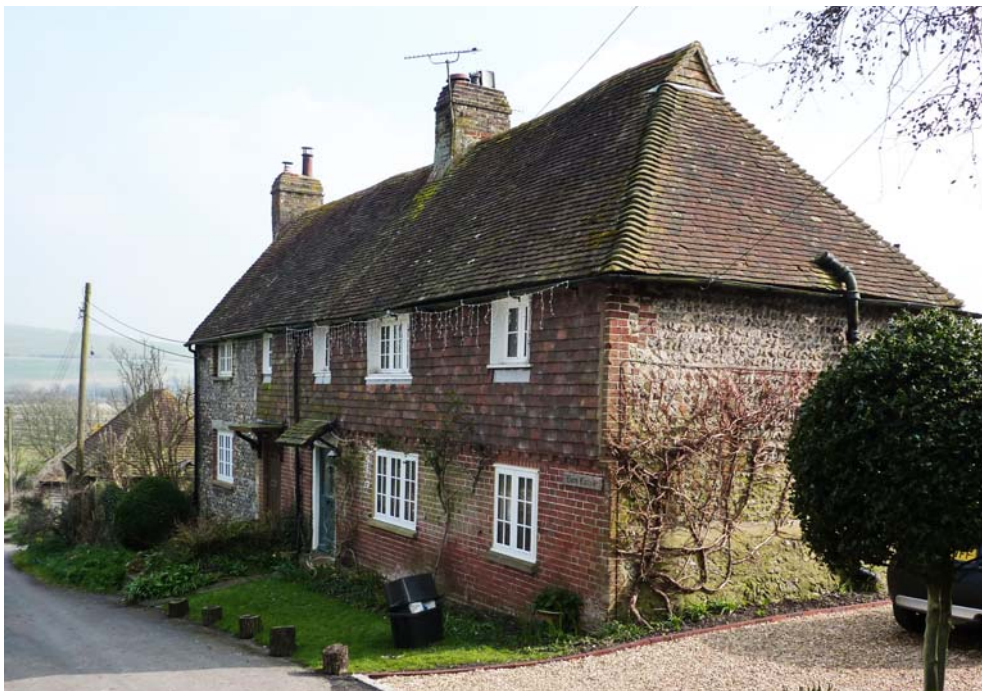
Figure 14: Rock Cottage & Barn Cottage.

Once a farmhouse, later converted into 2 dwellings. Probably C18, though the west end (Rock Cottage) may be a later addition or refronted at a later date. Two storeys. Five windows. Barn Cottage is faced with flints with red brick dressings and quoins, Rock Cottage with red brick and tile-hanging. Tiled roof. Casement windows. Flint and brick chimney breast on east wall of Barn Cottage.

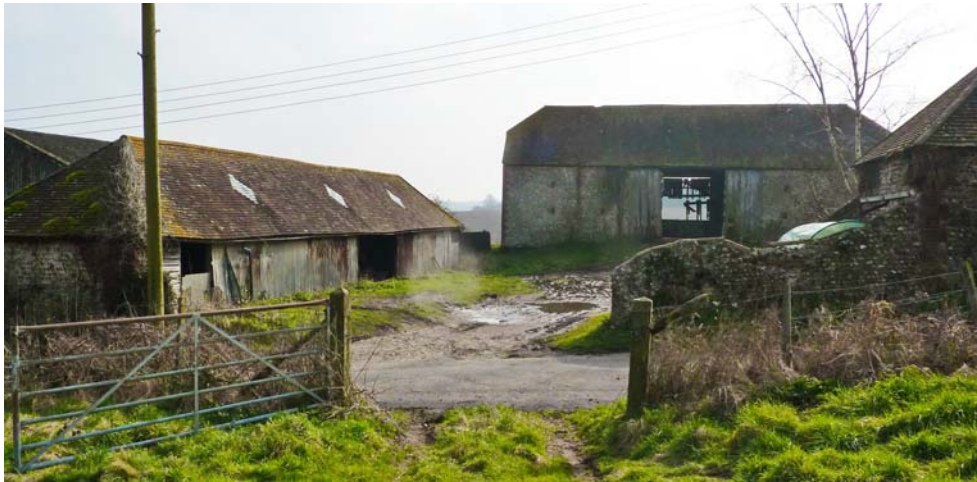
4.21 The Cottages originally formed the farm house to one of the two original farmsteads in the village. It stands next to its steading, which includes all the traditional buildings of an 18<sup>th</sup> century farm group, largely redundant, an important and characterful survival (Figure 15), although one at risk from under-use and poor condition. The barn, on the southern boundary of the Conservation Area is the dominant feature in views of the Conservation Area from the south and remains in use for farm storage.

Figure 15: The Southern Farmstead: An 18<sup>th</sup> century farmstead which survives intact, along with its farm house (Rock Cottage/Barn Cottage), at the southern end of the settlement.

The group of buildings makes a significant contribution to the character of the Conservation Area and their poor condition is both detrimental and an opportunity.

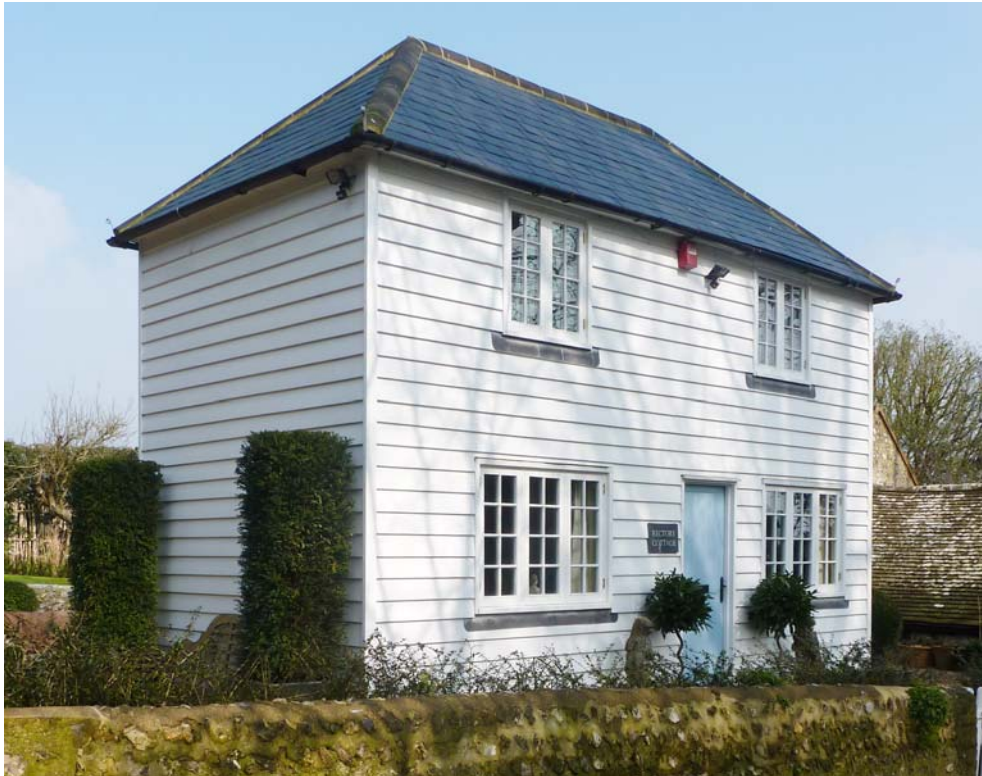
Figure 16: Rectory Cottage (above ) and Corner Cottage (below): Buildings which makes a positive contribution to the character of the Conservation Area.

4.23 There are several unlisted buildings, notably Rectory Cottage, Sunnymead and Corner Cottage and many of the traditional flint and brick agricultural buildings, which also contribute to the character of the area, both individually and as groups (Figure 16).

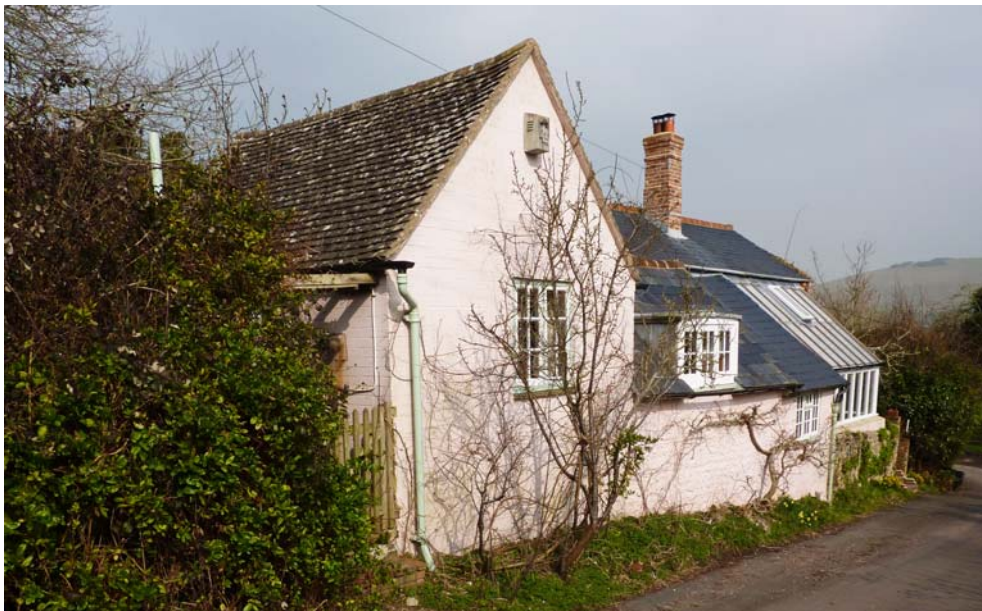
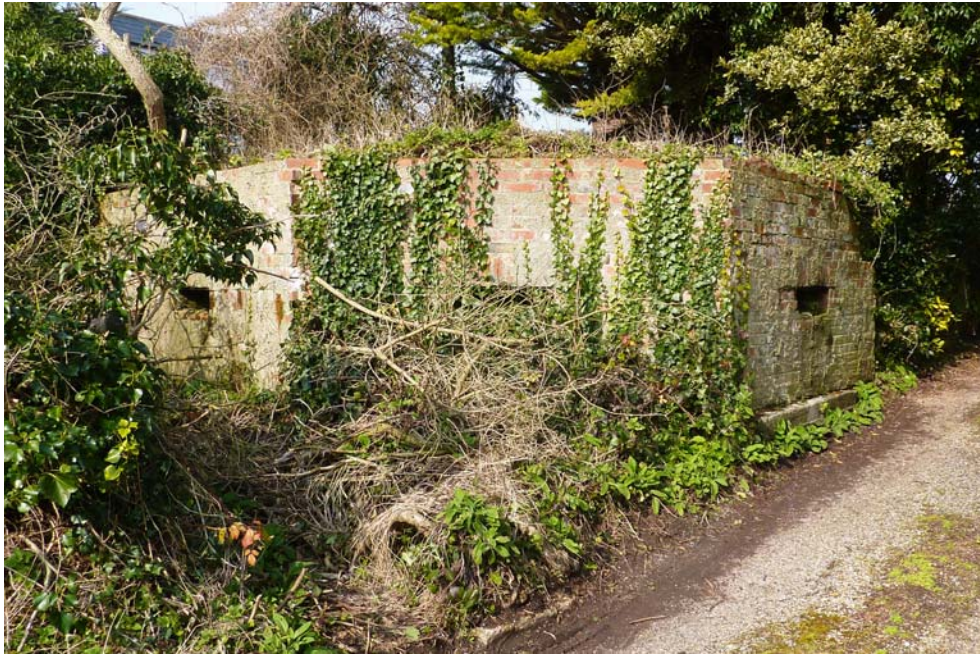
Figure 17: Relics of the Second World War in the village

4.25 Physical remains of more recent history survive in the village in the form of four World War II Type 24 pill boxes (Figure 17 top), located broadly at each

Wartime Pill boxes (above), of which there five within the village forming part of the Ouse Divisional Stop Line.

Grave of Sergeant A J Vaughan, with its War Grave Commission grave stone, in the churchyard (below).

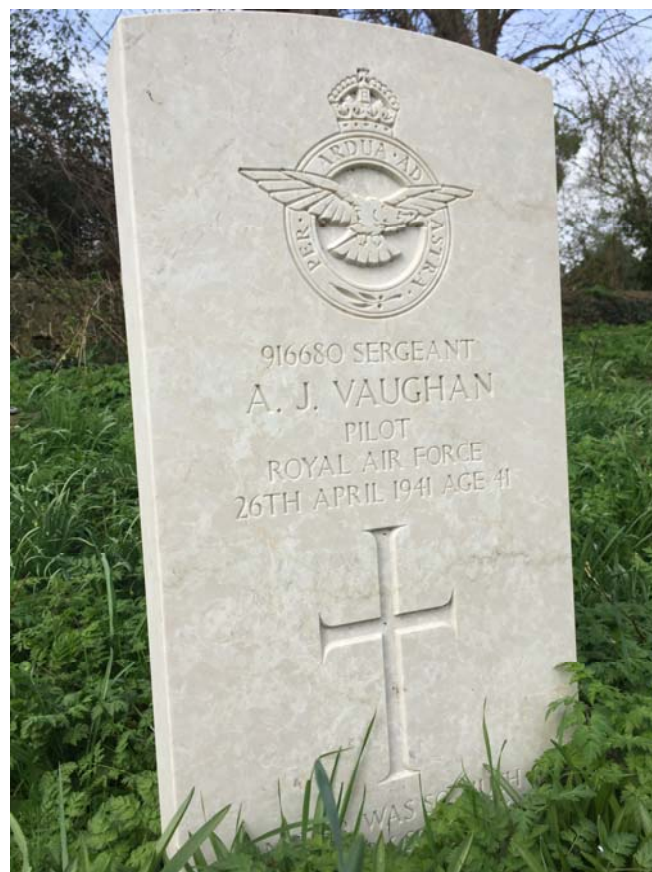
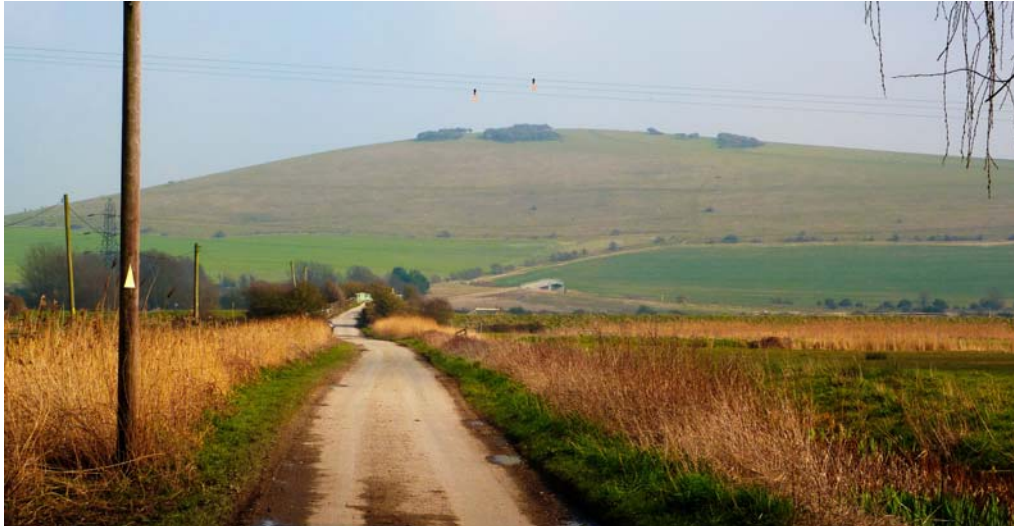
5.5 The exception, however is the large, sheet metal grain-dryer at the southern end of the village standing immediately alongside the southern farmstead. This is still in use but if it became redundant or could be relocated in a less sensitive location, its removal would be a significant improvement, both to the setting of the immediate group of historic farm buildings and the wider conservation area.

Figure 18: Views from the village looking westwards over the Ouse Valley towards Mount Caburn (above), from the bridge back to the village (middle) and showing a traditional barn largely obscured by a modern grain drier (Bottom).

The electricity poles and wirescape detract from the Conservation Area and its setting and their removal would represent a significant enhancement.

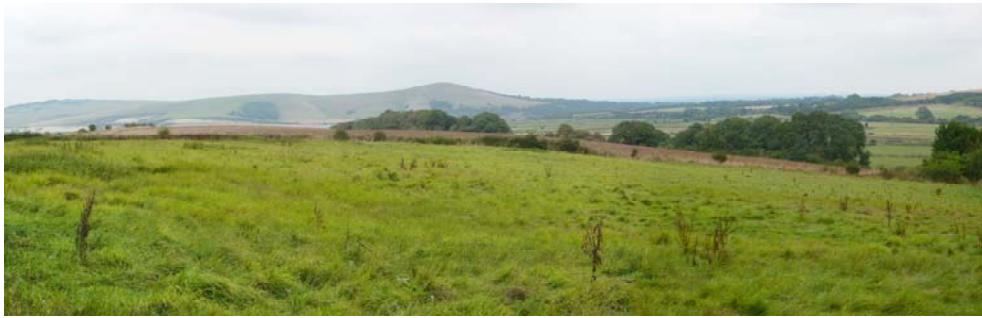
Figure 19: Long range views across the wider landscape from within the Conservation Area (top and middle) and towards the Conservation Area from the south (bottom).

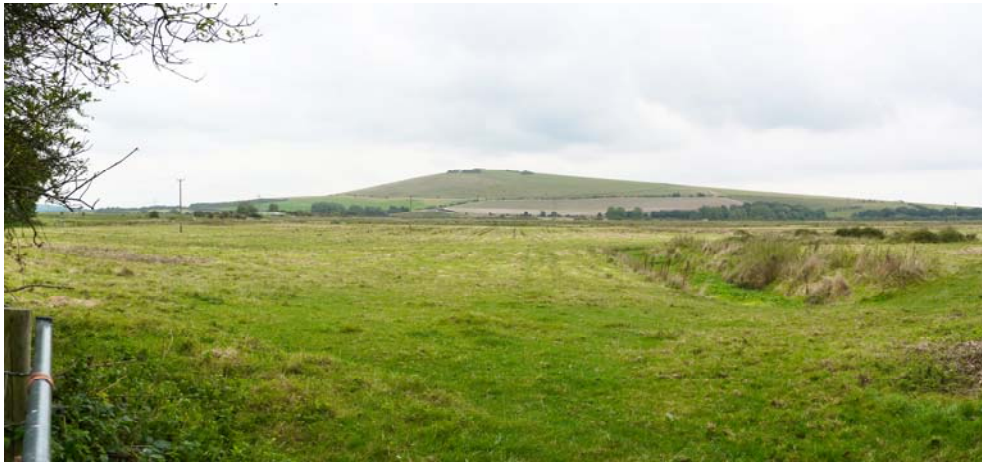
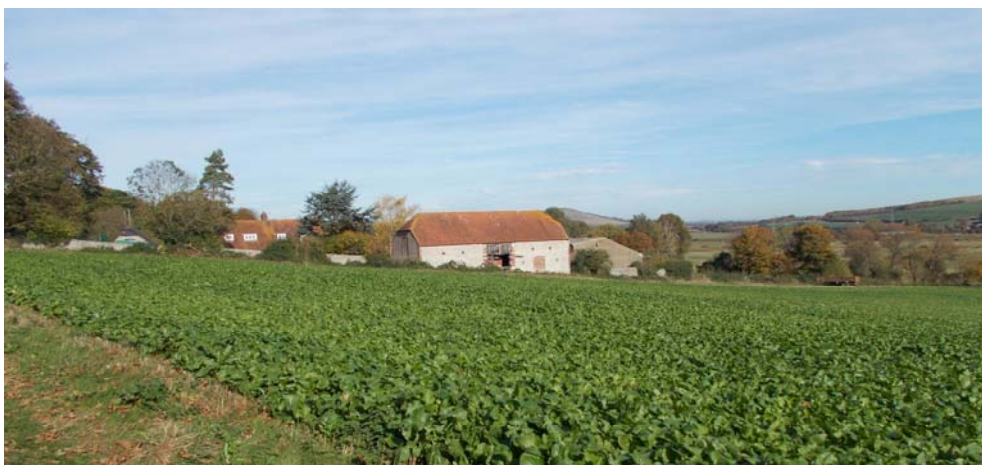
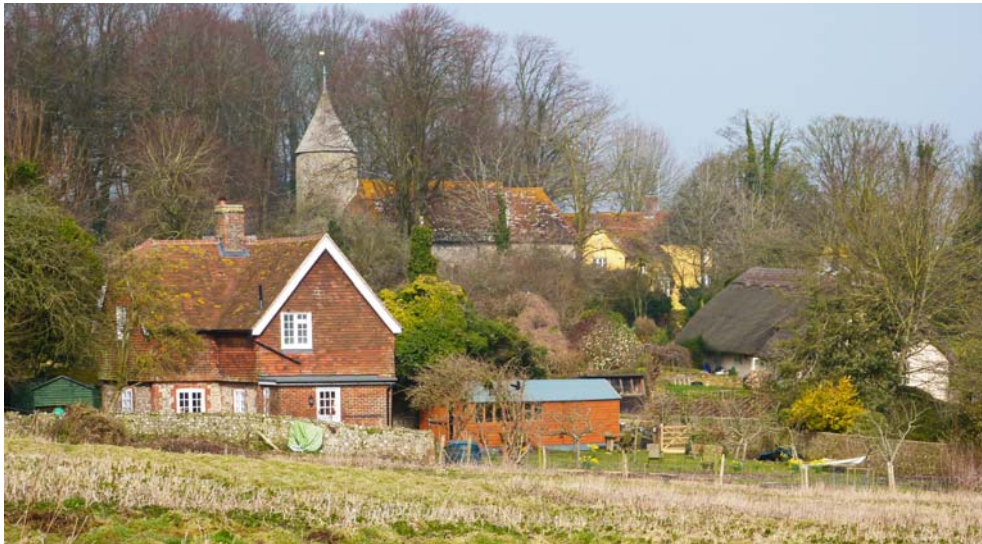
Figure 20: More Views within the village, including the village pond (bottom).

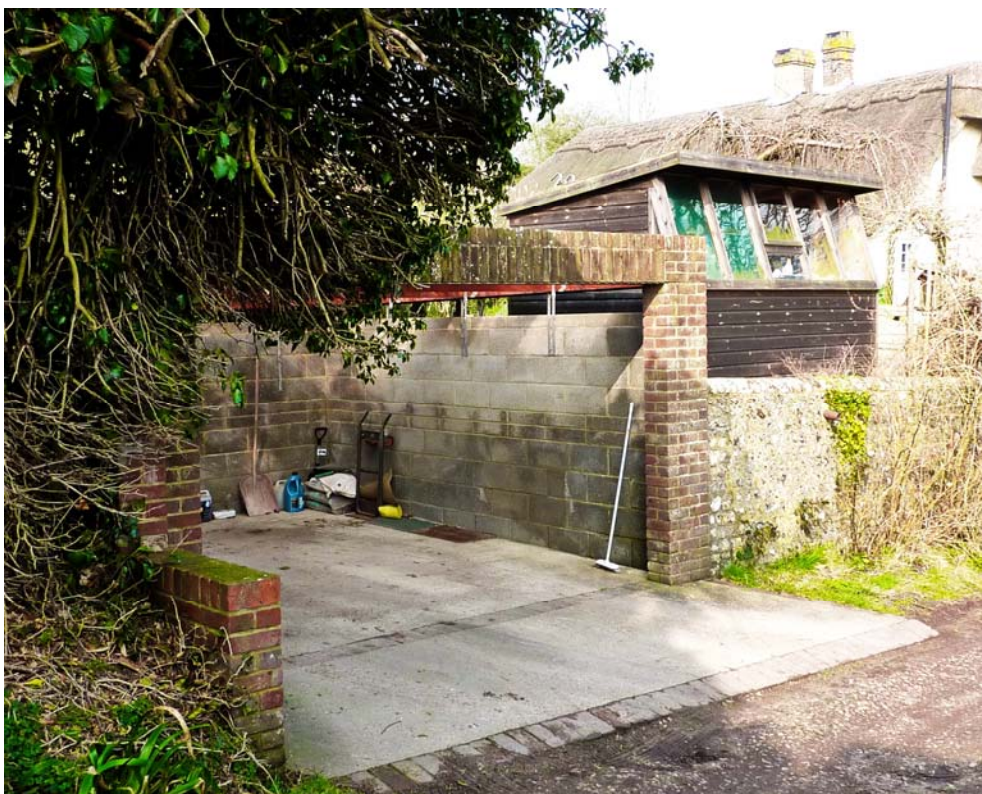
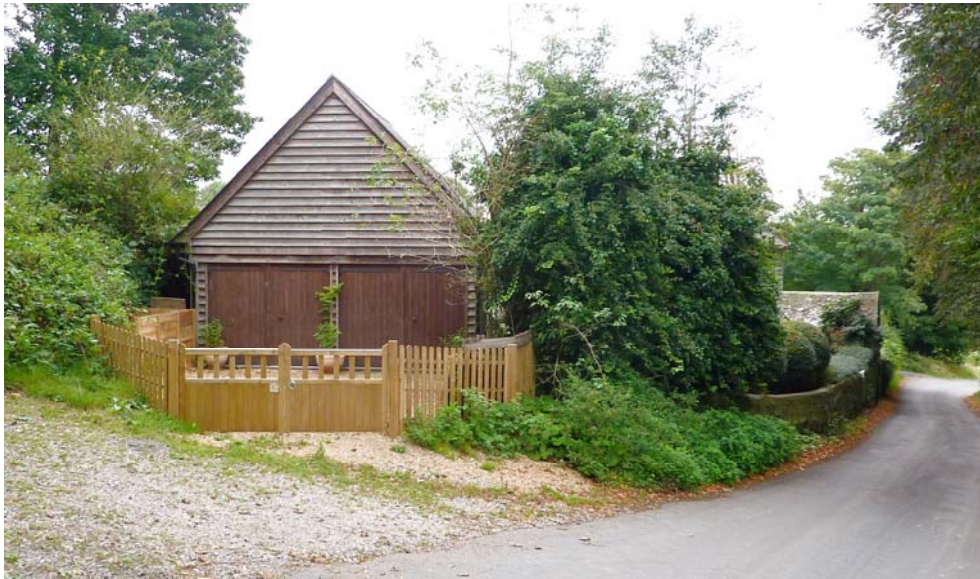
Figure 22: Cars cannot be wished out of existence but care needs to be taken when making changes to accommodate them. The garage above, which stands in a prominent position at the entrance to the village is much larger than it needs to be, whilst the modern wide up-and-over garage door jars visually with the period building in which it sits (below).

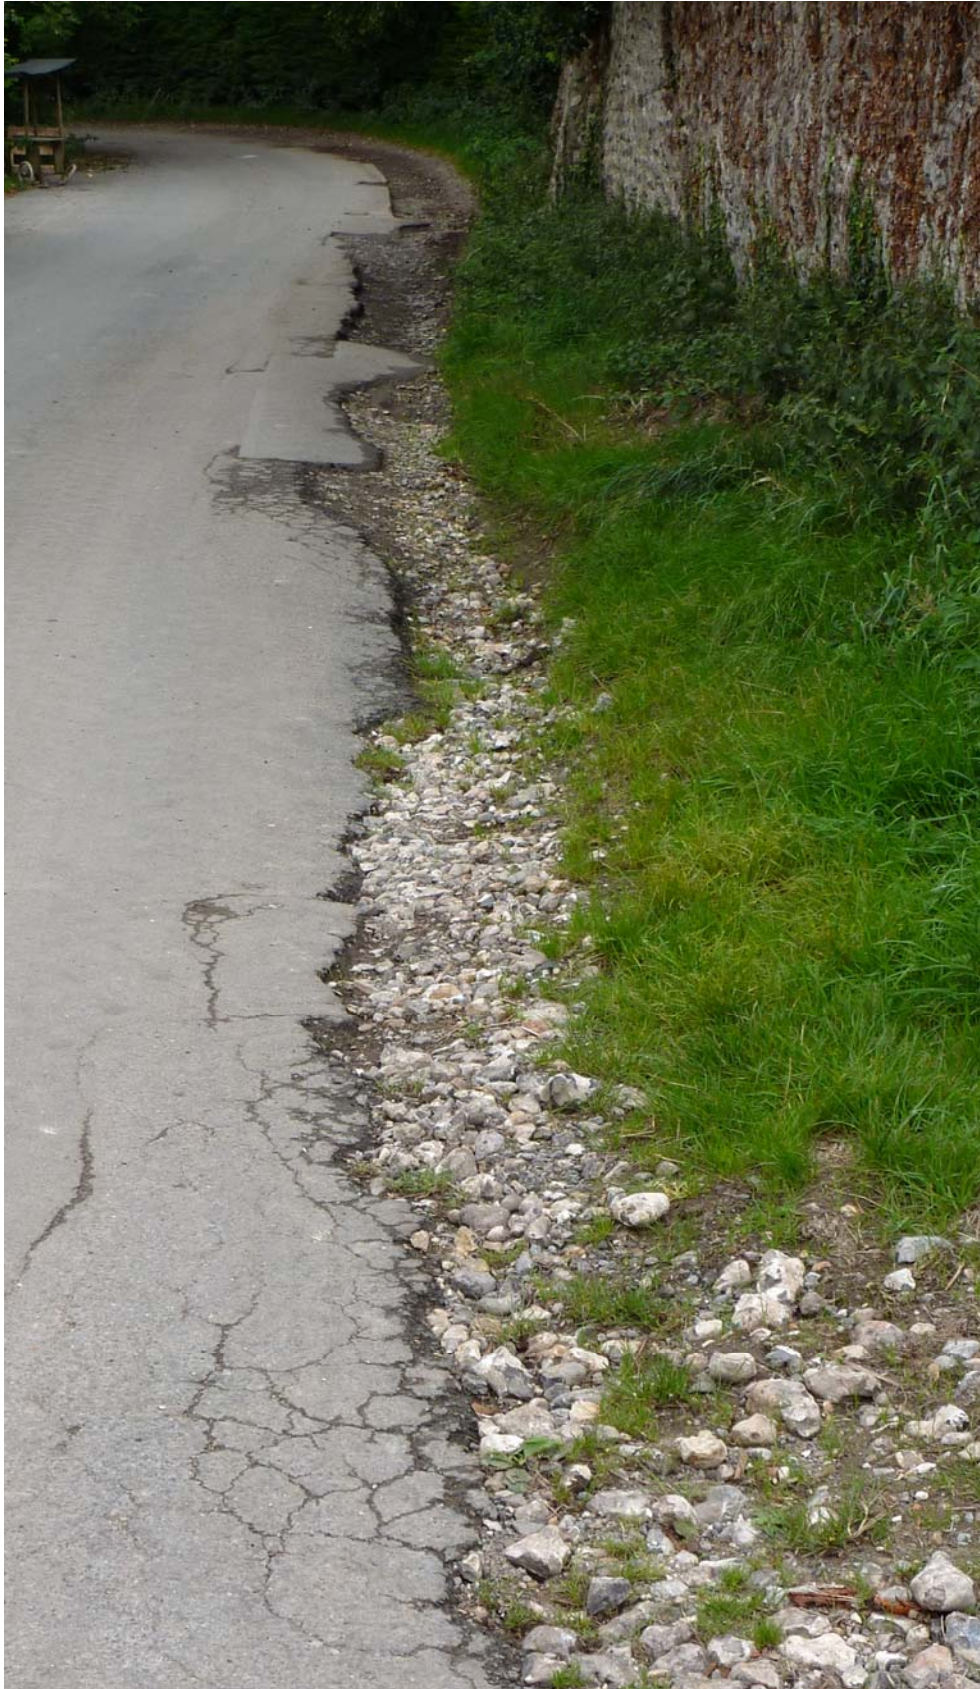
Figure 23: Poor road surfaces on the South Downs Way

- Like the flint walls, the wartime pill boxes are also disappearing and decaying amid overgrowth.
- There are some inappropriate structures, including
  - the large garage which is the first structure visible as one enters the Conservation Area (Figure 22)
  - The open garage/car port (Figure 21)
  - The large shed in the front garden of Sunnymede (Figure 21)
  - The wide modern garage door inserted into the annexe to Southease Place (Figure 22)
- The presence of telegraph poles and various wires, both within the village and in views out from it across the valley. (Figure 18)
- The condition of some of the road surfaces. (Figure 23)

**ACTION 7** – that the National Park Authority encourages the Highway Authority to address maintenance and repair of the road surfaces in a manner that is sympathetic to their nature and, more specifically, repairs the section of lane identified above in the same manner.

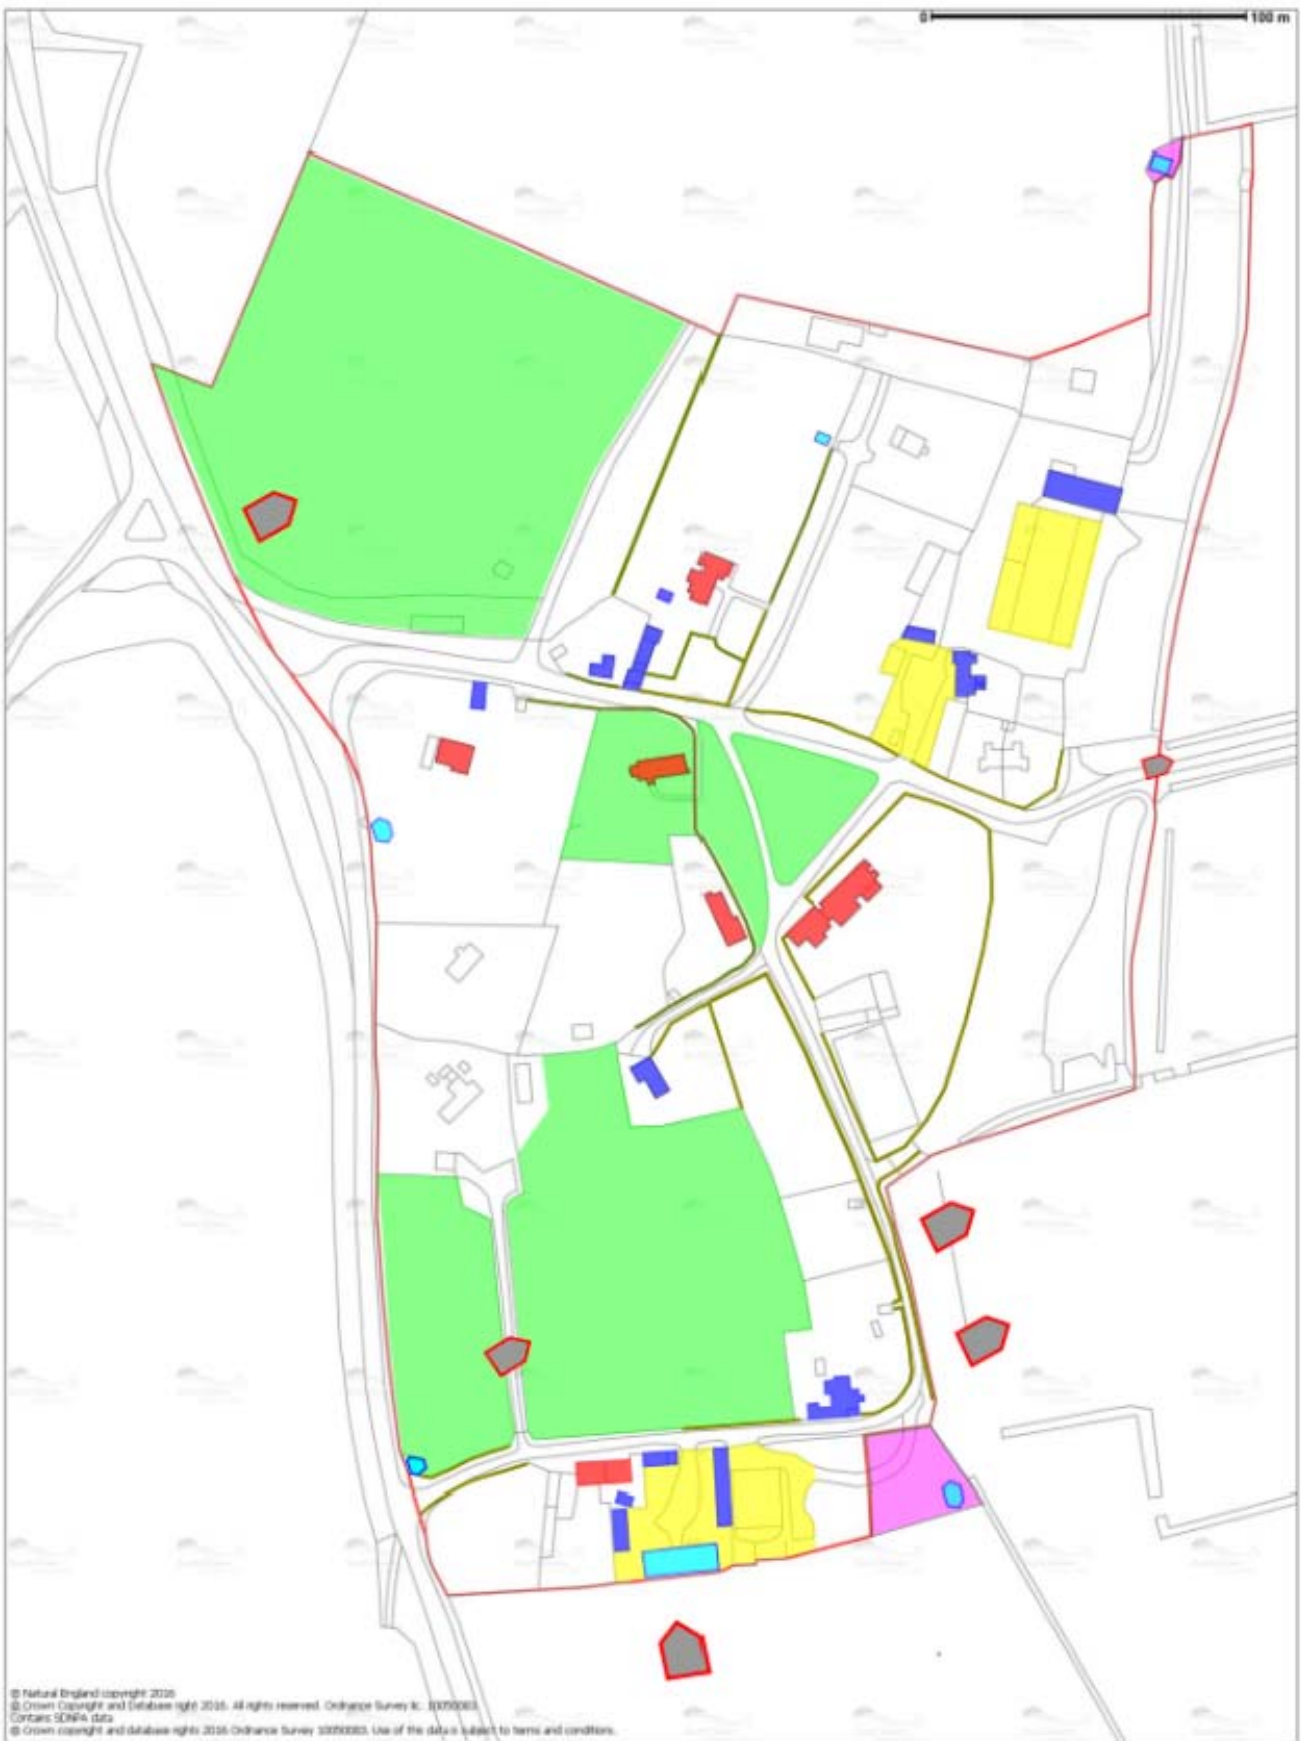
6.4 In undertaking this review of the Conservation Area, the boundaries were found to be substantially sound. Only two small extensions are proposed one at the northern end of the village and the other at the southern. Both are shaded pink on Figure 24. In both cases the extensions are drawn to incorporate a pill box.

Figure 24: Elements which make a Positive Contribution to the Character of Southease Conservation Area, including listed buildings (red), other buildings which make a positive contribution (dark blue), potential additions to the Local List (light blue), important open green areas (green), important boundaries (olive green), and significant views (red and grey arrows). Potential extensions to the Conservation Area are indicated in pink and enhancement opportunities in yellow.

[NB: The map does not attempt to distinguish curtilage listed buildings and some of those marked in blue may fall into this category]
