## Conservation Area Character Appraisal and Management Plan

# Castle Goring

December 2015

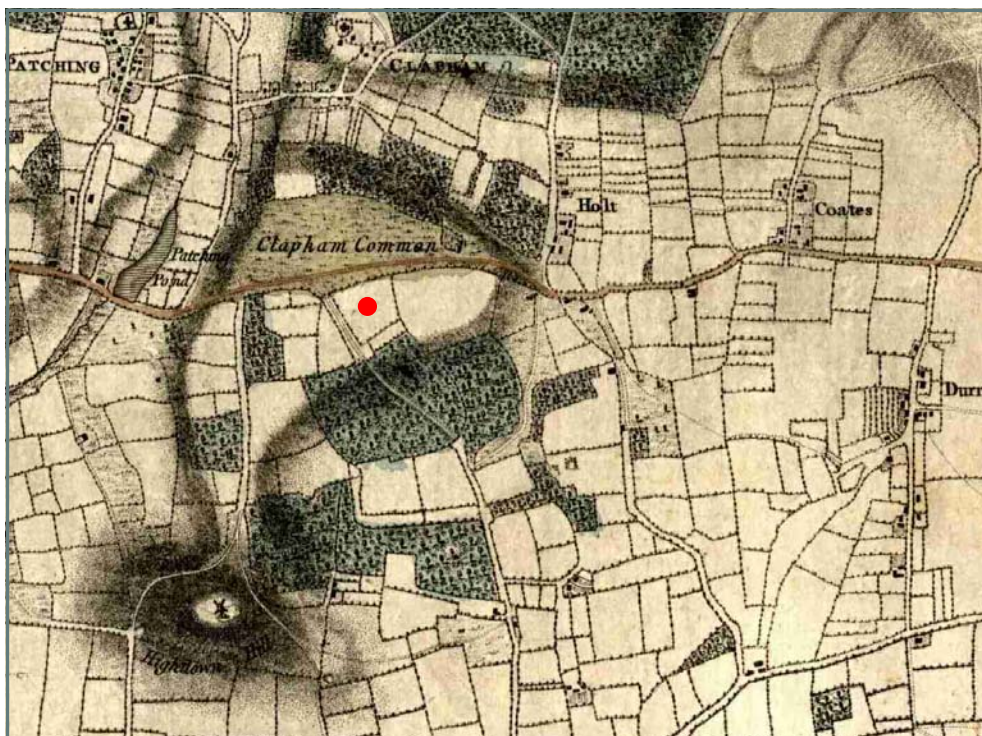
Figure 1: Yeakell & Gardner's Map of 1778-83.

3.9 Such evidence shows that much of the area has been wooded through most of the post-mediaeval period, with a stable core of woodlands based on Titnore Hill, Goring Wood, Highdown Copse and Street's Copse. Yeakell & Gardners Map of Sussex (figure 1), published between 1778 and 1783, shows a number of blocks of woodland but no sign of the house. The later site of Castle Goring is indicated by the red dot

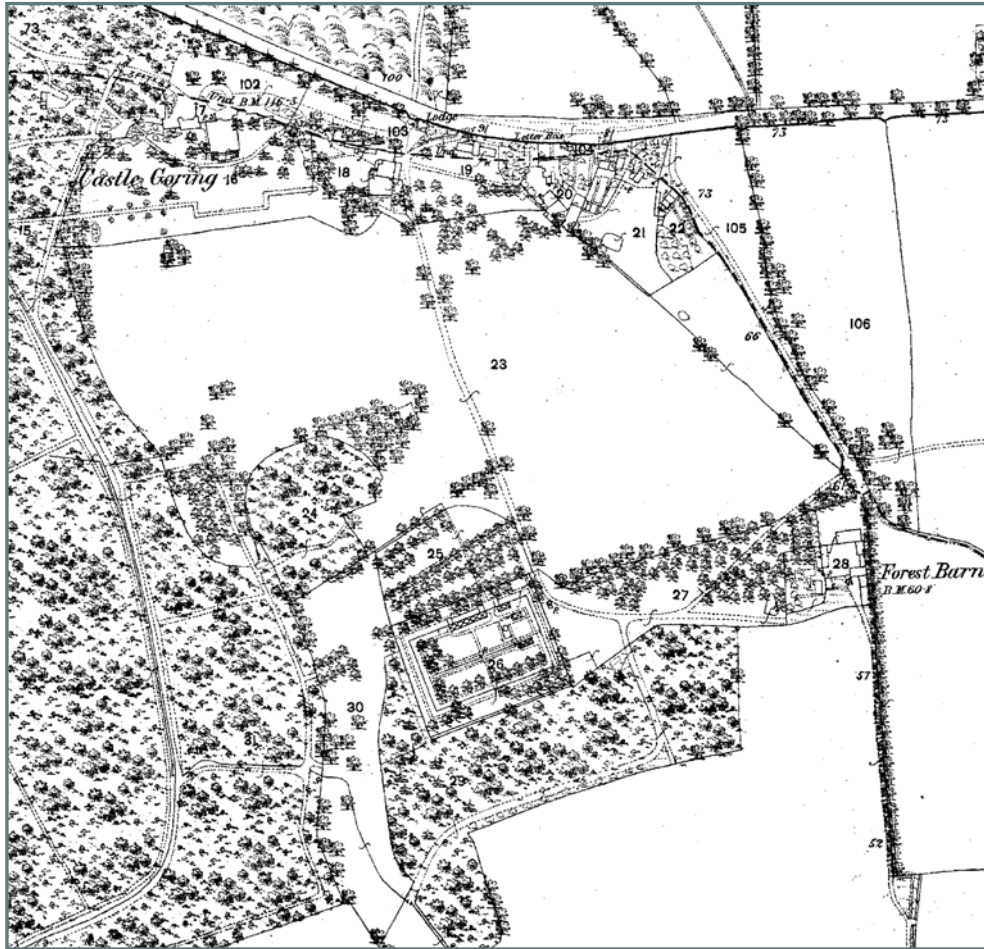
Figure 3: Ordnance Survey Mapping of 1875

3.11 When compared with the Tithe Map, the Ordnance Survey map of 1875 (figure 3) shows the Roundel demarcated for the first time, although it is not annotated as such, and the orchard to the north of the walled garden stands out more clearly, with rows of trees. An east – west wall divides the interior of the walled garden which was presumably intended to increase the amount of south facing wall for growing. A track, which also appears on the tithe map, links the walled garden to the main group of buildings running across the parkland and there appears to be a drive out to the north-west of the house.

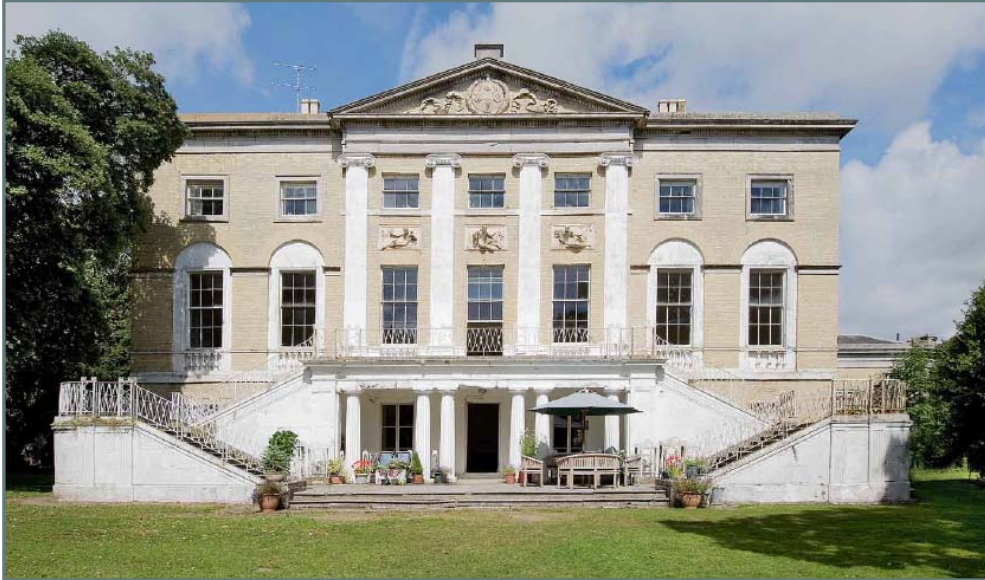
Figure 7 (above): The south elevation in a neo Classical style

4.8 The south front (figure 7) is said, on the basis of meagre evidence, to be a copy of a villa near Rome. The centre portion of three windows projects slightly with stuccoed Ionic pilasters and an entablature and pediment with the Shelley arms in the tympanum. The Coade stone panels are set between the first and second floor windows. The remainder of the front has a cornice continued from the first floor windows in arcading with arched panels over and balustrading

beneath. On the ground floor is a portico with six fluted Doric columns in front of three central windows with two flights of curved staircases on either side.

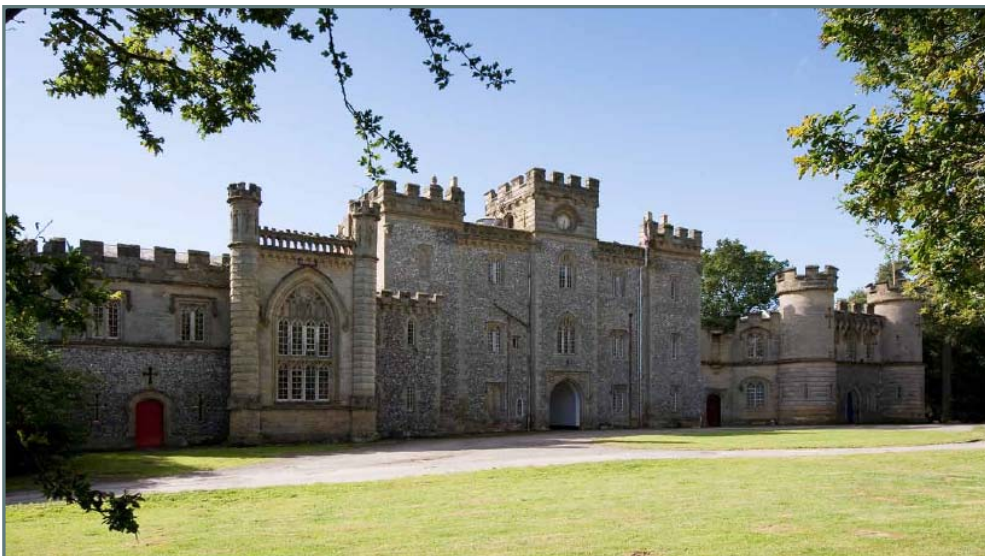
Figure 8 (below): The north elevation, in a castellated Gothic style

4.10 The Gothic north elevation (figure 8) has a square tower in the centre and castellated parapets at the ends. The Gothic style carries through to the pavilions. The stables have two round turrets and the kitchen a large traceried window in the perpendicular style.

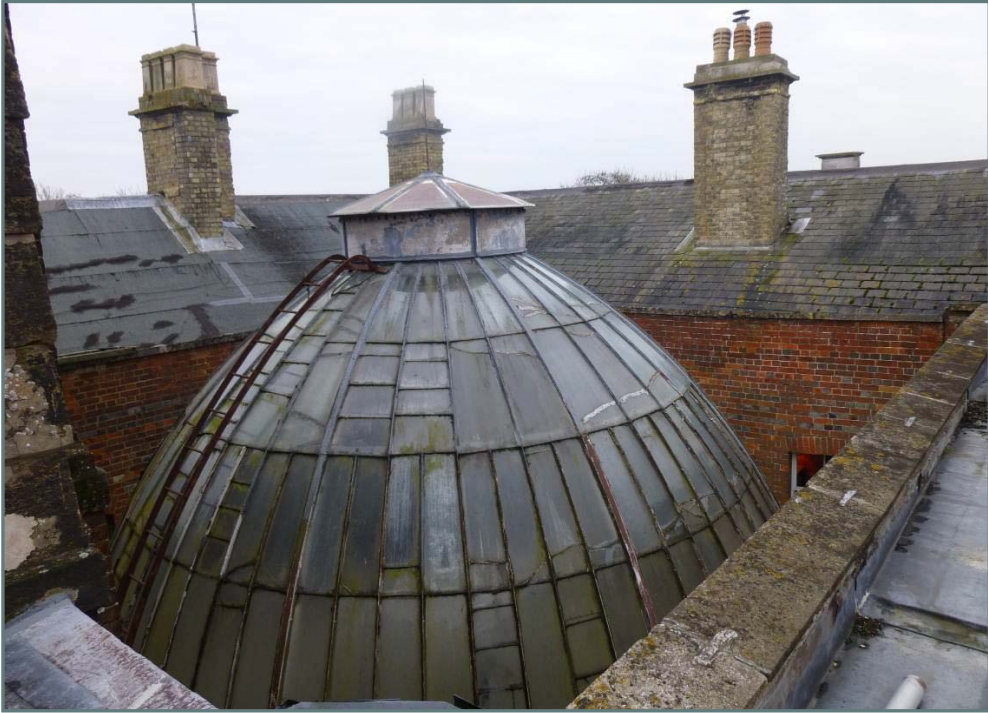
Figure 9 (above); the glazed dome above the central staircase

3.3 In plan, the house seems to have been originally envisaged as a courtyard house but an early change saw this space roofed under a large glazed skylight and equipped with a staircase.

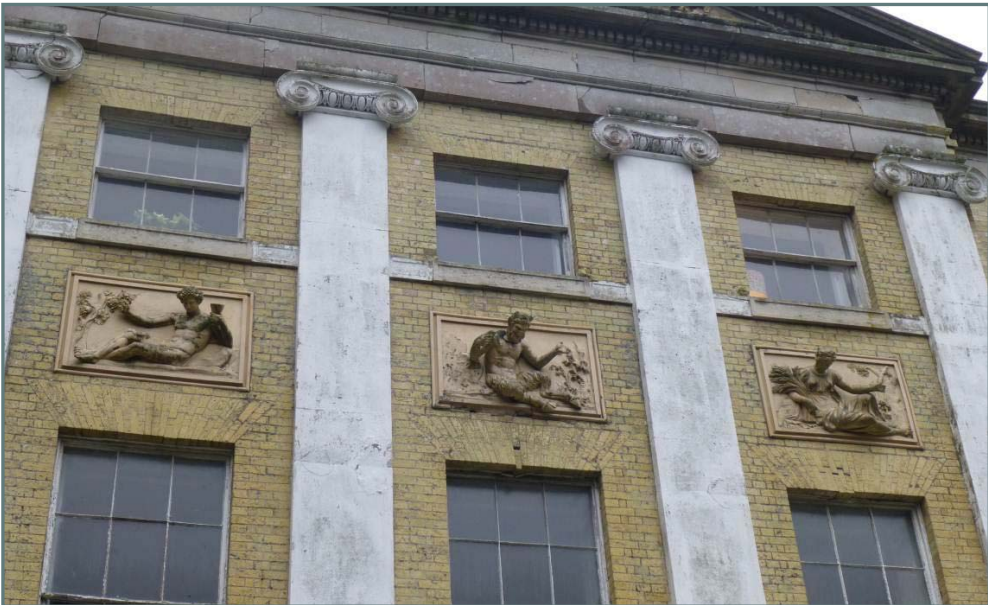
Figure 10 (below): Coade stone panels of Pan, Bacchus and Ceres

3.4 The available evidence suggests that the Palladian southern half was built first, probably in 1797-98; a date derived from the Coade Stone plaques bearing figures of Pan, Bacchus and Ceres. Construction on the Gothic half then seems to have continued until about 1810. Active work on the house ceased after the death of Sir Bysse Shelley in 1815, when the house passed to his son, Sir Timothy.

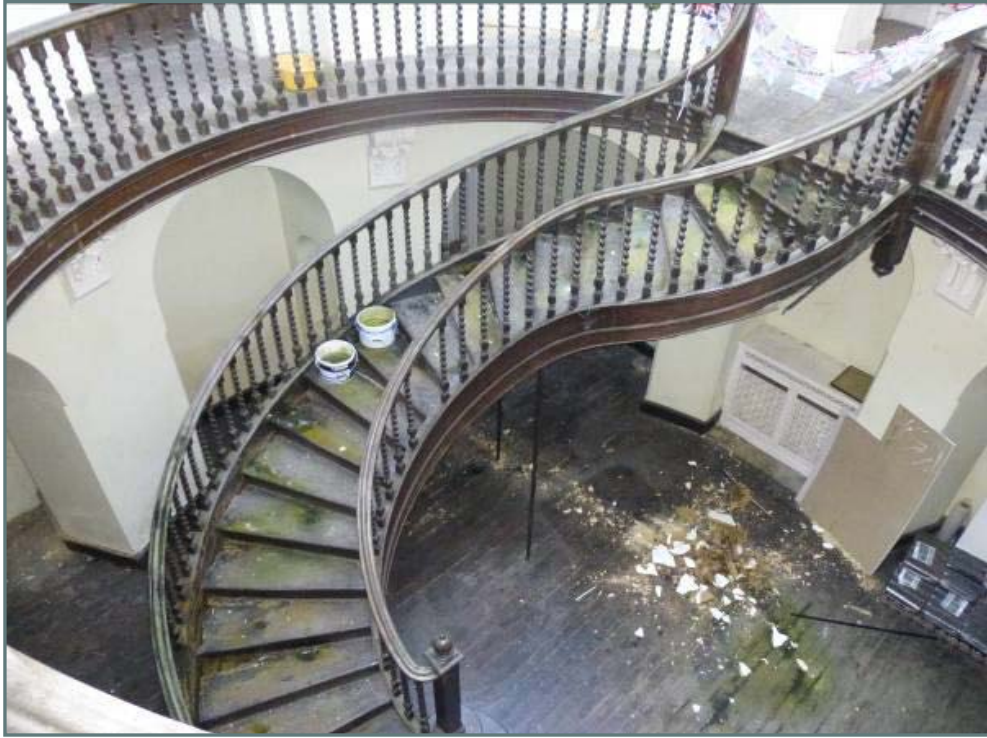
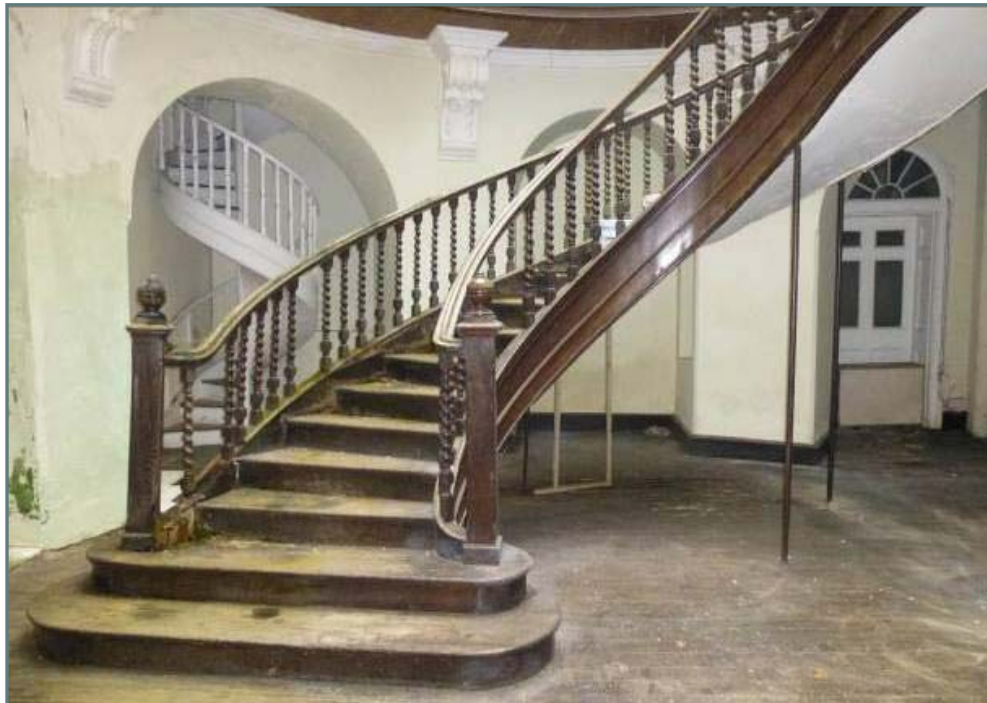
Figure 11: the central staircase

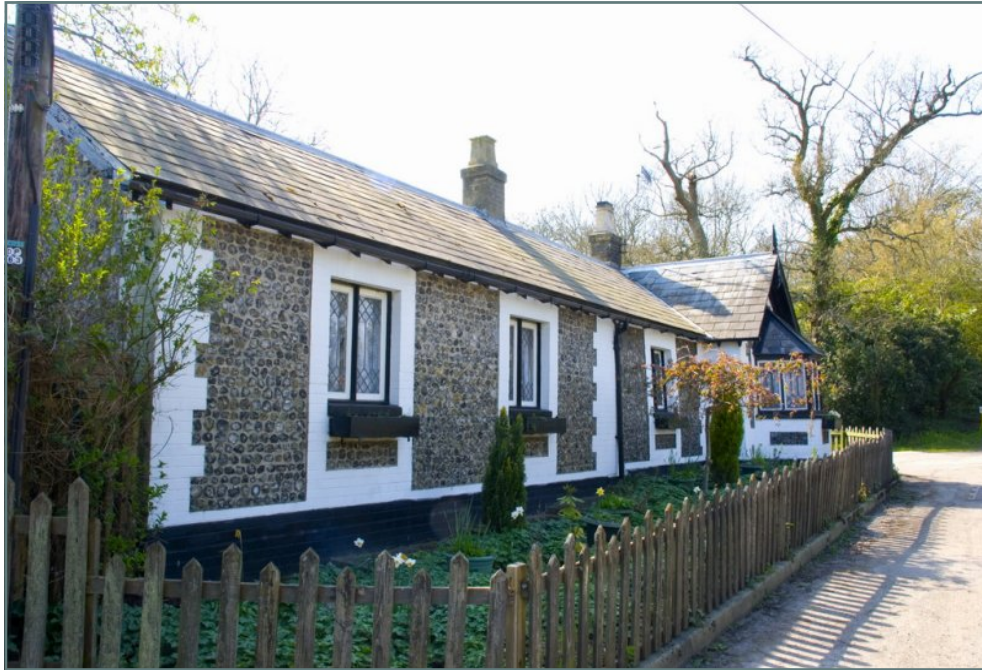
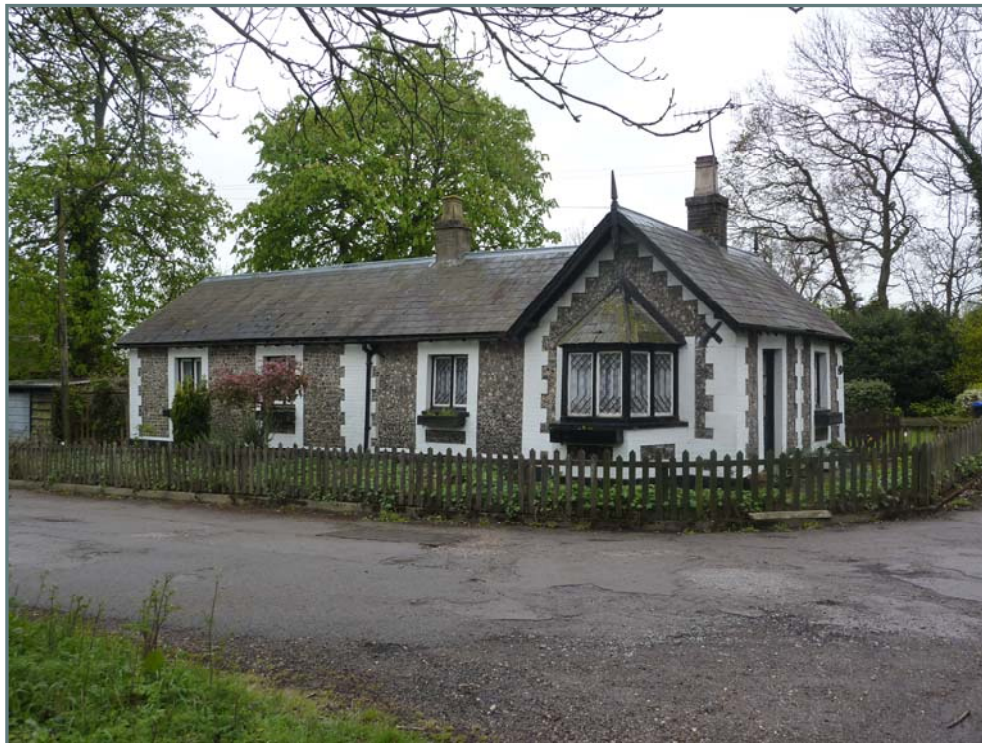
Figure 12: The Grade II listed Lodge

4.12 The Lodge (figure 12) is slightly later in construction than the main house, probably having been built by George Petchell about 1830, and is the only estate building that makes any architectural allusion to the main house. Typically for a lodge building, it is a single storey structure combining a level of architectural detail and a selection of materials that reference the main house. In this instance that takes the rather diluted form of the gothic and flint walls with stuccoed quoins, a slate roof, and decorative barge boards.

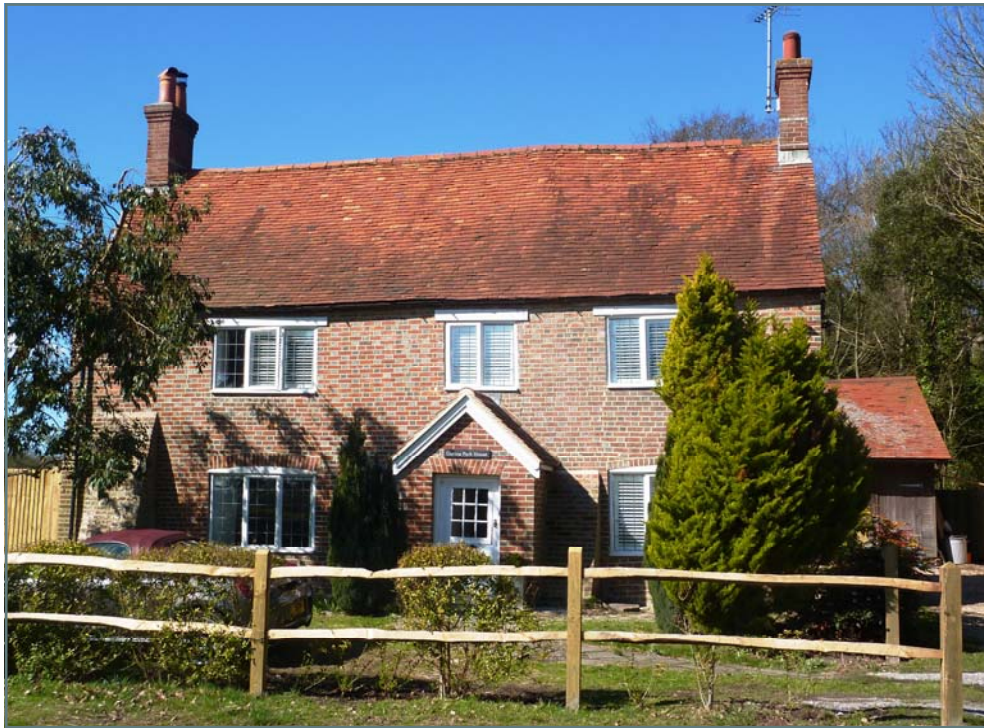
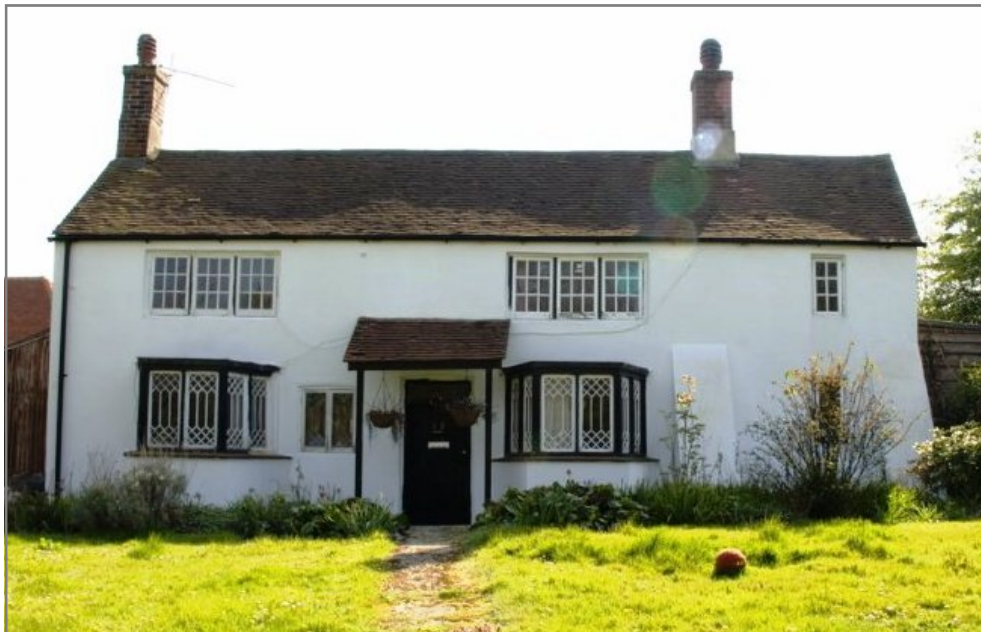
Figure 13: 18<sup>th</sup> Century Grade II listed cottages.  
14 Arundel Road (above)  
12 Arundel Road, ( below)

4.14 Numbers 12, 13 and 14 Arundel Road (figures 13 and 14) are all detached cottages facing the old road, probably of 18th century date and therefore, in all likelihood, pre-dating the main house. They range from a relatively simple brick cottage (No 14) through a cottage built of grey headers (No 13) to a rendered cottage with windows having quite decorative lattice glazing bars (No.12)

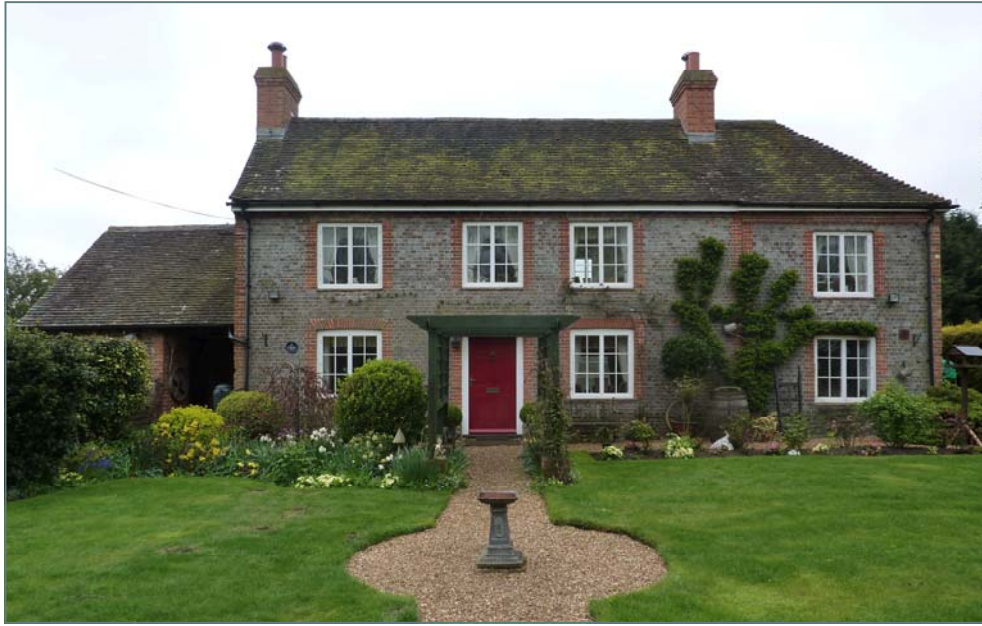
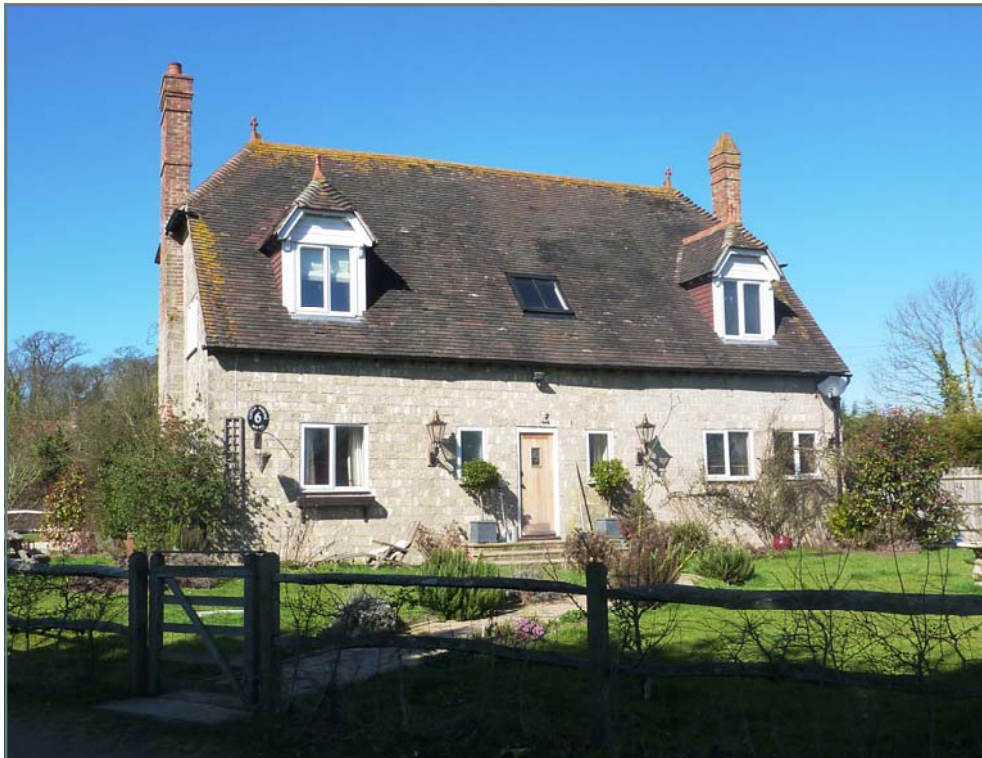
Figure 14:  
18<sup>th</sup> century Grade II listed cottage, 13 Arundel Road, Castle Goring Cottages  
(above)  
Cottage forming part of the second stable block, built c.1875 (below)

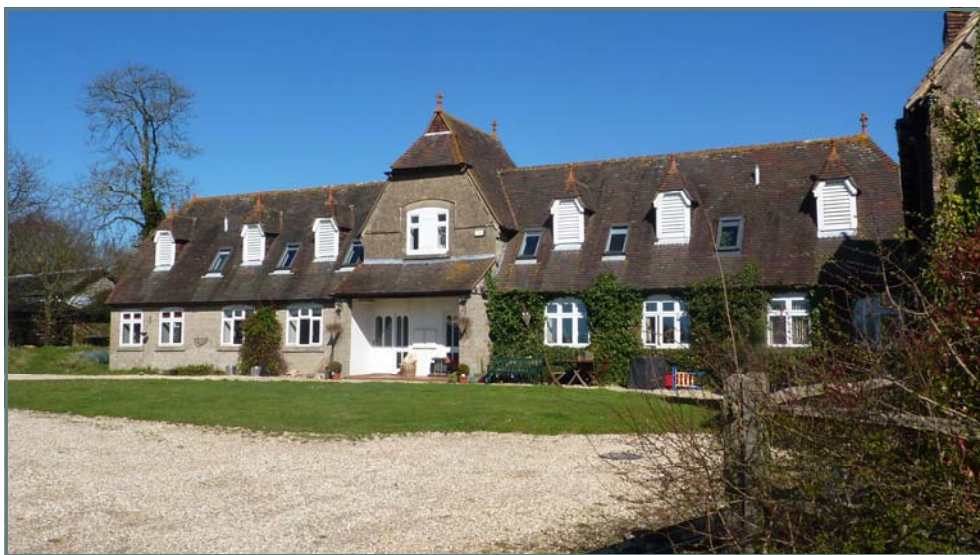
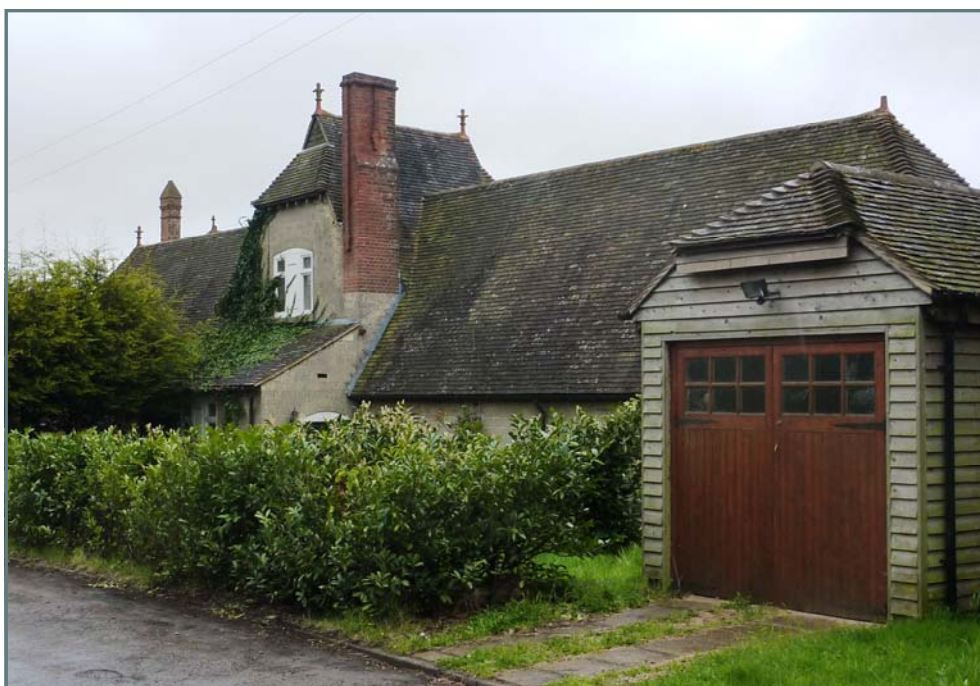
Figure 15 : The Stables Range  
South elevation (above)  
North elevation (below)

4.13 The Stable block and coach house (figure 15) form a defined courtyard and were constructed around 1875 using concrete blocks with exposed aggregate; an early use of this material. The main range comprises an unusual and quite complex central bay of two tall storeys flanked on either side by one-&-a-half storey ranges, four windows each in width, with very distinctive louvred dormers. These buildings have been converted and sub-divided into residential units.

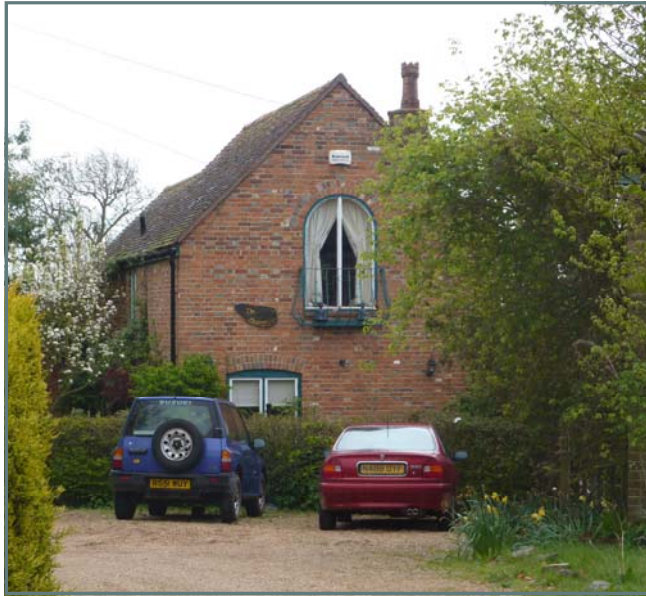
Figure 16: Other unlisted buildings which make a positive contribution to the character of the Conservation Area

4.16 A number of other, more minor buildings make a positive contribution to the Conservation Area (figure 16), including The Hermitage, and these are identified on the character map (figure 20).

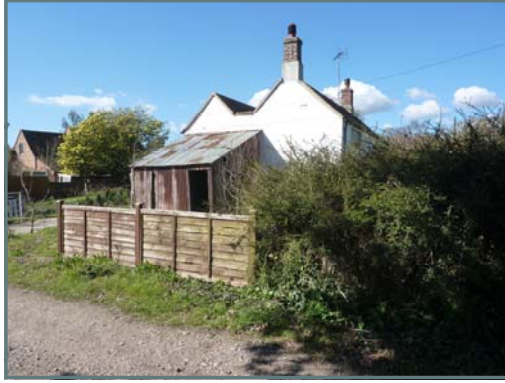
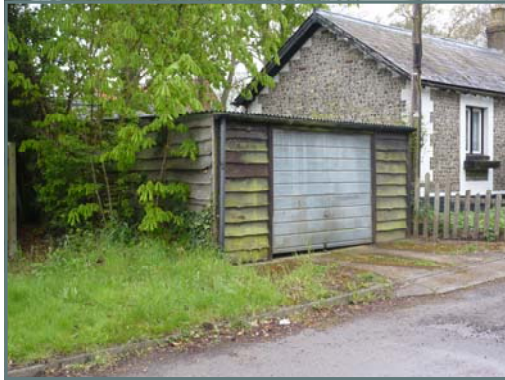
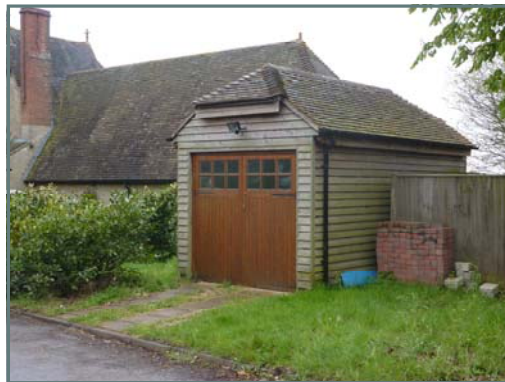
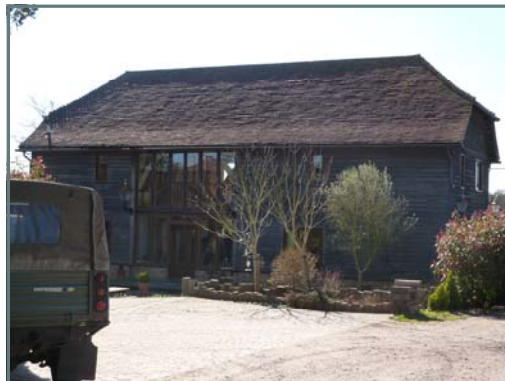
Figure 17: Some structures detract from the character of the Conservation Area (above) whilst others are more neutral (below)

5.5 Others buildings have seen inappropriate changes, such as the addition of a satellite dish to the stable block, whilst a number of more recent and quite inappropriate structures have appeared in the Conservation Area; in particular the garages to the east of the Lodge and the corrugated sheet lean-to structure (figure 17)
