Soft sand and Silica sand Study

Final Report - Appendix A

Sampling Site Details and Testing Results

Cuesta Consulting Limited

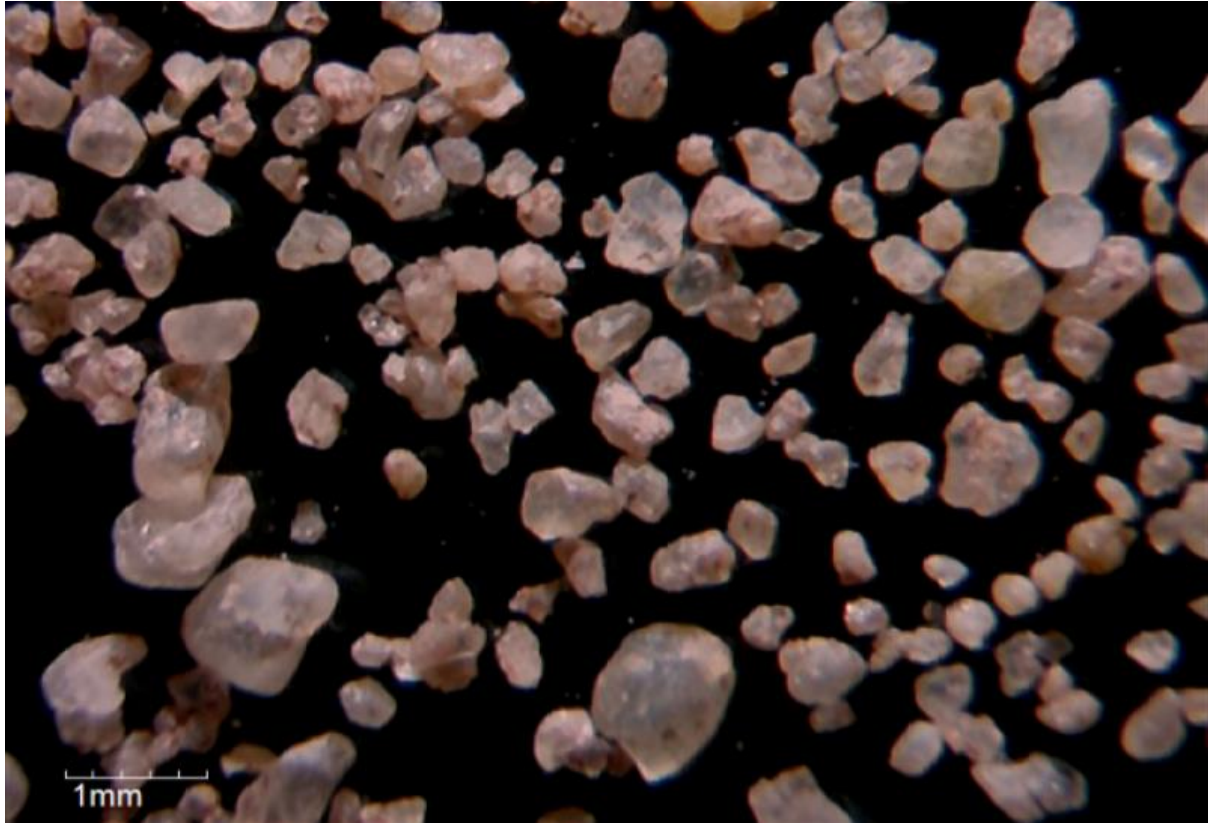
Photomicrograph

SASS1 - Sandgate Park Quarry

In-situ sample of upper horizon from current working face

Colour under Microscope	Other Observations	Roundness	Sphericity
Golden yellow and translucent white, coated in red 'silt'	A range of grain sizes observed a few at around 1mm but the majority smaller. Larger grains have red stained 'pock marks' or indentations. Grains coated in very fine grained red 'silt' - like material. Groups of grains 'stick together' before use of pestle. Some grains of low sphericity, some of high sphericity but generally medium sphericity. Occasional sub-angular grains.	Sub-Rounded to Rounded	Medium Sphericity

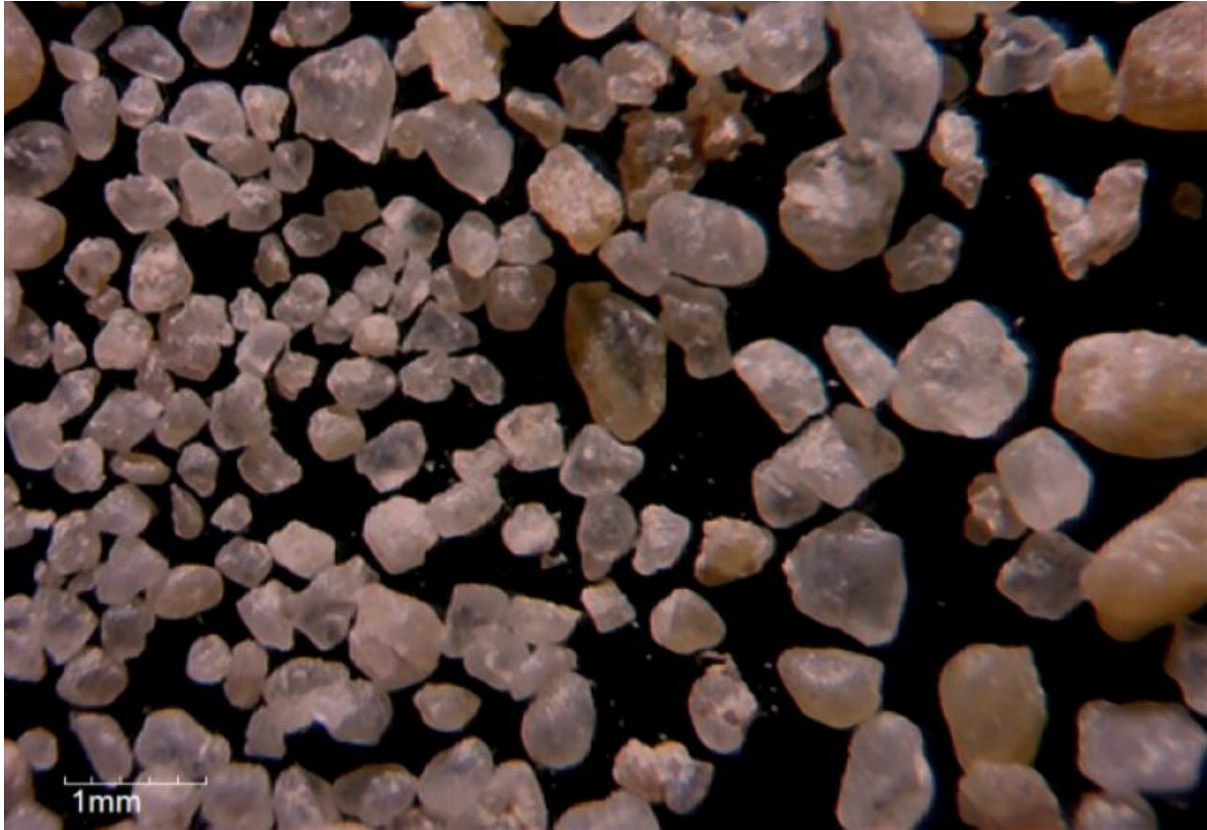
Photomicrograph

SASS2 - Sandgate Park Quarry

In-situ sample of lower horizon at side of haul road

Colour under Microscope	Other Observations	Roundness	Sphericity
Golden yellow and translucent white	A range of grain sizes observed a few at around 1mm but the majority smaller. Very occasional larger grains have iron stained 'pock marks' or indentations. Groups of grains 'stick together' before use of pestle. Some grains of low sphericity, some of high sphericity but generally medium sphericity. More occasional sub-angular grains.	Sub-Rounded to Rounded	Medium Sphericity

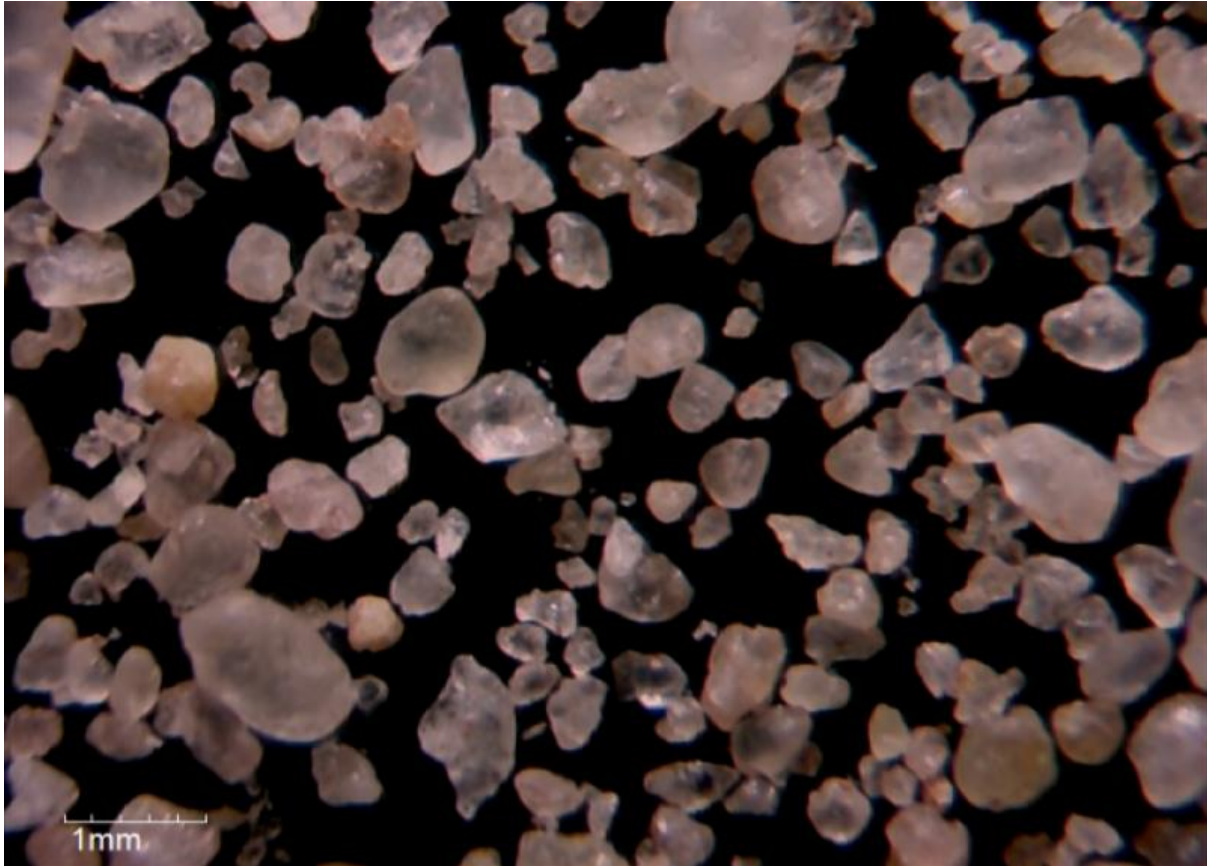
Photomicrograph

SASS3 - Sandgate Park Quarry

Disturbed sample from blended and washed sand stockpile

Colour under Microscope	Other Observations	Roundness	Sphericity
Clear (like fine glass) translucent white with some golden yellow grains with red staining	A range of grain sizes observed a few at around 1mm but the majority smaller. Some grains of low sphericity, some of high sphericity but generally medium sphericity. More occasional sub-angular grains. About half the grains clear like glass.	Sub-Rounded to Rounded	Medium Sphericity

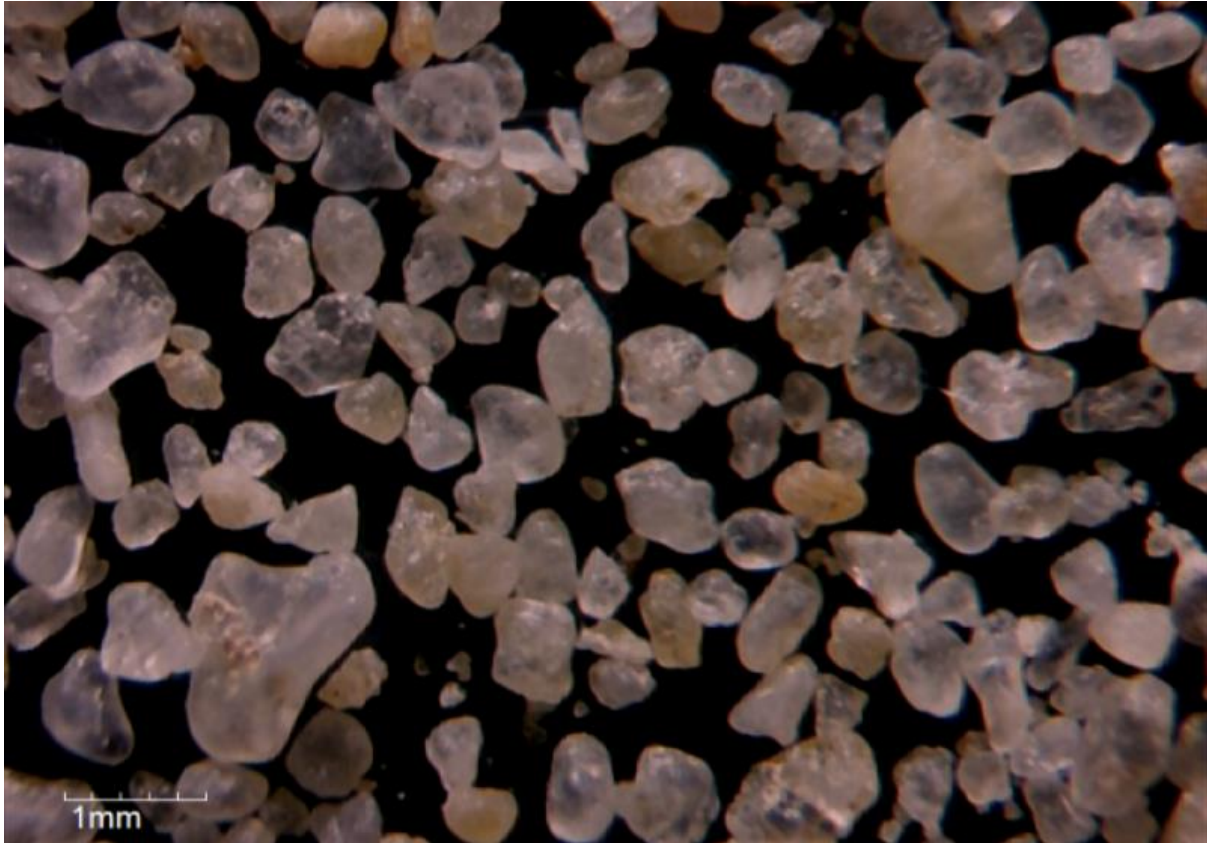
Photomicrograph

SASS4 - West Heath Common Quarry

In-situ sample of “White Sand” from northern end of original quarry

Colour under Microscope	Other Observations	Roundness	Sphericity
Clear (like fine glass) translucent white with very occasional golden yellow grains with red staining	A range of grain sizes observed a few at around 1mm but the majority smaller. The majority of the grains are clear like fine glass. Grains vary in shape some are almost well rounded, others sub-angular.	Sub-Angular to Rounded	Medium to High Sphericity

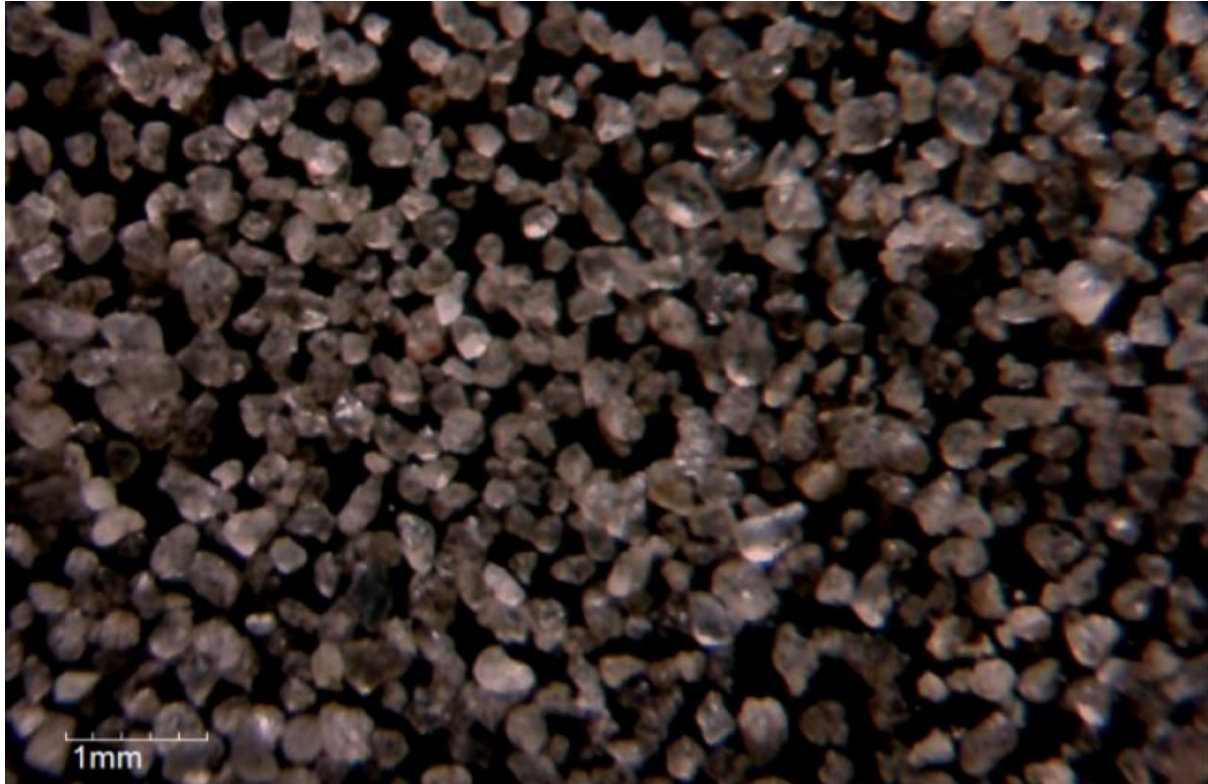
Photomicrograph

SASS4a - West Heath Common Quarry

In-situ mixed sample of black, brown and pink horizons from eastern side of current workings

Colour under Microscope	Other Observations	Roundness	Sphericity
Clear (like fine glass) translucent white and light grey sand grains coated in grey 'silt'	No coarse sand grain sizes observed. Grains all very similar in size. Groups of grains 'stick together' before use of pestle. Despite the colour of the sand being almost black, the sand grains themselves are clear to light grey in colour but coated in darker grey fine grained 'silt' like material.	Sub-Angular to Sub-Rounded	Medium to High Sphericity

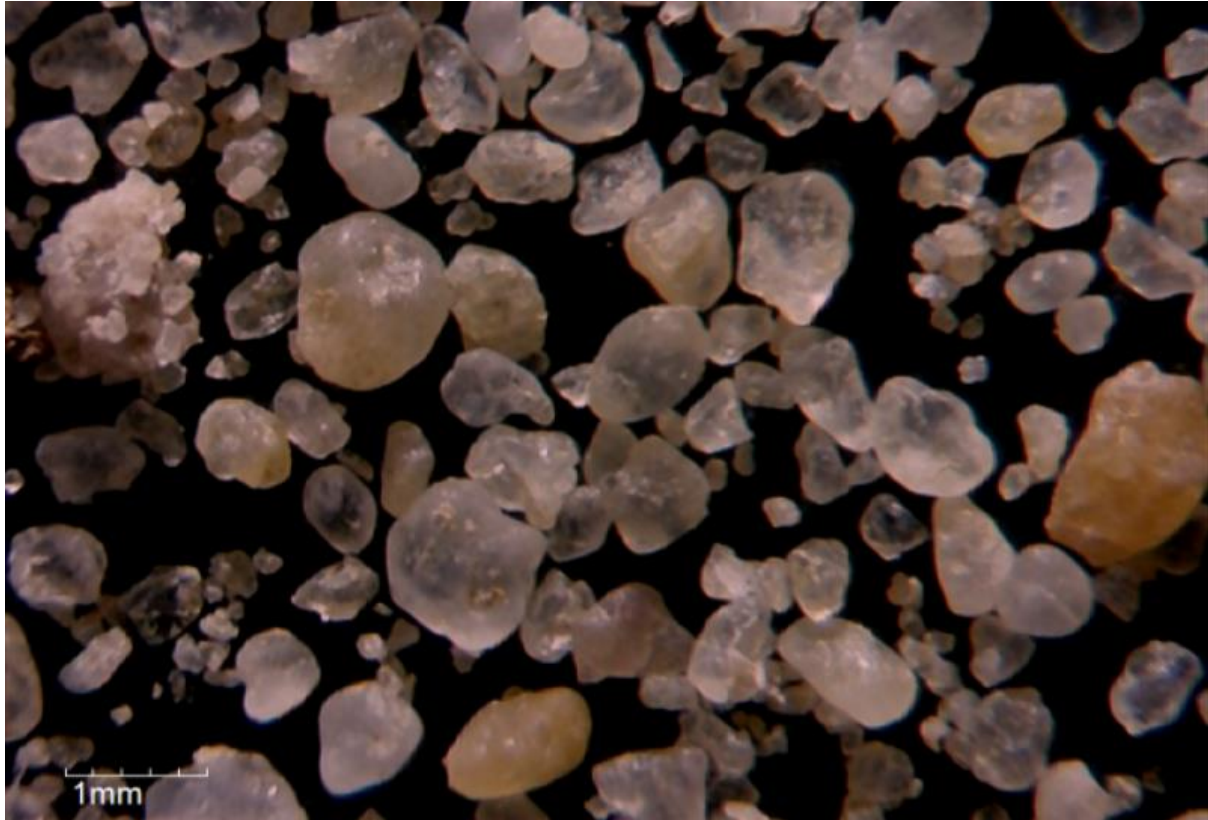
Photomicrograph

SASS5 - West Heath Common Quarry

Disturbed 'as dug' sample of yellowish sand from current workings (excavated below water from side of lagoon)

Colour under Microscope	Other Observations	Roundness	Sphericity
Golden yellow and translucent white with some clear (like fine glass) and some orange grains	A range of grain sizes observed with occasional larger than 1mm size grain. Very occasional black 'silt'- like material coating the grains.	Sub-Angular to Sub-Rounded	Medium to High Sphericity

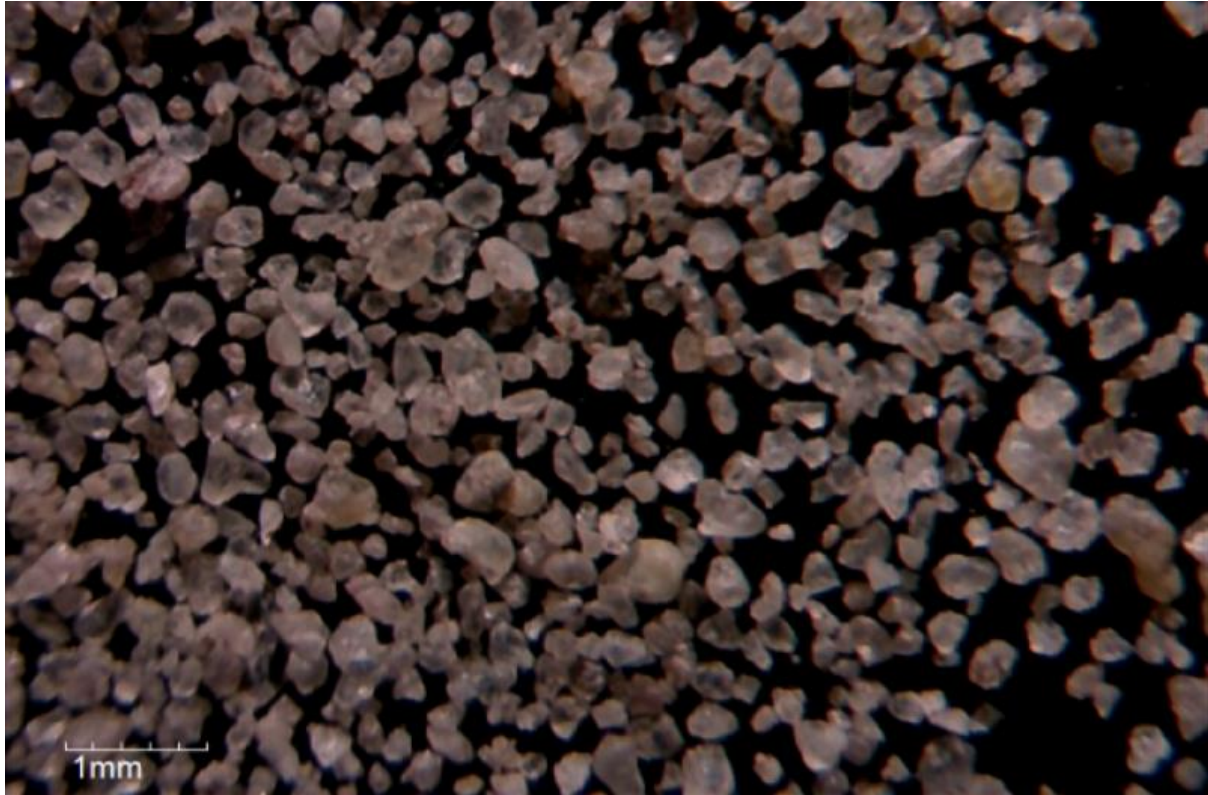
Photomicrograph

SASS6 - West Heath Common Quarry

Disturbed 'as dug' sample of mostly pink sand from eastern side of current workings (excavated dry).

Colour under Microscope	Other Observations	Roundness	Sphericity
Clear (like fine glass) translucent white and light grey	No coarse sand grain sizes observed. Grains all very similar in size. Some parts of the sand form hard compact lumps that break up with the pestle. Occasional orange stained grains. Occasional fine 'silt' - like coating on the grains. Occasional Angular grains.	Sub-Angular to Sub-Rounded	Medium to High Sphericity

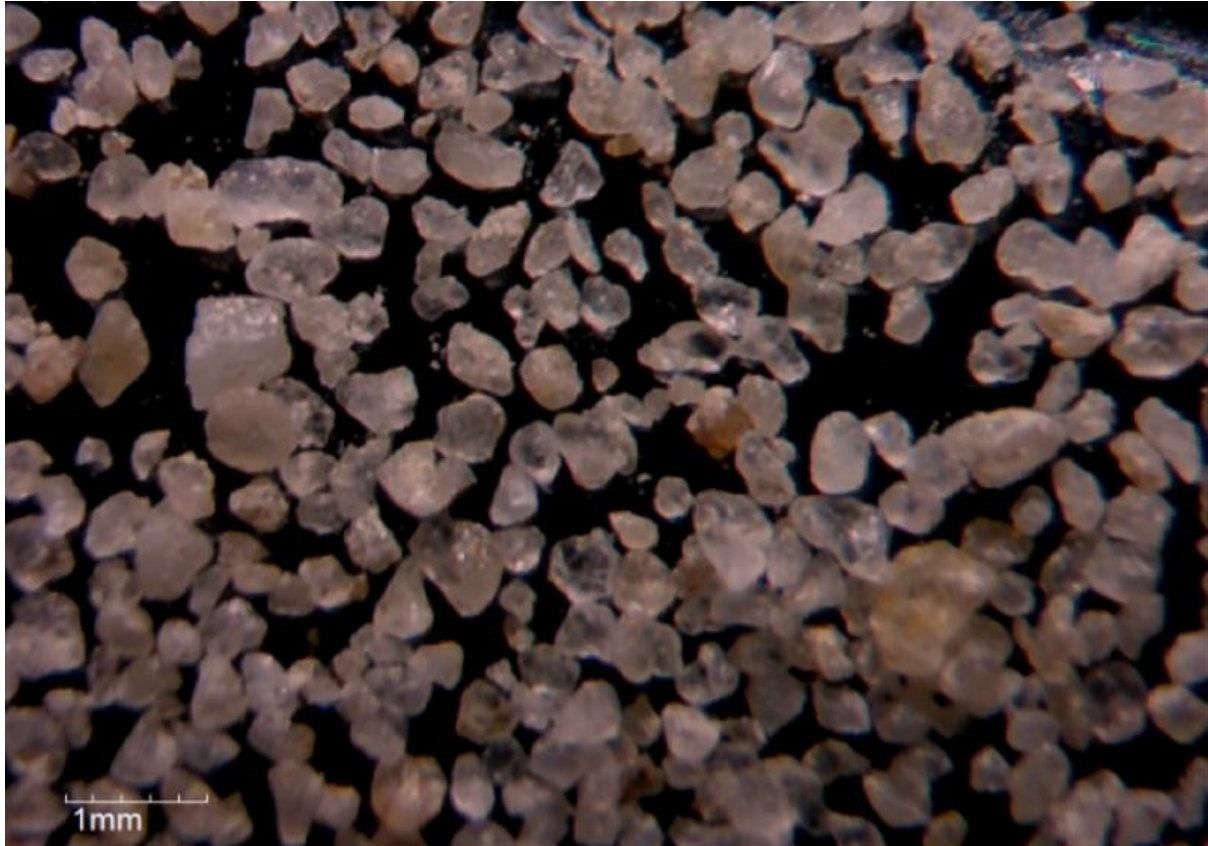
Photomicrograph

SASS7 - Midhurst Common Quarry

In-situ sample of yellowish sand from base of quarry - above thin clay drape

Colour under Microscope	Other Observations	Roundness	Sphericity
Clear (like fine glass) translucent white and some light orange	No coarse sand grain sizes observed. Grains all very similar in size. Occasional light grey or orange 'silt' like material coating some grains	Sub-Angular to Sub-Rounded	Medium to High Sphericity

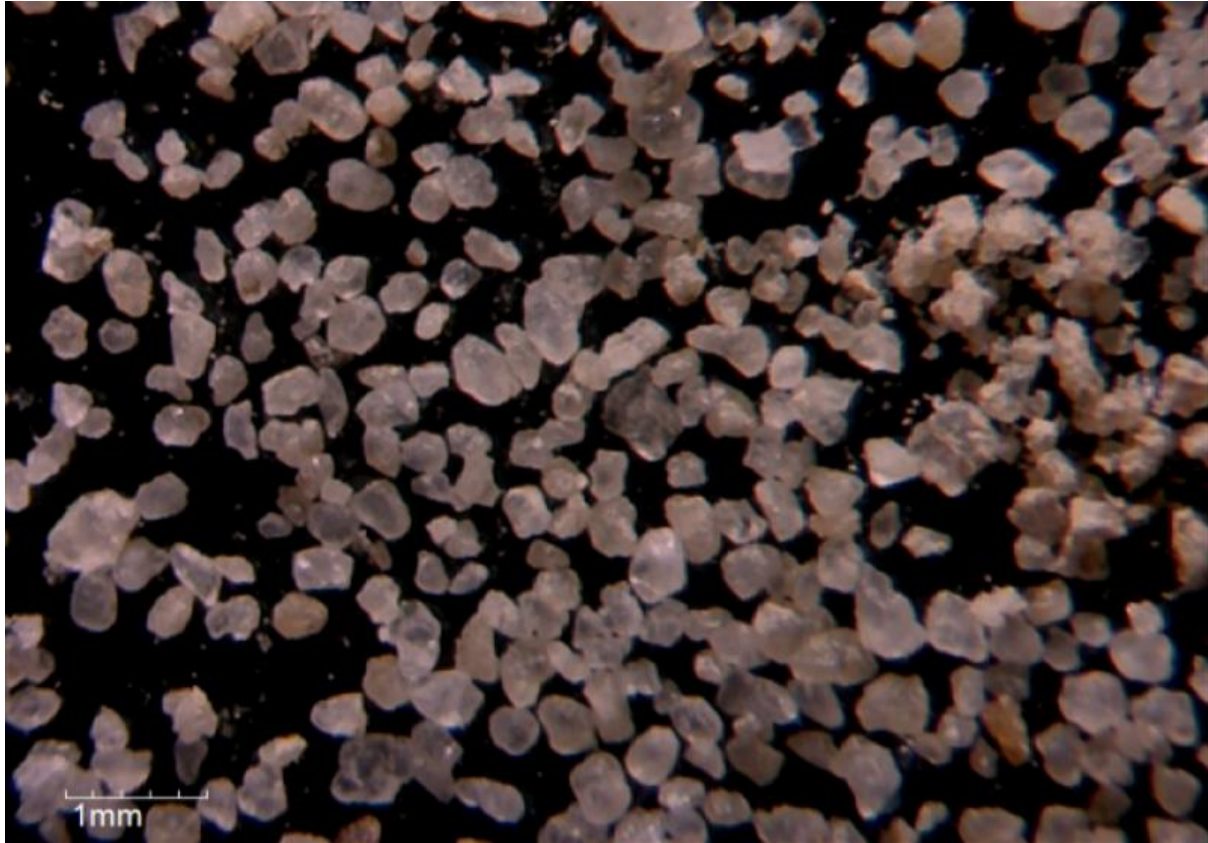
Photomicrograph

SASS8 - Midhurst Common Quarry

In-situ sample of yellowish-orange sand from base of quarry - below thin clay drape.

Colour under Microscope	Other Observations	Roundness	Sphericity
Clear (like fine glass) translucent white and light grey	No coarse sand grain sizes observed. Grains all very similar in size. Occasional light grey 'silt' like material coating some grains	Sub-Angular to Sub-Rounded	Medium to High Sphericity

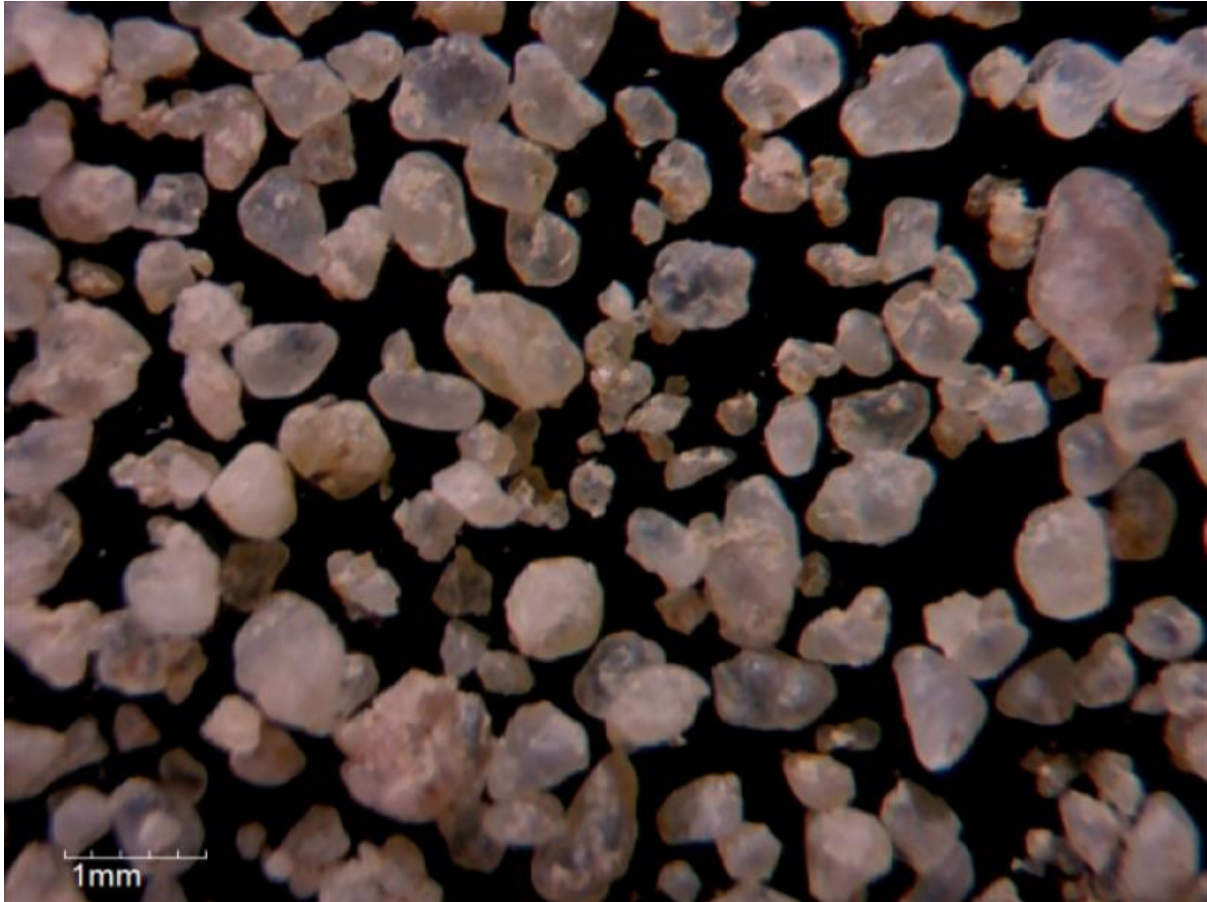
Photomicrograph

SASS9 - Coates Pit Quarry

In-situ sample from lower part of quarry face in NE corner

Colour under Microscope	Other Observations	Roundness	Sphericity
Golden Yellow and translucent white	No coarse sand grain sizes observed. Dark orange staining on some grains. Occasional light orange 'silt' - like material coating some grains	Sub Rounded	Medium to High Sphericity

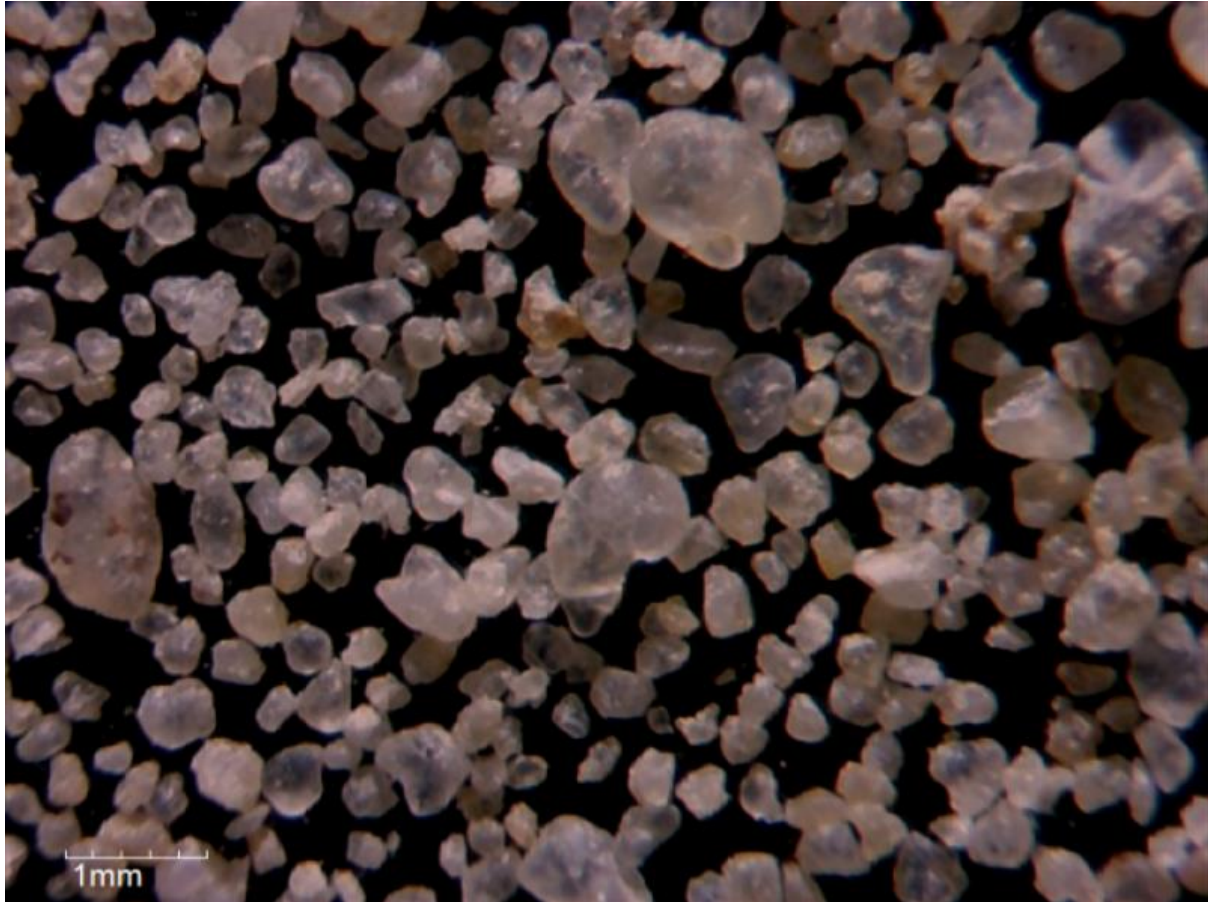
Photomicrograph

SASS10, - Coates Pit Quarry

In-situ sample from higher part of quarry face in S side of quarry.

Colour under Microscope	Other Observations	Roundness	Sphericity
Golden yellow and translucent white	A range of sand grain sizes observed some more than 1mm but the majority smaller. Dark orange staining on some grains. Occasional light orange 'silt' - like material coating some grains	Sub Rounded	Medium to High Sphericity

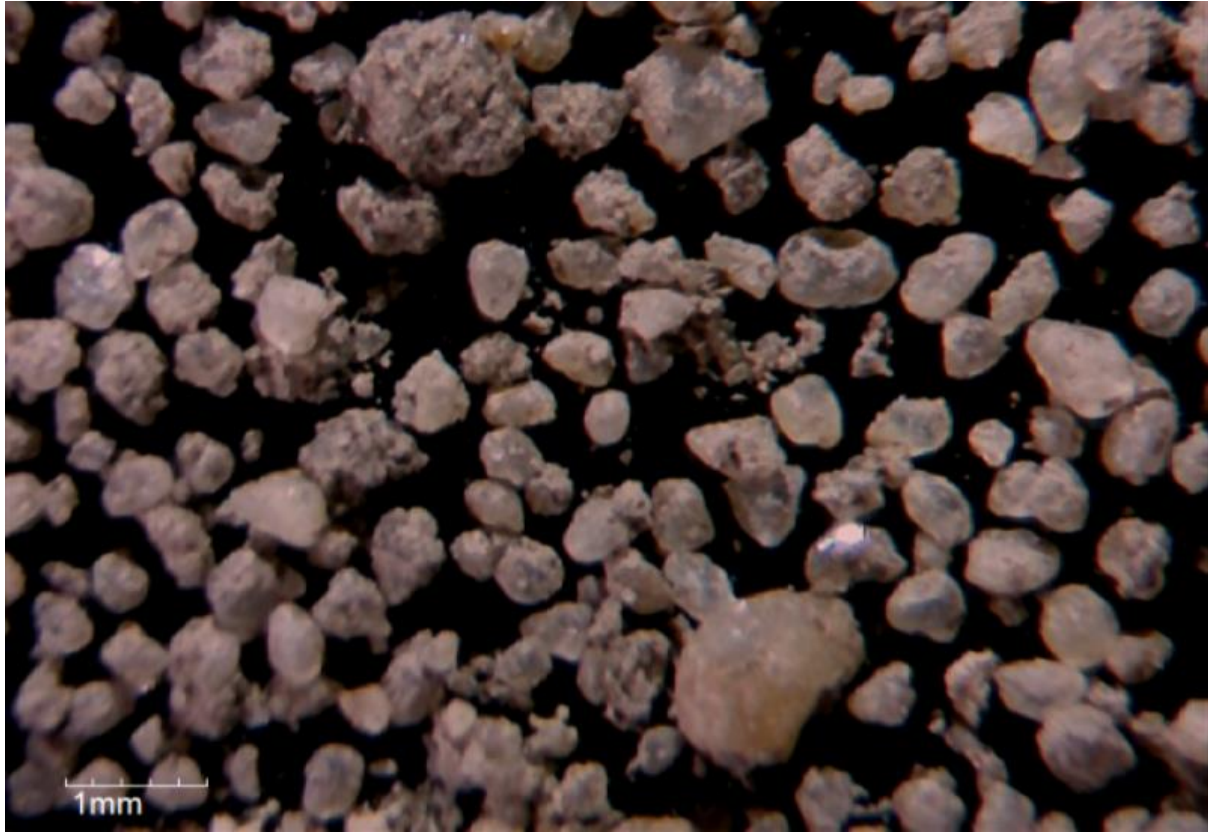
Photomicrograph

SASS12, - Wickford Bridge

Disturbed near-surface sample of sandy soil, from molehills in SE part of site.

Colour under Microscope	Other Observations	Roundness	Sphericity
Yellow and white grains heavily coated in light brown 'silt' particles	No coarse sand grain sizes observed. Grains heavily coated in fine grained light brown 'silt' - like material. Small roots present.	Sub-Angular to Sub-Rounded	Medium to High Sphericity

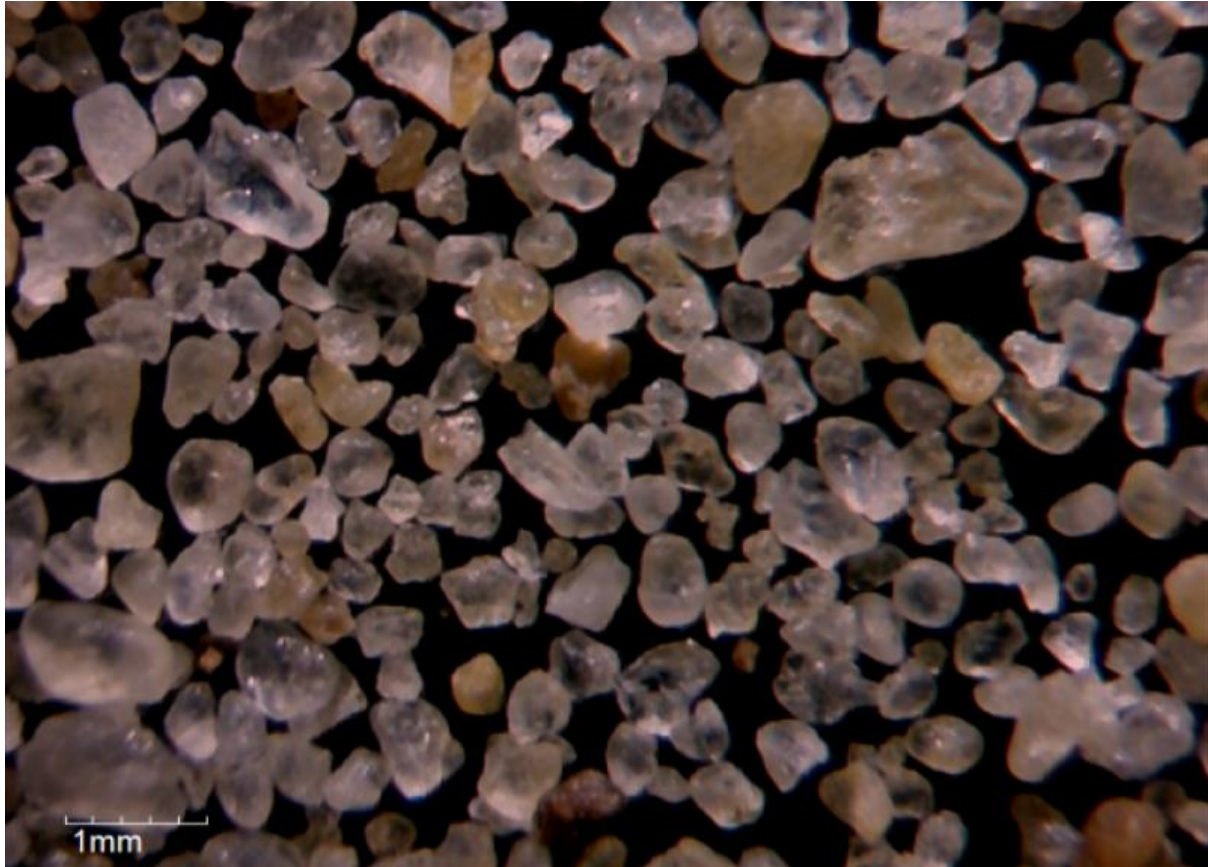
Photomicrograph

SASS14, - Kingsley Quarry

Disturbed sample of yellowish sand from current workings (excavated by suction dredging and washed).

Colour under Microscope	Other Observations	Roundness	Sphericity
Yellow orange and clear (like fine glass) translucent white	No coarse sand grain sizes observed. Occasional brown grain present. Grains very 'clean'.	Sub-Angular to Sub-Rounded	High Sphericity

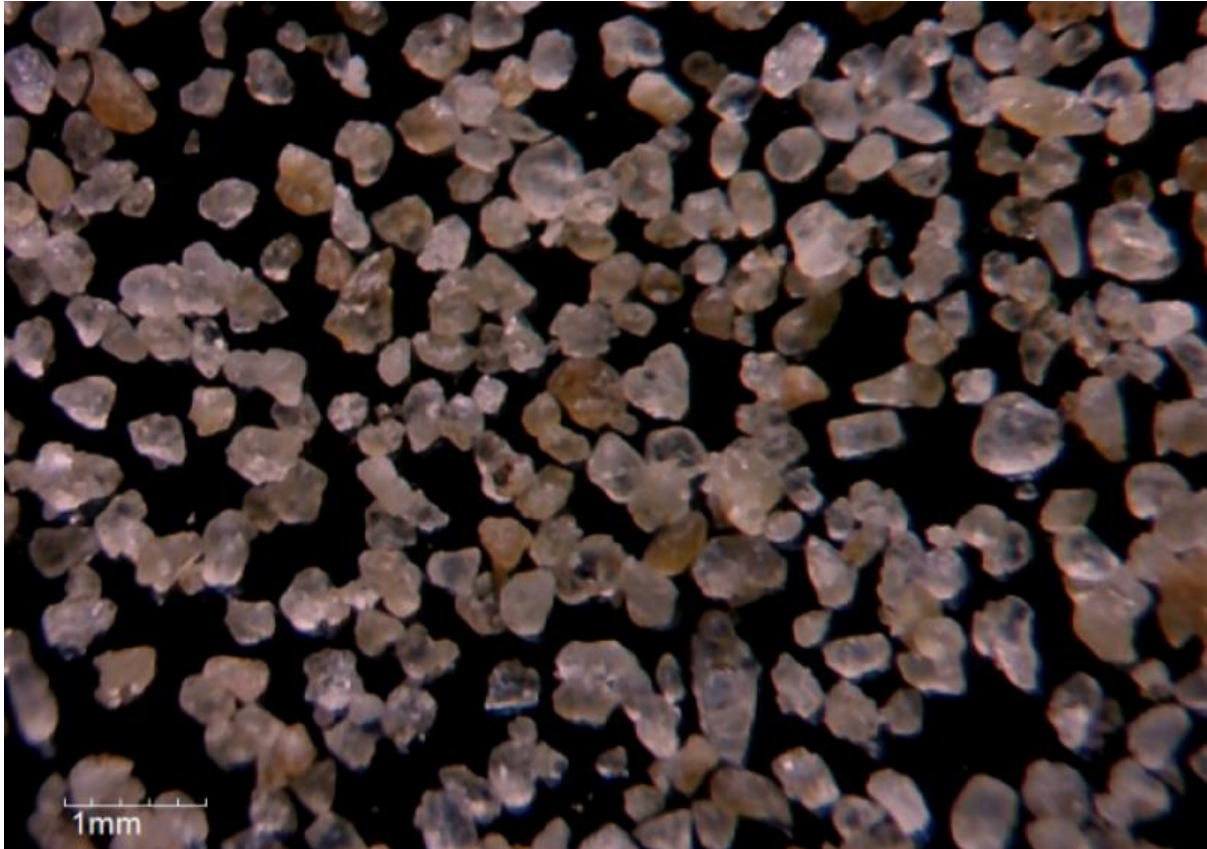
Photomicrograph

SASS15, - Kingsley Quarry

In-situ sample of yellowish sand from southern edge of current workings (above water level).

Colour under Microscope	Other Observations	Roundness	Sphericity
Yellow orange and clear (like fine glass) translucent white	No coarse sand grain sizes observed. Occasional brown grain present. Some dark orange staining on some grains.	Sub-Angular to Sub-Rounded	Medium to High Sphericity
