Case Study

Experiences of River Restoration

The project

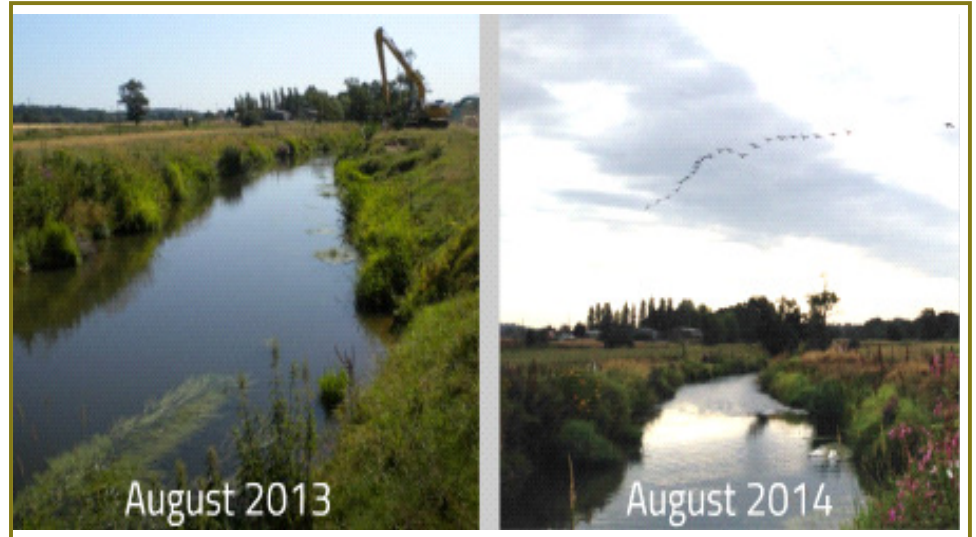
It is these 'variable flow conditions' that create a diversity of habitat – including conditions attractive to fish for spawning. The riffle was constructed with a mudstone base overlain with a coarse gravel substrate. Its impact on river flow can clearly be seen in the images above – the once uniform flow (August 2013) now appears to be 'broken' (August 2014) reflecting more natural flow variability.
