Bepton New Barn/New Farm

Field work 17th February 2016

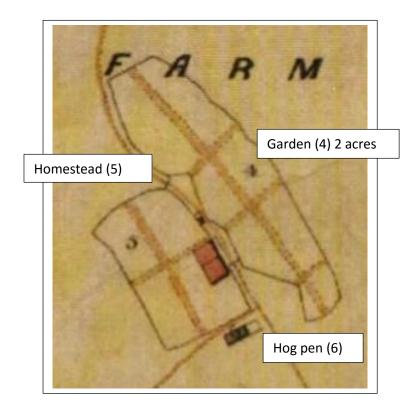
Bepton Tithe Map TDW11 surveyed 1838

In the accompanying tithe apportionment, it records the owner and occupier as being William Stephen Poyntz, the same owner as in 1799. However, William Stephen Poyntz married the heiress to the Cowdray Estate in 1794 and was a Whig member of Parliament for various constituencies between 1800 and 1837. He was unlikely to be living in a cottage (5), with a hog pen (6) in the woods. Plot 4 was described as a garden with the rest of the land used a fir plantation and underwood. There were 54 acres of underwood and 42 acres of Fir Plantation with no arable or pasture lands whilst it was called new Farm plantation.

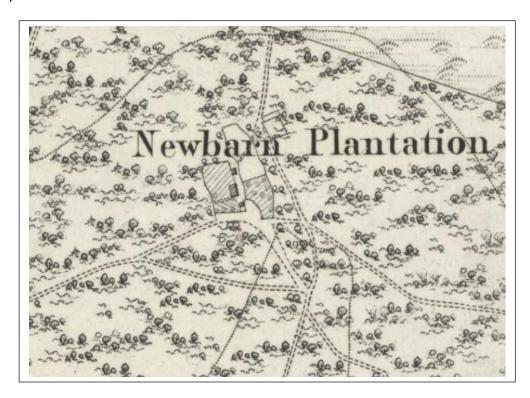
In 1874 the footprint of the building has little changed but the mapping gives good detail of the manged landscape immediately adjacent to the cottage. It shows a small roughly square building to the north-east which did not figure on the earlier tithe map. However, it should be noted that the plantation is called Newbarn and not Newfarm.

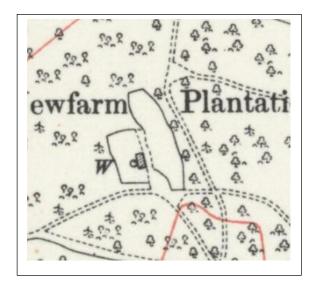
By 1896 the site appears to have been shrunk but possibly also mapped in less detail although a well is now shown to the rear of the cottage. In 1910 the hog pen and building to the north-east are no longer mapped, neither is there any detail within the garden. The plantation name has reverted to Newfarm.

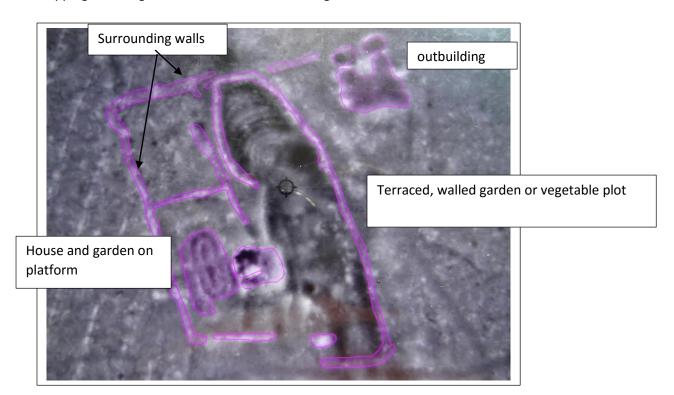
A screen shot taken from the field tablet of the LRM image, showing the NMP mapping shows there to be reasonable survival of this cottage in the woods, it can hardly be described as a farm in this location. It shows a wall surrounding the property to the north and west sides which was not shown on the historic maps. Otherwise the remaining footprint shows a remarkable similarity to the historic mapping including the remains of the outbuilding to the north-east.

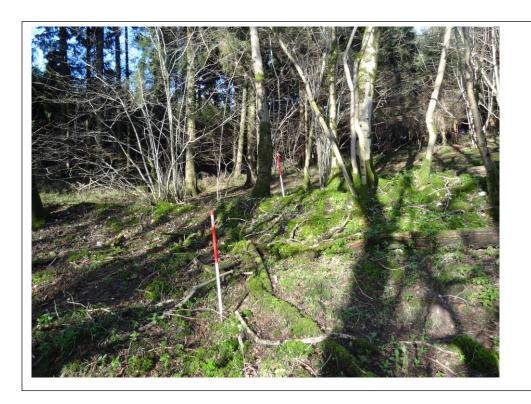
On the ground a rough built flint wall survives, partially enclosing the property, in some places, to about a metre high, but generally lower, and is built against the sloping ground to the west and north which is not depicted on any of the maps. A curving wall to the east, part of the garden completes the enclosure on the eastern side. The cottage and adjacent garden were built up on raised platform.

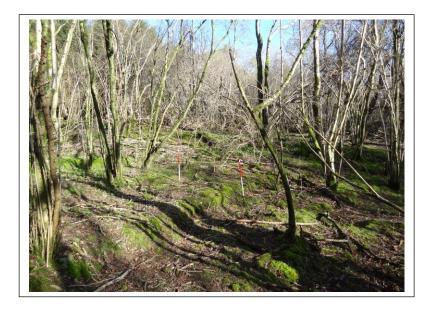
Terracing in plot 4 (Tithe)

The terracing within in this garden plot reflects the sloping nature of this ground and terracing is clearly visible, making small, up 1 to 1.5-metre-wide beds across the slope. Clearly a great deal of effort went into making this working plot surrounded by plantation and underwood.

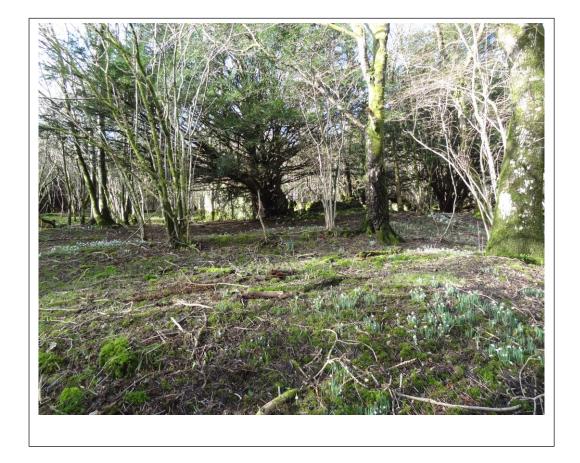
It was not possible to see whether any of the paths had survived, nor was the well located. Within plot five there was further evidence of a garden layout surviving, both in the lidar image and on the ground. Another possible survival from the time when this plot was a cared for garden were the snowdrops that were blooming in mid-February and emerging leaves promising a later show of daffodils. These were on a bank to the front of the cottage where standing walls survive.
