## Conservation Area Character Appraisal and Management Plan

# East Chiltington

June 2017

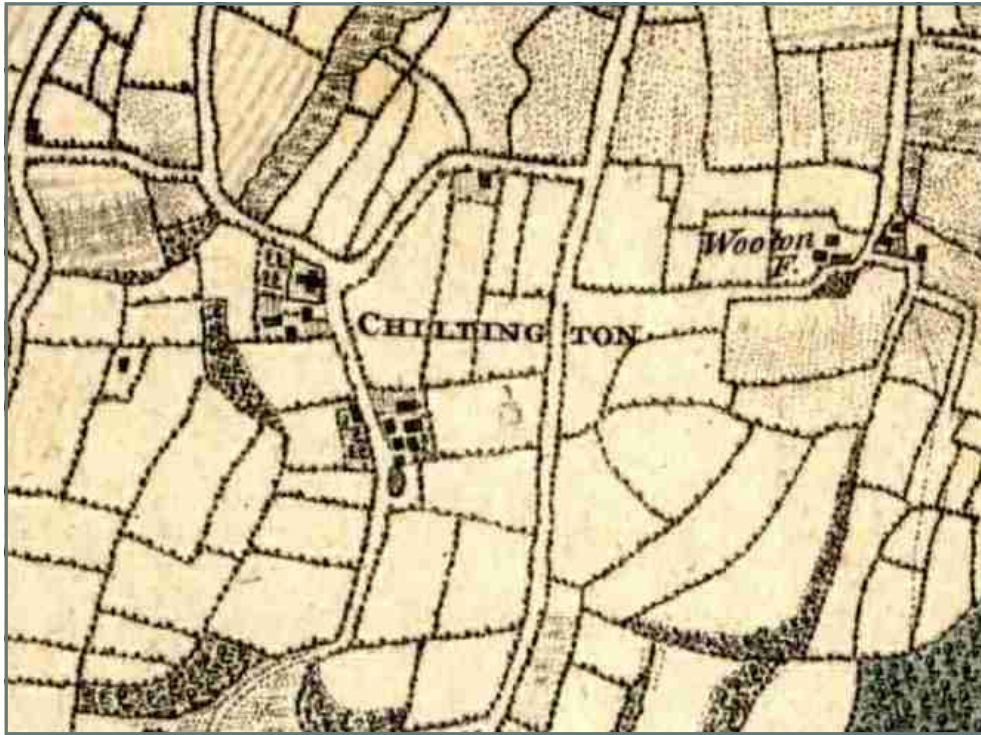
Figure 1: Yeakell & Gardners's map of 1778 – 1783

3.4 Yeakell & Gardners's map of 1778 – 1783 (Figure 1) shows a small cluster of buildings, one of which is clearly the Parish Church and another likely to represent the 16th century Chapel Farm and its outbuildings.

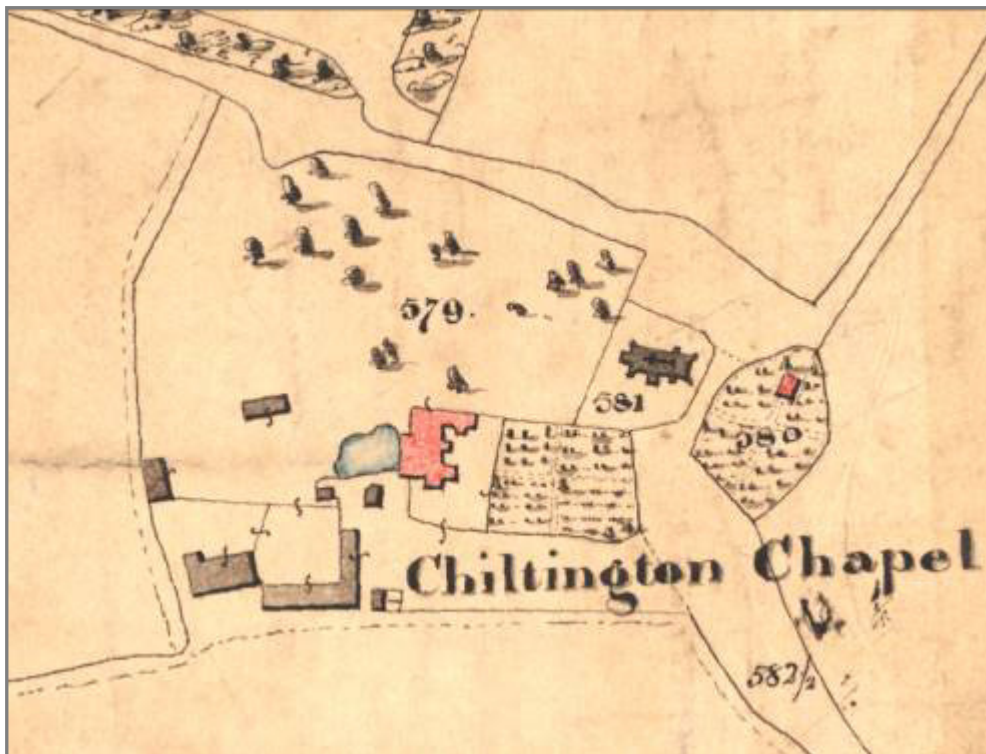
Figure 2: Tithe Map

3.5 The Tithe Map (Figure 2) shows Chapel Farm with outbuildings, some of which have now gone, and what appears to be a formal garden to its east. Chapel Cottage is also shown but not Stantons Bungalow.

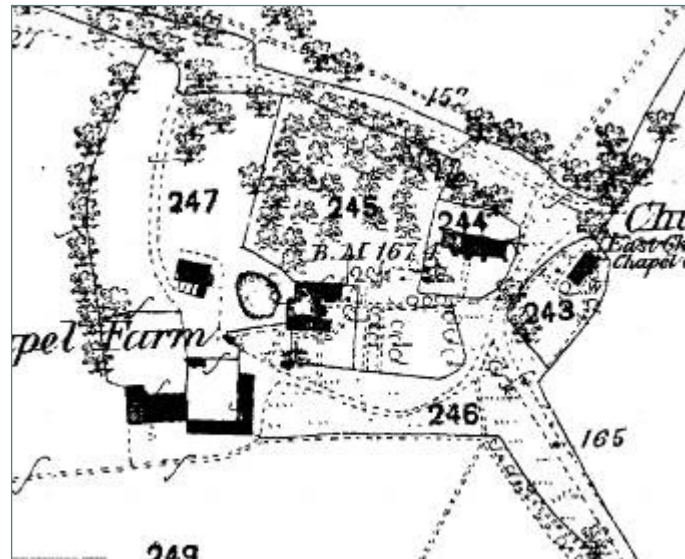
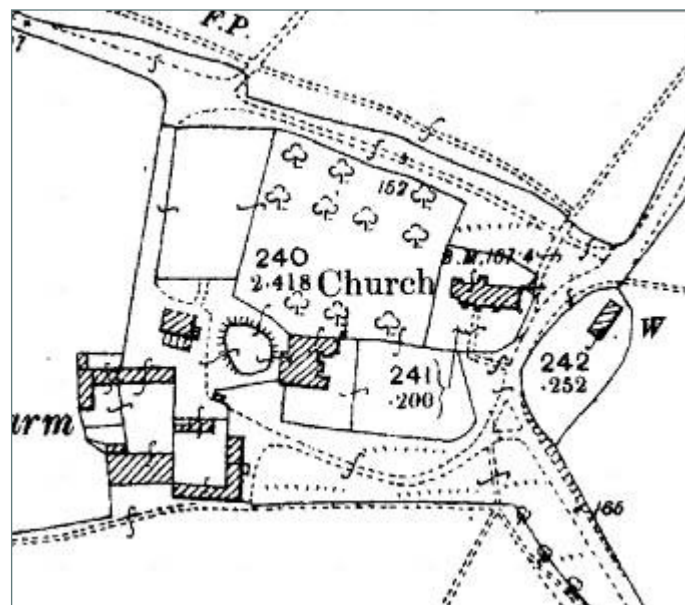
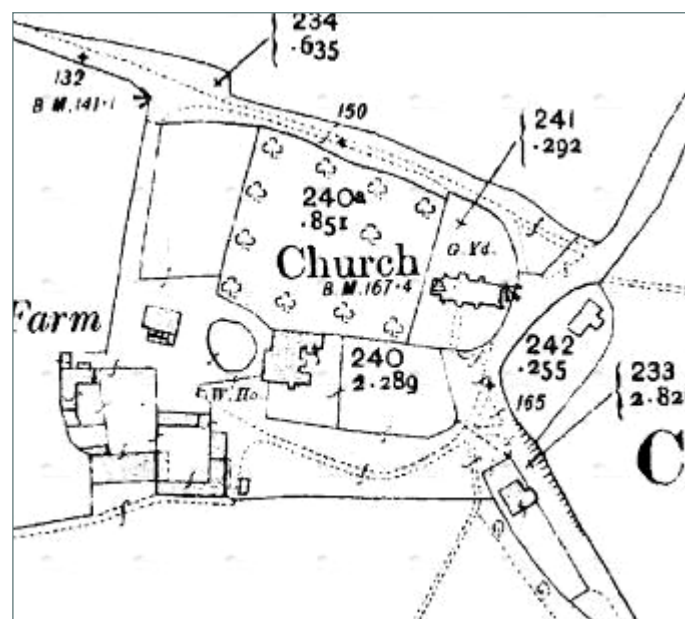
Figure 3: OS Mapping of 1873, 1897 and 1910 (top to bottom)

3.5 Early Ordnance Survey maps show the development of the area in the late 19th century. The 1873-1875 map (Figure 3 top) shows that Chapel Cottage and the barns immediately west and south of Chapel Farm were in existence by that time and, by 1897 (figure 3 middle), the barn at the westernmost limit of the conservation area. Stantons Bungalow is not present on the 1897 map but is shown in 1910 (Figure 3 bottom).

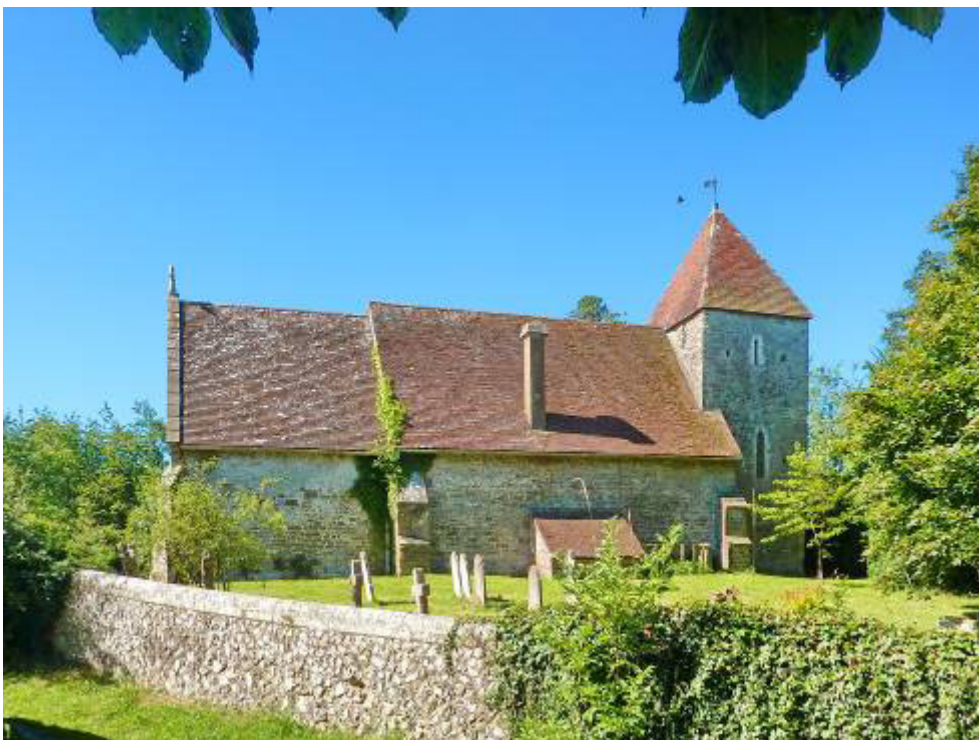
Figure 4: Parish Church, War Memorial and Lychgate

4.10 The Parish Church forms a focal point within the conservation area (Figure 4). It is built of sandstone rubble stone, with a tiled roof. The earliest part is the nave, which dates to the early 12th century. Its small tower with pyramidal roof and the chancel date to the early 13th and 14th centuries respectively. Restoration occurred in 1889-90.

4.12 The church lies within a churchyard surrounded by a flint and Sussex marble wall, capped with half-round coping bricks, and with a lychgate to the south dating to 1913. The latter comprises a timber frame sitting on a stone plinth beneath a tiled roof and with attractive timber panelling. When re-roofed in 2000 local people were invited to sponsor a tile and the names of those who donated money can be seen on the underside of the tiles.

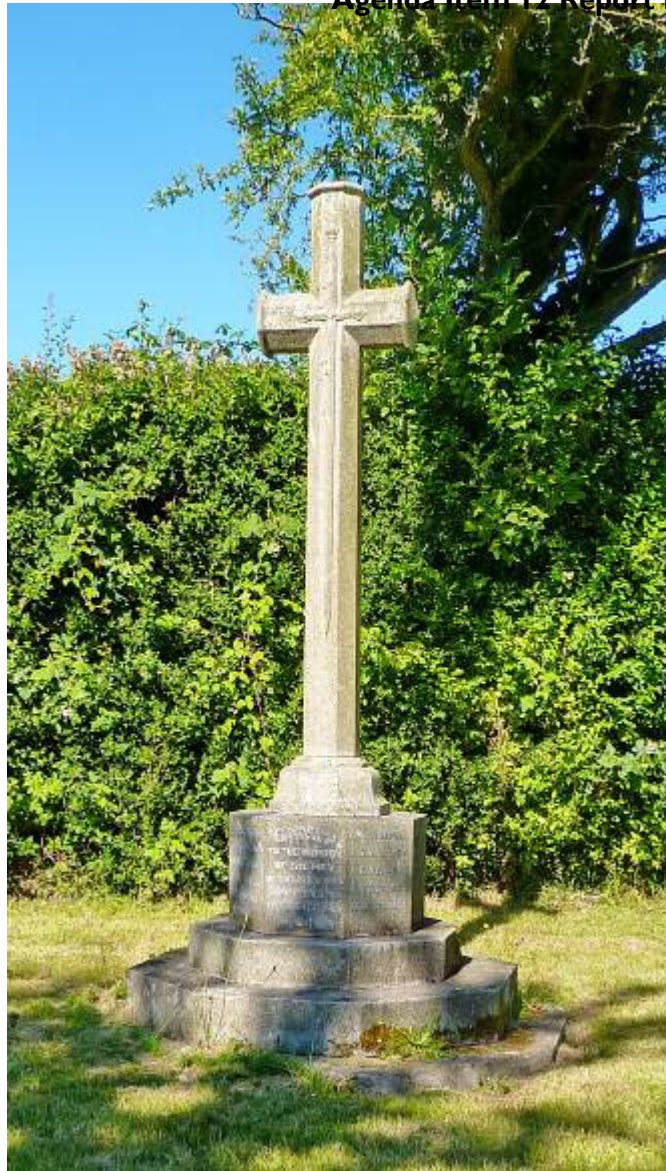
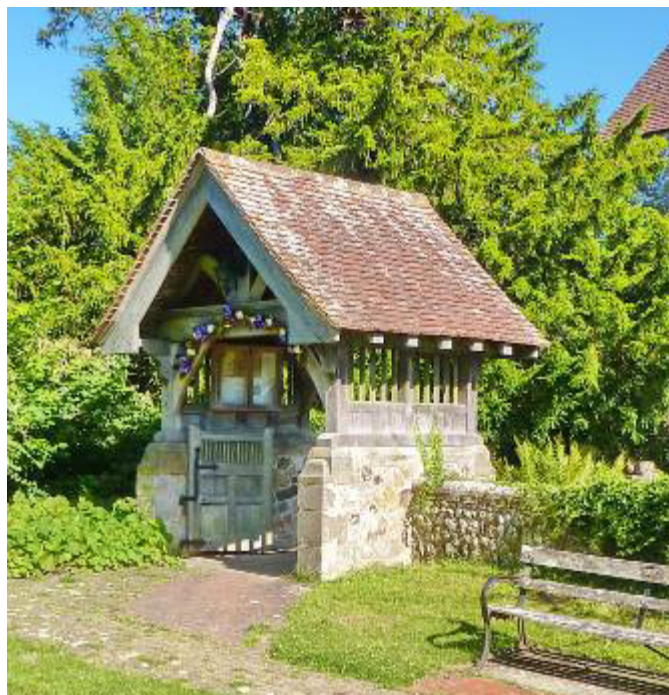
Figure 5: War Memorial

Figure 6: Lychgate

4.18 The War Memorial (Figure 6) is a key feature of the conservation area, being prominently sited within the small village green and just south of the churchyard.

- The War Memorial (Figure 5)
- The Lychgate (Figure 6)

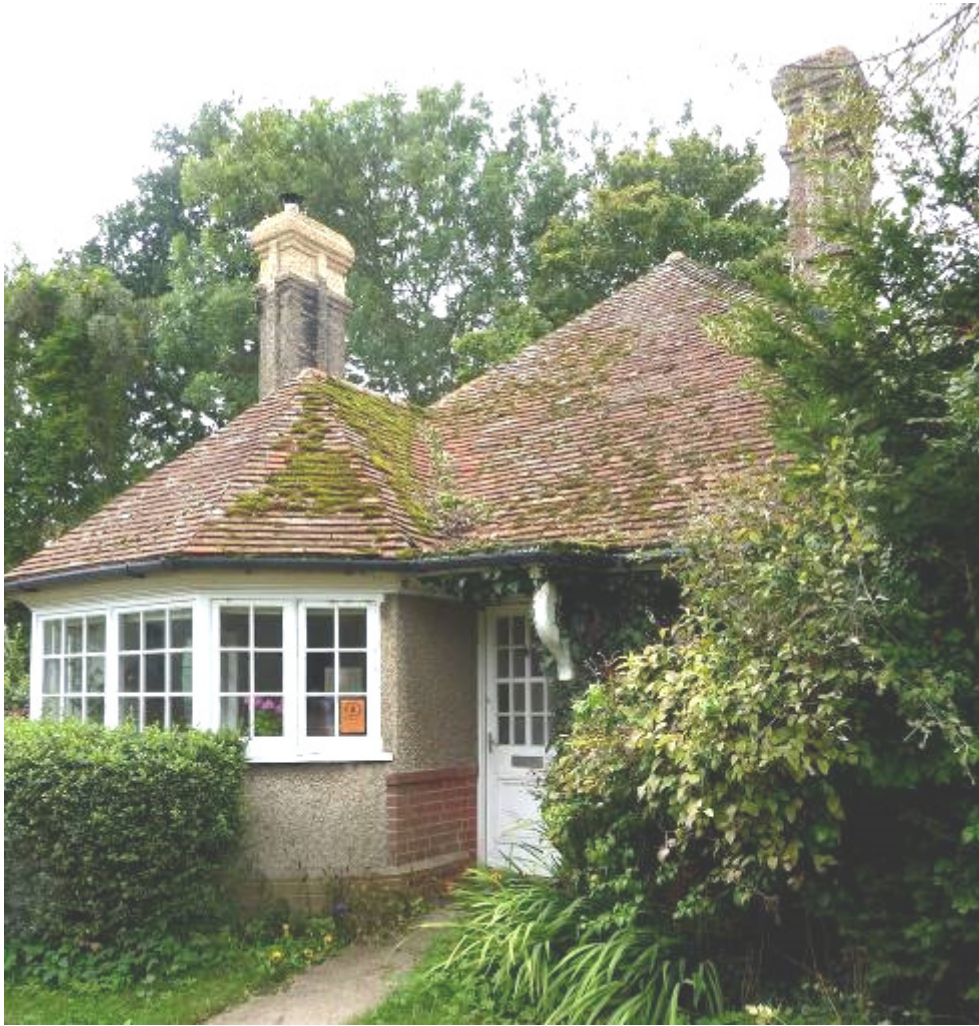
Figure 7: Stanton's Bungalow (above)

Figure 8: Chapel Cottage (below)

4.16 Chapel Cottage lies toward the eastern boundary of the Conservation Area (Figure 8). It is a small and simple building which nestles into its plot behind a well tended hedge. It is built of traditional materials including brick, tile-hanging, clay roof tiles and timber casement windows.

4.17 Stantons Bungalow is situated close to the southern boundary of the Conservation Area (Figure 7). It too is a single-storey building. Early 20<sup>th</sup> century in date (between 1897 and 1910) it has a simple porch and polygonal bay window to its front elevation, pebble-dashed walls, a clay tile roof and two tall and prominent chimneys.

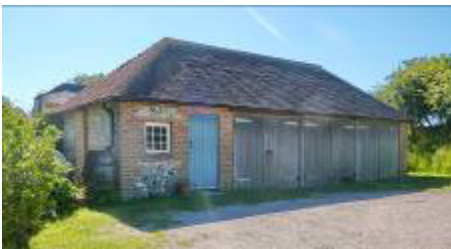
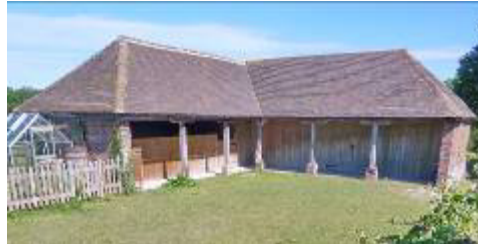
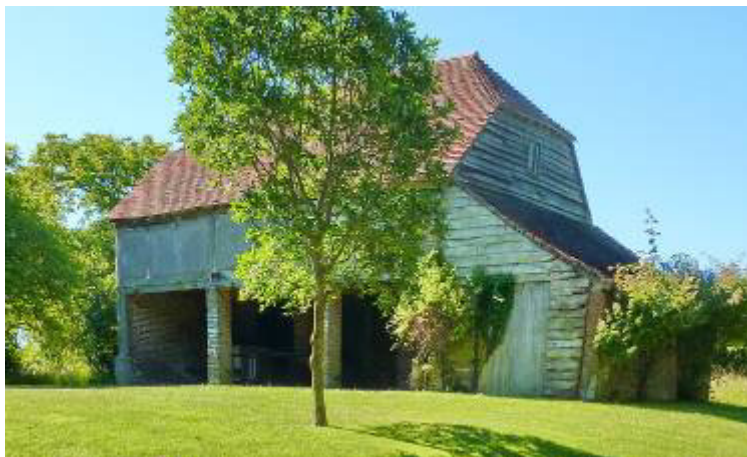
Figure 9: Chapel Farm, a Grade II\* listed building with 16<sup>th</sup> century origins, and associated farm buildings

4.13 Chapel Farmhouse is an attractive four century timber-framed building (Figure 9). While parts of the building still consist of exposed timber frame with render infill panels, it has been refaced in part with red brick and has a slate roof.

4.14 Within the curtilage of Chapel farmhouse, and therefore covered by its listing, are several attractive and historic barns and outbuildings (Figure 9). These are vernacular buildings constructed using traditional local materials and, as such, make a positive contribution to the character and interest of the Conservation Area.

4.22 Stone is found in the form of flintwork, on the barns to Chapel Farmhouse, where it is used in conjunction with red brick quoins and window

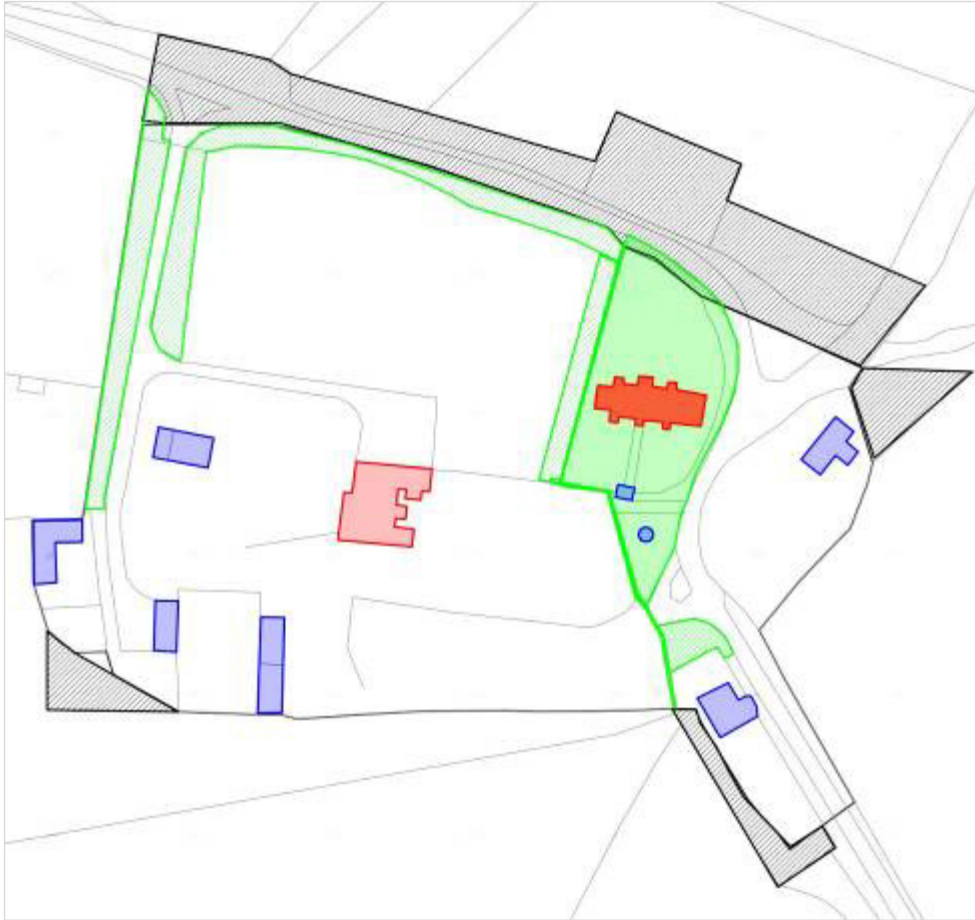
Figure 14: Elements which make a positive contribution to the character of the Conservation Area, including listed buildings (red), unlisted buildings which make a positive contribution to the Conservation Area (blue), open space (green), trees and shrubs (green hatching). The proposed extensions to the Conservation Area are hatched in black.

4.1 The boundaries of the Conservation Area and the individual elements which make a positive contribution to its special character are shown on a map on the back page of this document.

6.4 In undertaking this review of the Conservation Area, three small amendments to the existing boundary have been identified. These are shown hatched in black on Figure 14.

**ACTION 1 – that the boundaries of East Chilton Conservation Area be amended to incorporate the three areas shown hatched in black on Figure 14**
