Conservation Area Character Appraisal and Management Plan

West Meon

July 2017

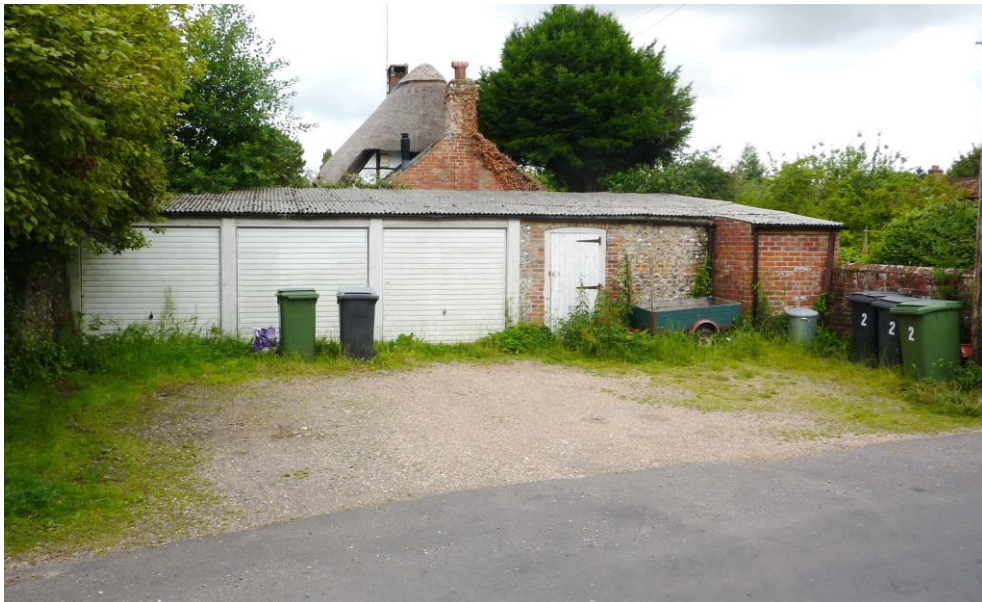
Figure 11: **Unattractive garages** on Station Road. These buildings, whilst serving a useful purpose, detract from the quality of the Conservation Area and the setting of the adjacent listed buildings. Redevelopment in an appropriate manner may offer potential to enhance the Conservation Area and an application to replace them with oak-framed garages was approved in 2016.

5.11 Within the village there is one small site where redevelopment in an appropriate form may have potential to improve the Conservation Area, were it to come forward, the unsightly row of garage units located on Station Road (figure 11). A permission exists to replace the block with oak-framed garages.

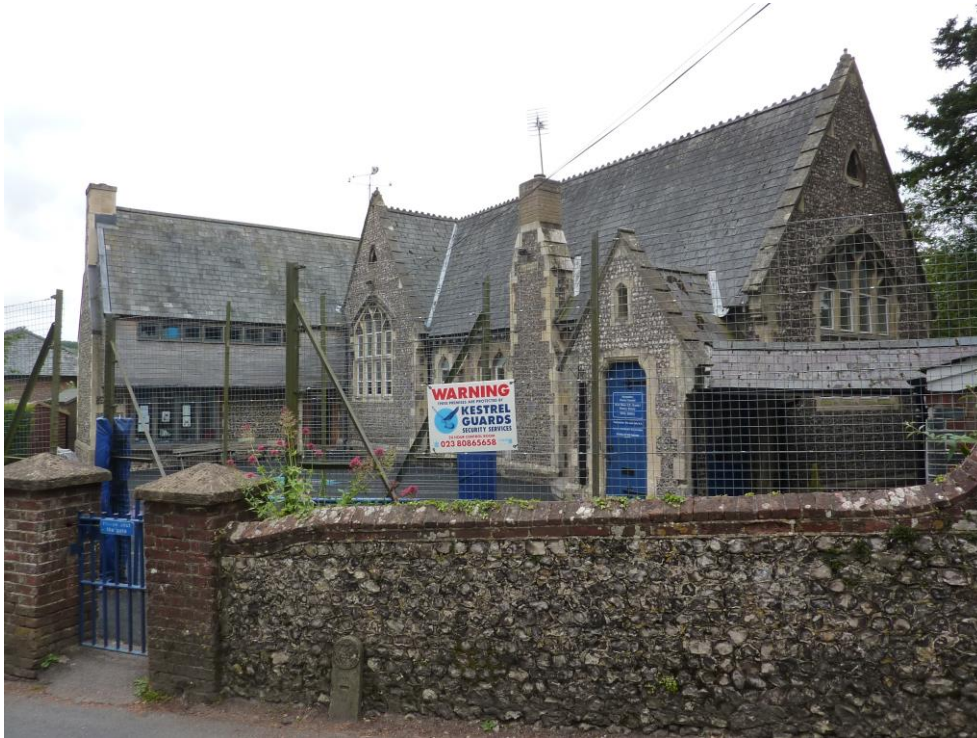
Figure 25: **The Village School**, Church Lane, of 1852-3, sits close to the church and is also built in a Gothic style. The high wire fence and warning signs degrade the setting of the listed building and represent a significant visual intrusion into the Conservation Area. Replacement with something less clumsy would be welcome.

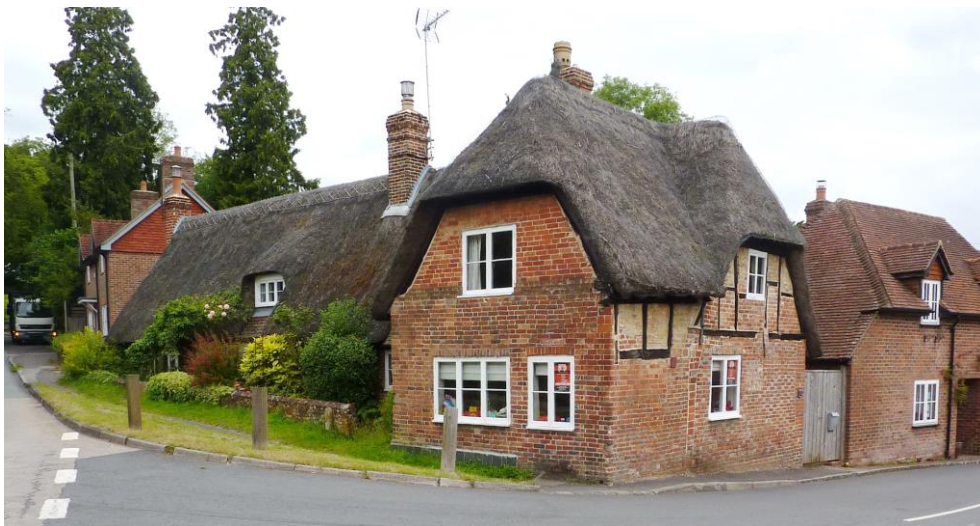
Figure 35: **Riverside**, High Street: At the core of this group is “Riverside”, a four-bay 18th century house. In the 19th century, the prominent gabled wing was added to the east end and a projecting shop-front followed in the 20th century, perhaps replacing an earlier one. The group is Grade II listed. At the west end of the range is a gabled brick wing of the last century; this is excluded from the listing. Good historic photographs exist of this building and some reinstatement of lost features could form a worthwhile enhancement project.

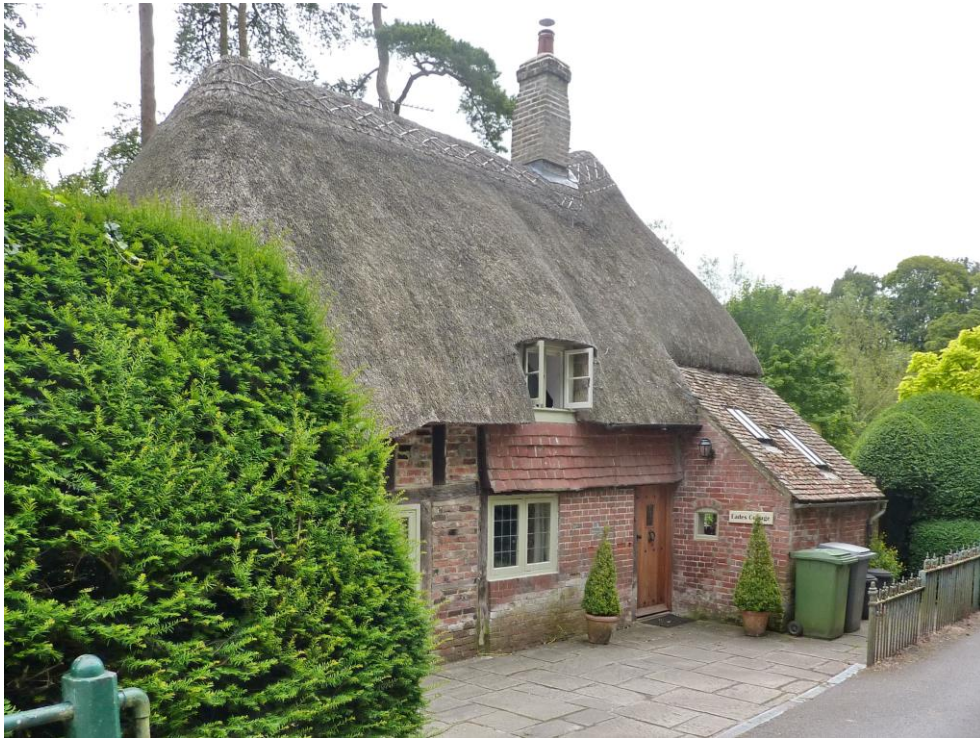
5.7 Works to *The Red Lion* should lead to removal from the vulnerable category of the Register. *The Mill House* and *Shafts House* were identified as being vulnerable because of a general lack of maintenance to all parts of the buildings and necessary repairs to the rainwater goods.

Figure 49: **Shafts House**, East Meon Road. Timber-framed in origin and clad in brickwork in the 18th century

6.15 As reported in paragraph 5.4, the historic building stock in West Meon is generally in good condition. The main exception comprise the Grade II listed railings in the Churchyard, but two other buildings are identified as 'vulnerable' and in need of attention; the *Mill House* and *Shafts House*.

ACTION 3 – that the National Park Authority seeks to secure repairs to the *Mill House* and *Shafts House* by working in co-operation with the owners. It will also seek repair of the Churchyard Railings and reinstatement of missing sections.

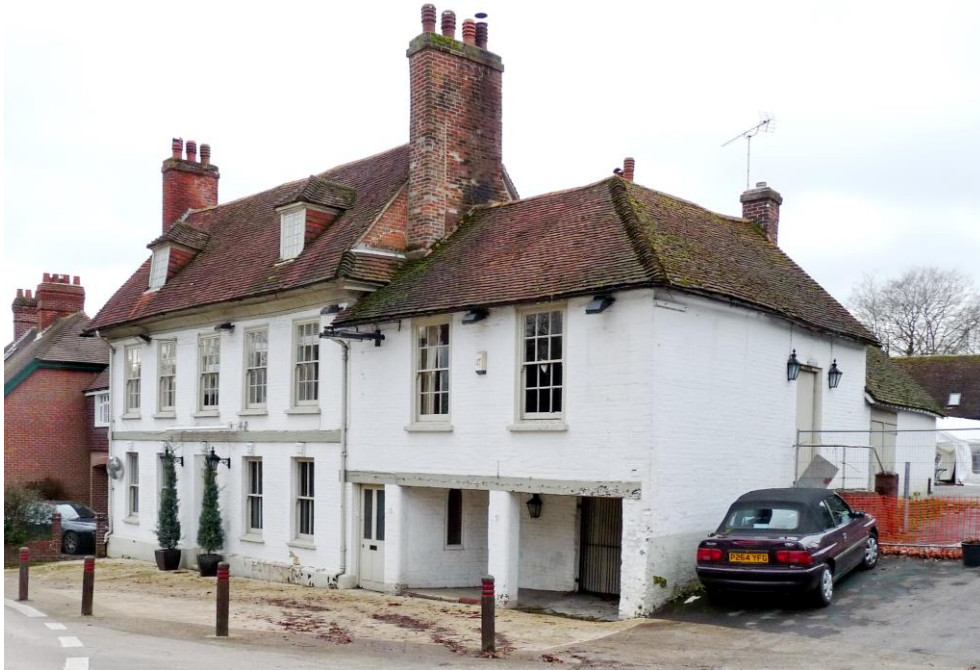
Figure 52: **The Red Lion Public House**: early 18th century, with early 19th century lower wing to the north side. Considerable works were undertaken to this building, now named **Lion House**, while this document was being written.

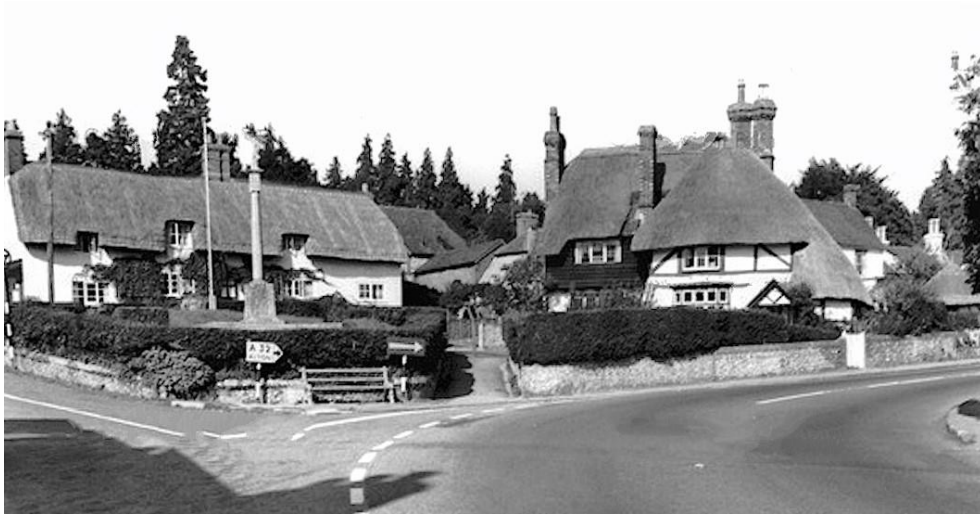
Figure 53: **Streetscene at The Cross in the 1960s.**

Figure 54: **The same scene today.**

It is striking to note how tree and shrub growth has transformed this view over a relatively short period. Instead of forming a backdrop to a visually cohesive building group, as before, planting has now almost entirely obscured the cottages behind The Cross

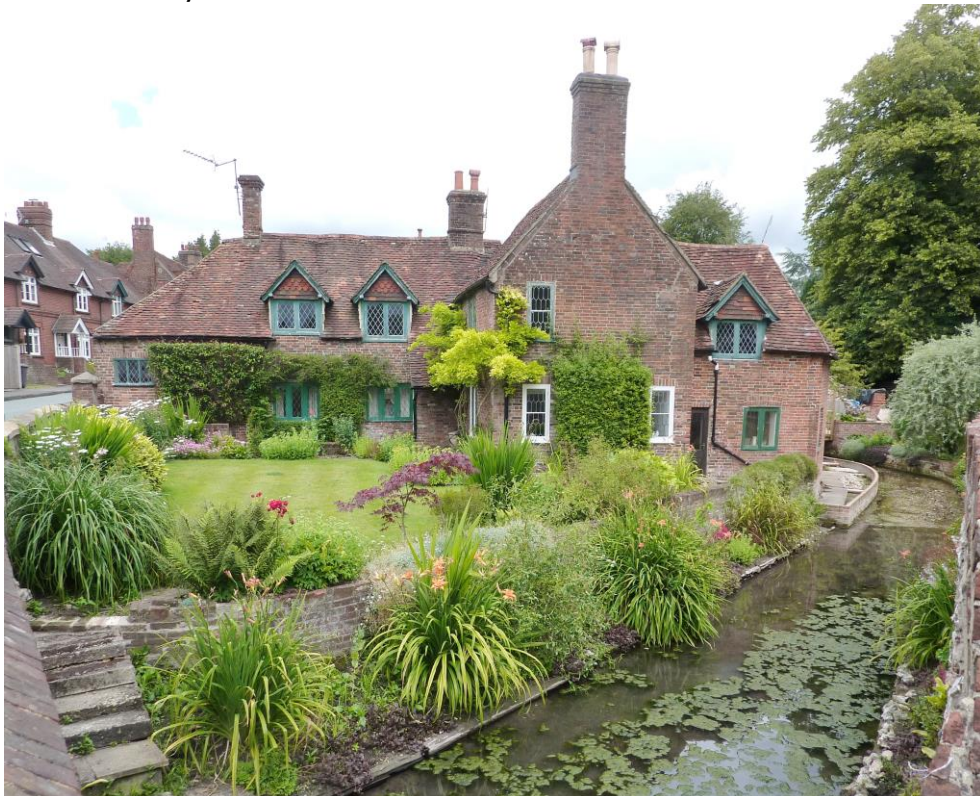
Figure 58: **Mill House**, Warnford Road. Mill and House. 18th century in date with late 19th century extensions and alterations.
