# Planning Committee Meeting

## Agenda Item 7

Change of use from existing agricultural buildings to various uses, including residential, under the general description of an Ecumenical Retreat, Prayer Centre with bunk house accommodation, the erection of new agricultural buildings with access and creation of a car parking area

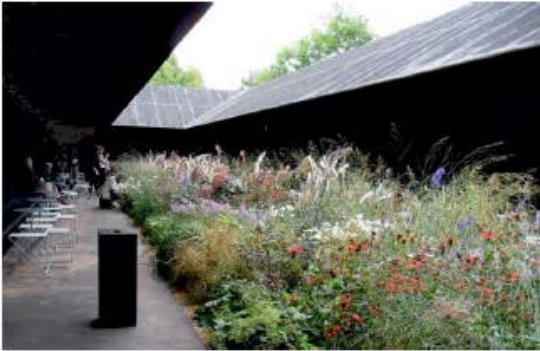
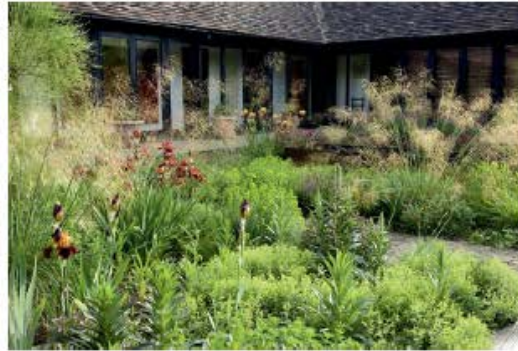
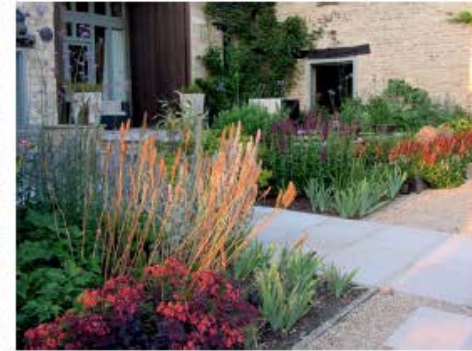
Enclosed courtyard  
Simple planting scheme  
Reflective space  
Year round interest

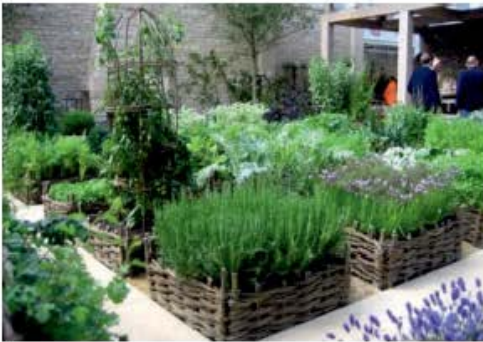
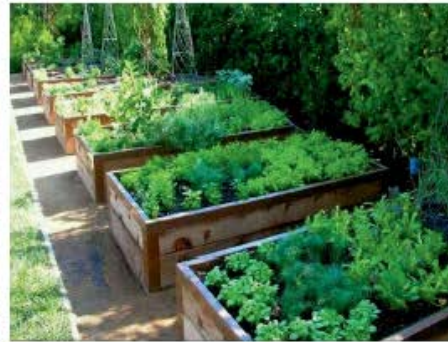
Herb garden  
Raised beds  
Hurdles / timber planters  
Reflective linear pools

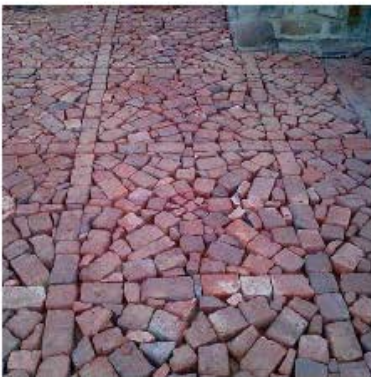
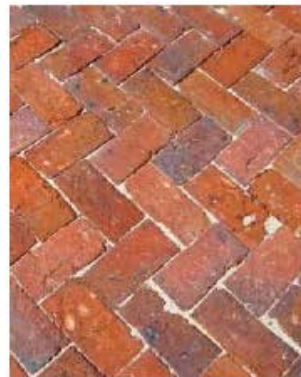
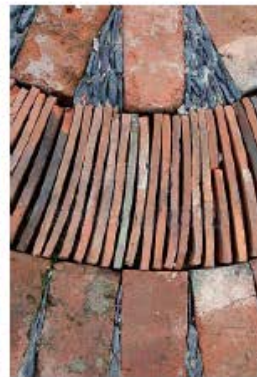
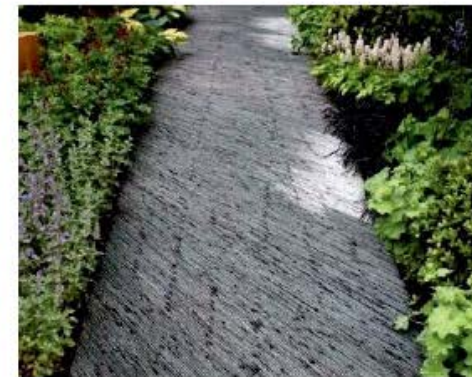
Feature paving patterns  
Reclaimed clay brick paving  
Feature clay tiles laid vertically  
Slate paving laid vertically
