## SOUTH DOWNS

### **Case Study**

# Conserving our cultural heritage: Flint walling at Stanmer Park

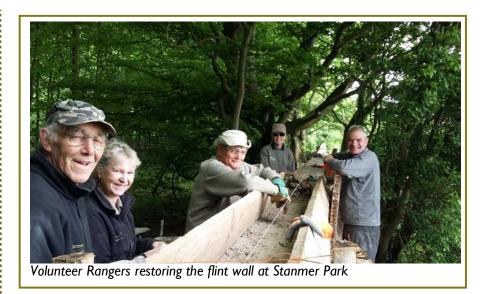
Sadly many of these flint walls are now in need of repair. Due to the impervious nature of flint, its unwieldy shape and small size, walls can be poorly bonded together and this can lead to loss of stability. Potentially serious problems can be avoided with regular maintainence and prompt remedial action. The flint wall at Stanmer Park is around 250 years old so flint construction can stand the test of time, albeit most of the wall does now need repairing/rebuilding.
