Conservation Area Character Appraisal and Management Plan

Exton

November 2015

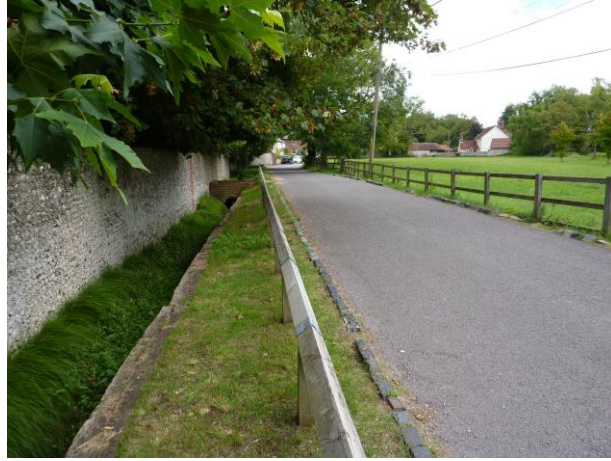
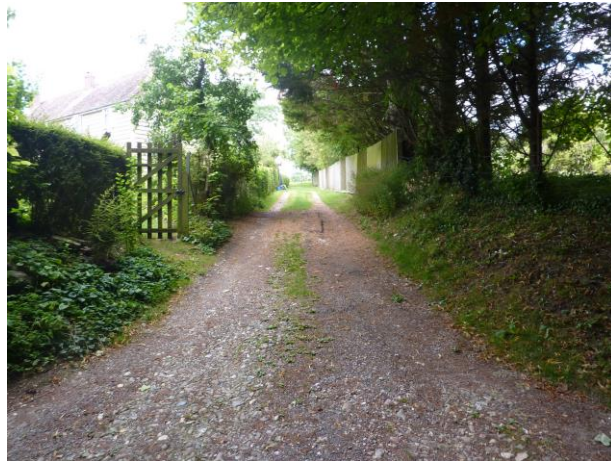
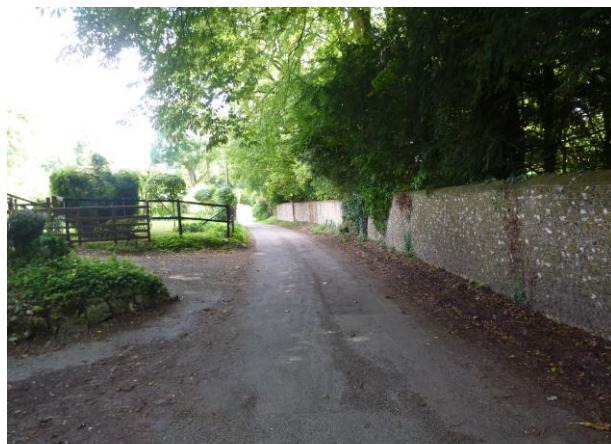
Figures 7-9; **Street scenes within the Conservation Area**, showing the rural and informal nature of the lanes. Also note the intrusive overhead wire-scape in Shoe Lane (top)

5.3 A second potential enhancement would be the undergrounding of the overhead wires and removal of telegraph poles within the village. In places, especially on Shoe Lane, these are quite obtrusive features which detract from character.

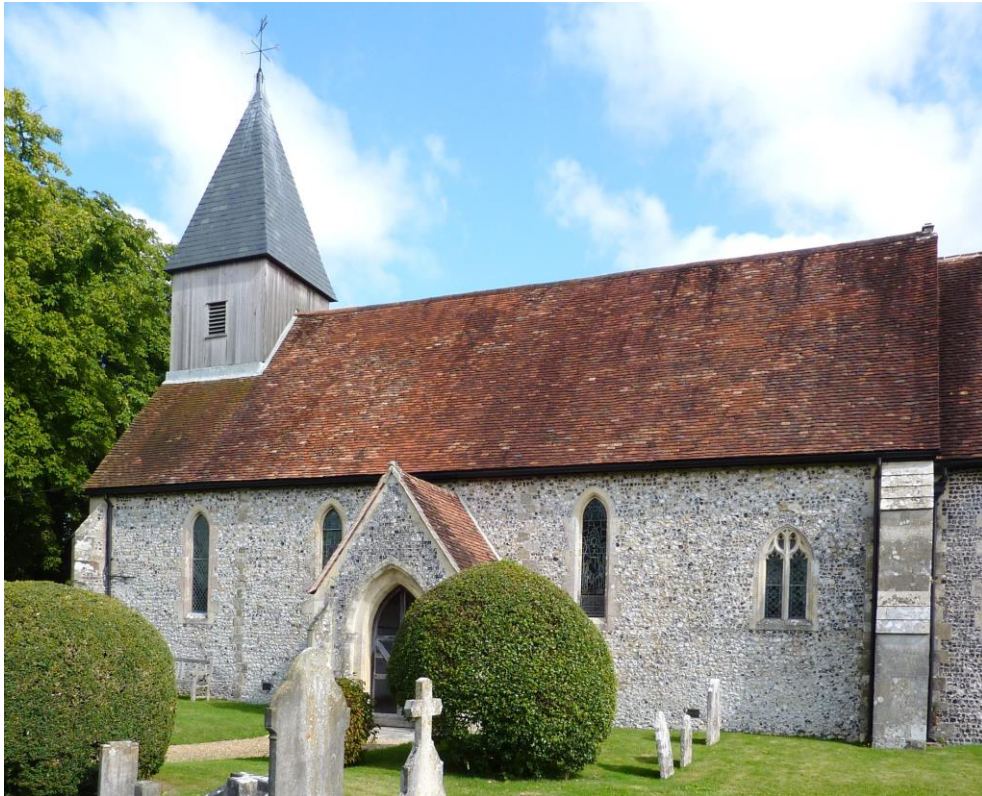
4.10 The Domesday Survey records the presence of a church in the late 11th century and this must have been replaced by the existing *Church of St Peter and St Paul*, which is largely 13th century in origin but heavily restored in the mid 19th century (Figure 10).

4.11 The church is a relatively modest example, Grade II listed, comprising an aisle-less nave, chancel and a bell-turret. It combines an attractive mix of materials, with the walls being mostly of flint, clay tiles on the nave and chancel roofs, and a bell turret of vertical timber boarding topped by a shingle-covered spire. Monuments in the churchyard possess great evidential value as a historical resource.

Figure 10: **Parish Church of St Peter and St Paul**

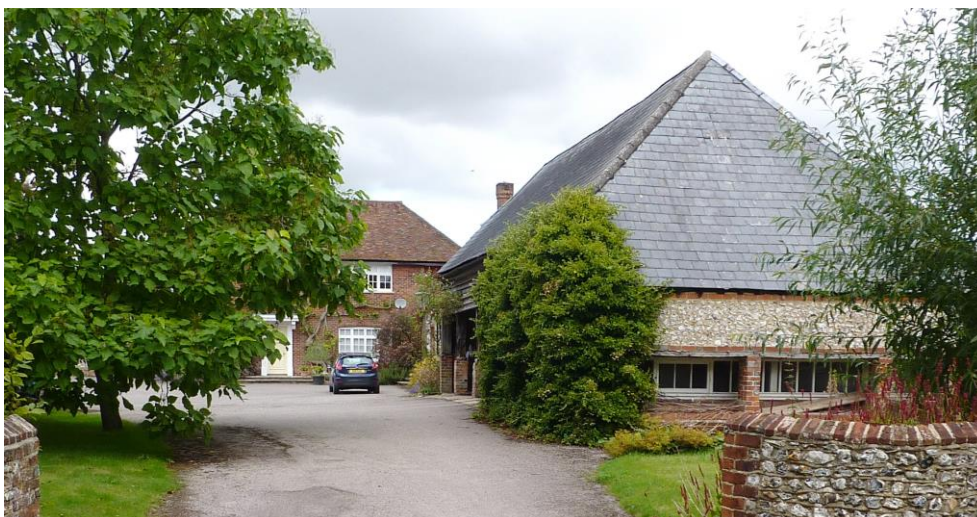
4.13 The buildings of *Manor Farm* are north-east of the manor and church (Figure 12) and include the farm house, a staddle stone granary and a long range of farm buildings. These are all within the boundaries of the Conservation Area but just beyond that boundary is the village *pound* (Figure 13), which should be brought into the Conservation Area. It may also be included on a local list.

Figure 12: **Manor Farm**

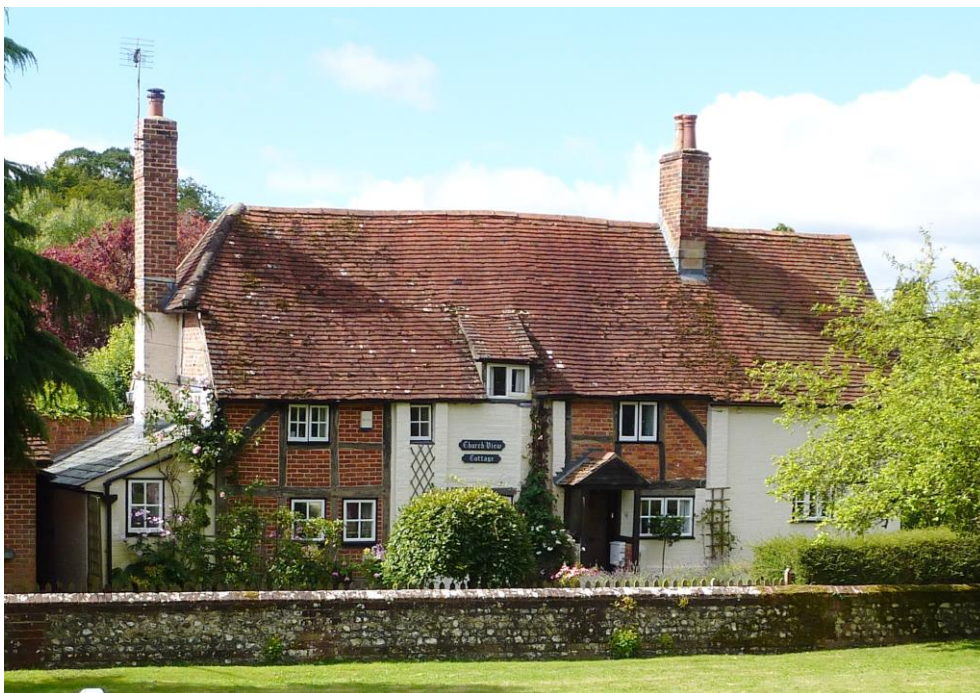
4.14 Other early buildings in this group are *Marriner's Cottage* (Figure 14) and *Church View* (Figure 15). Both have 16th century timber frames with brick infill. The former is thatched (albeit not the long-straw thatch that appears in old photographs) whilst the latter has clay tiles. However, old photographs show that it too was originally thatched in long straw. Of comparable antiquity is *Grove*

Cottages (Figure 16), a late medieval hall with cross-wings, subsequently subdivided to form three cottages.

Figure 16: **I Grove Cottages, Middle Cottage and Sunnyside**

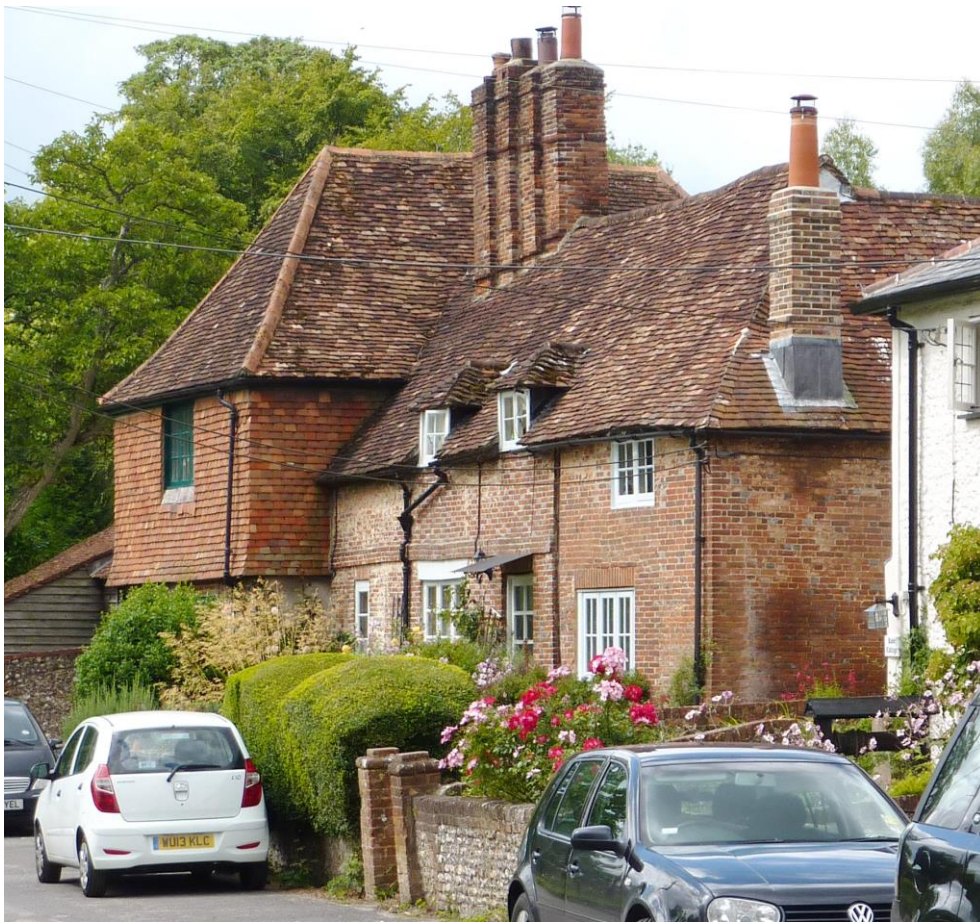
4.16 Prominent in views across the bridge is *Shoe Cottage* (Figure 17), with its large and attractive clay tile roof. Interestingly, photographic regression demonstrates that it too was originally thatched in long straw. None of the buildings in this node are included on the statutory list but most make a positive contribution to the Conservation Area, including *Bridge End Cottage* (figure 18), and *Bridge Cottage*, the former Post Office and Village Store (Figure 20), which retains its former shopfront and the attached cottage (Figure 21). The boundary walls, whether flint and brick, are particularly important in this part of the village. Also significant is the presence of the well maintained *K6 telephone kiosk*, designed by Sir Giles Gilbert Scott in 1935.

Figure 17: **Shoe Cottage.** This cottage sits in a prominent position when viewed from across the bridge into the Conservation Area. Removal of the telegraph pole and undergrounding of the wires would produce a significant visual improvement.

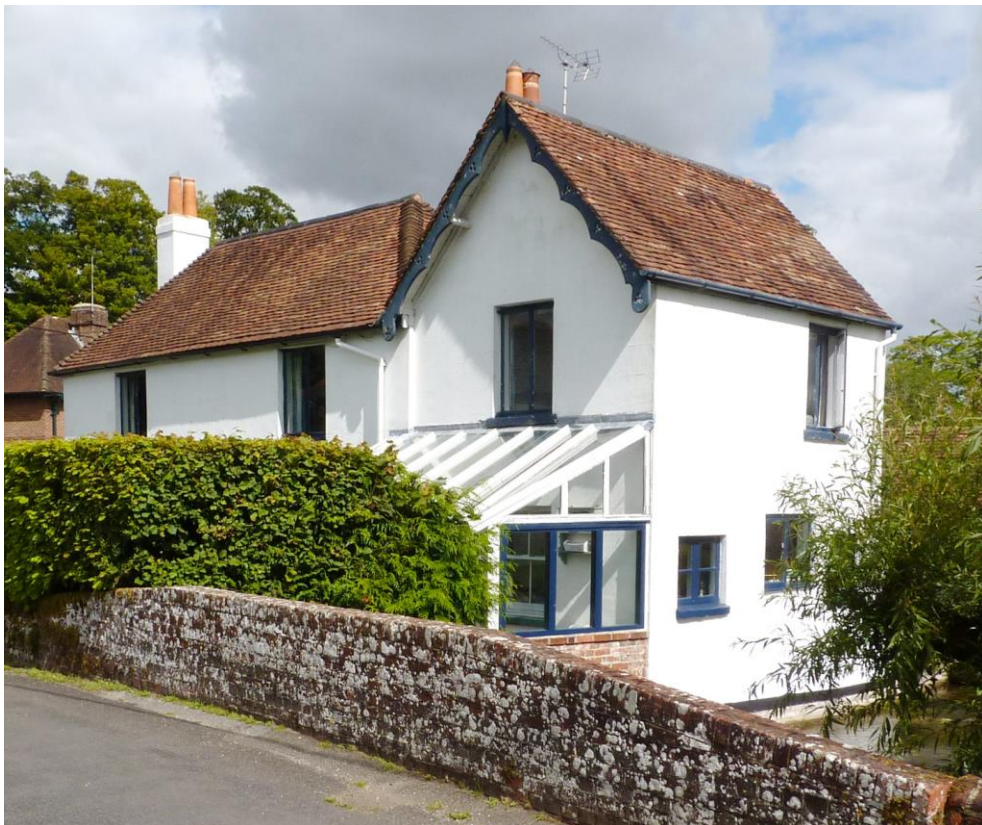
4.17 *The Shoe Inn* is a 1930s replacement of the original pub, which once stood on the opposite side of the road in the current beer garden. The building itself is quite traditional in form and materials and makes a positive contribution to the Conservation Area. However, the same cannot be said of the bare expanse of tarmac forming the car park around the pub. Some improvements to this area – a front boundary wall or some planting – would help to soften and mitigate this negative impact.

Figure 22: **The Shoe Inn.** The existing building replaced the original pub, which stood on the opposite side of the road, in the 1930s (or '50's?). The addition of a flint and brick boundary wall combined with planting within the car park would knit the site back into the village-scape and soften the visual impact of the tarmac.

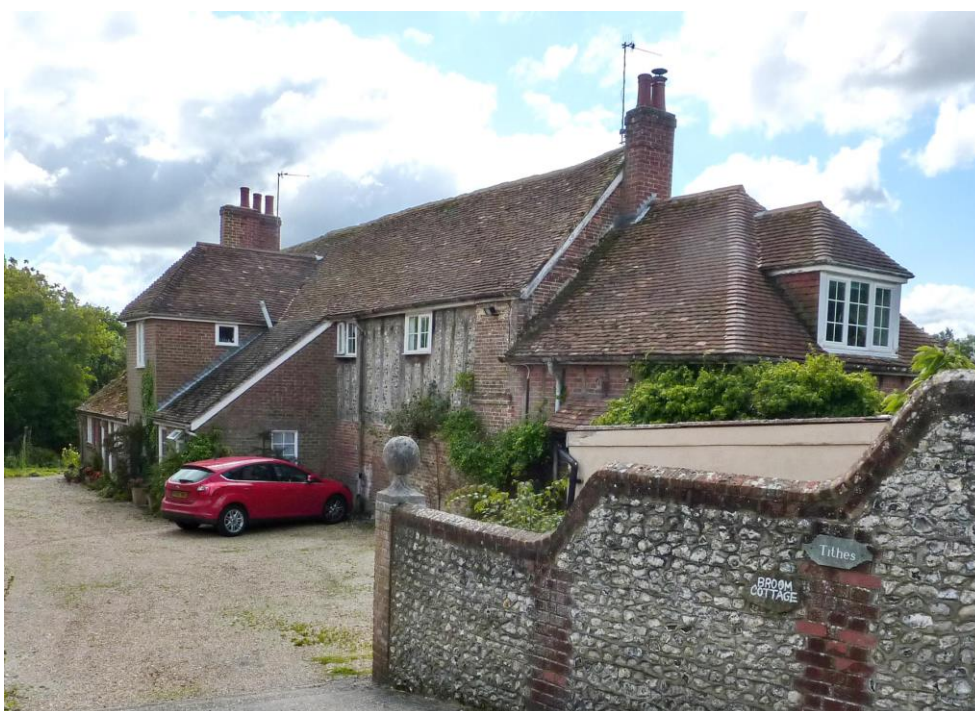
4.21 Other former farm buildings include *Broom Cottage* and *Tithes* (figure 26), formed out of a 17th century timber framed barn, and the buildings, currently derelict, standing opposite (figure 27). The latter has consent for conversion to residential use which should secure its repair and the continuation of its positive contribution to the character of the Conservation Area.

Figure 27: **Redundant farm buildings** on Allens Farm Lane. Planning permission has been granted for the conversion of this building into a dwelling and the implementation of that permission would secure and sustain the positive contribution made by these buildings to the character of the Conservation Area.

6.10 As reported in paragraph 5.4, the historic building stock in the village is generally in good condition but the important cob structure, *Sunrise* is vulnerable and requires monitoring. A staddle stone granary at Manor Farm is in poor condition and will require some repair if it is not to be lost. The condition of dilapidated farmbuildings opposite *Broom Cottage* and *Tithes* should be resolved by forthcoming residential conversion.

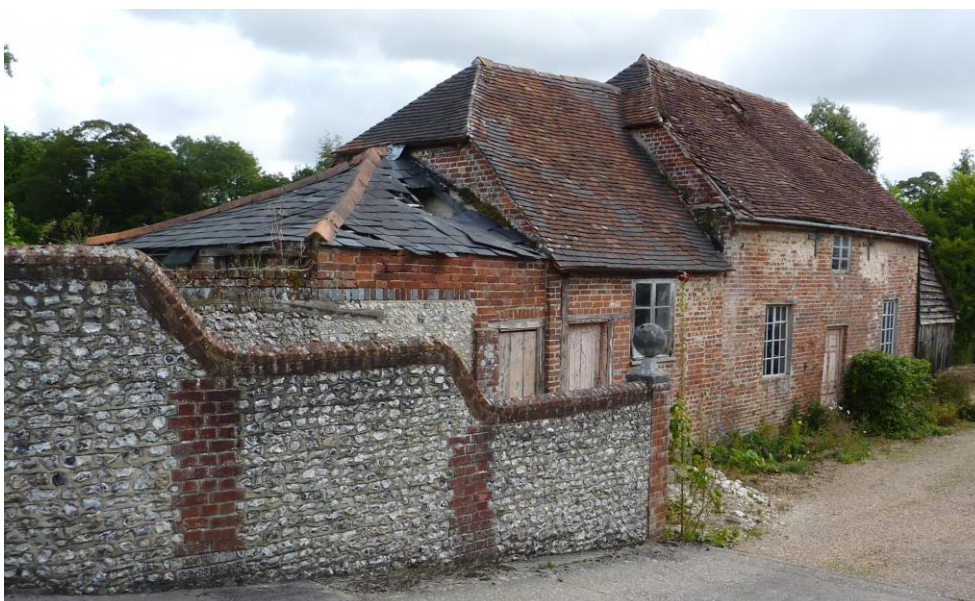
4.22 Other Grade II listed buildings within the conservation area include *Sunrise*, a late 18th century cottage constructed of cob (figure 28), *The Homestead*

Figure 28: **Sunrise**; an important survival of cob construction within the village and a building identified as 'vulnerable' in the National Park's Buildings at Risk Survey. The cottage has been recently re-thatched.

ACTION 4 – that the National Park Authority monitors the condition of *Sunrise*, the staddle stone granary at Manor Farm and redundant buildings opposite *Broom*

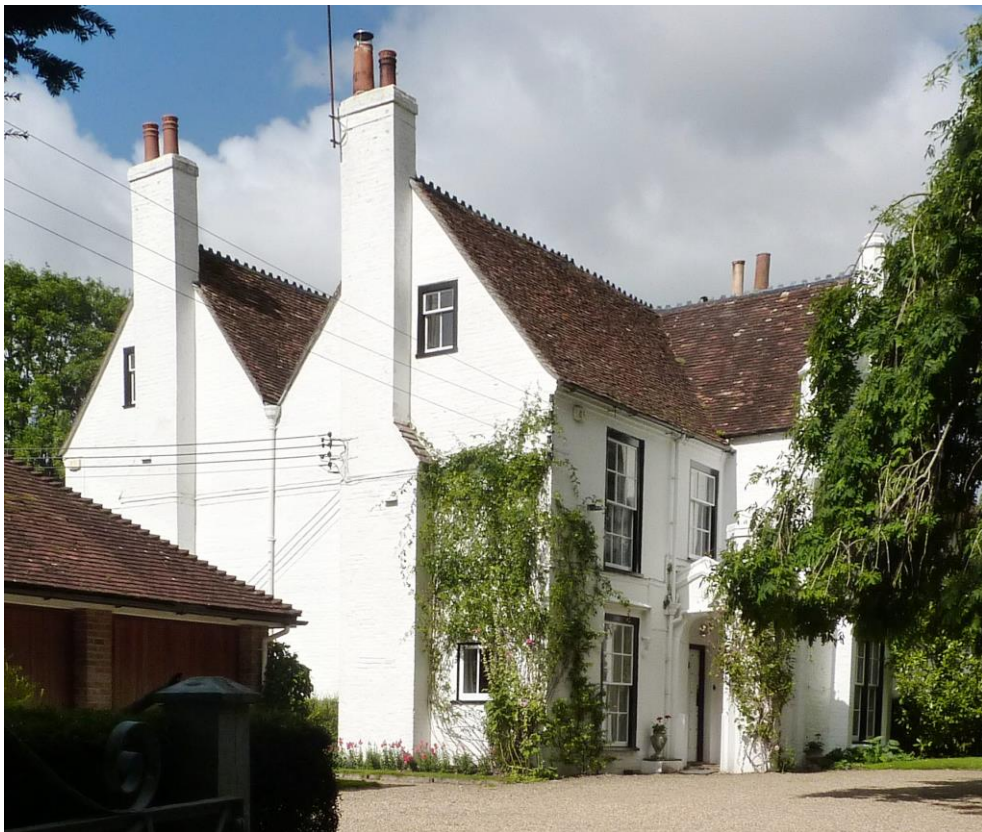
4.37 *Exton House* is located at the northern end of expansive grounds and despite its size and status, it is not a conspicuous presence within the conservation area. However, distant views of its handsome south-facing garden facade may be glimpsed over the southern boundary wall in places along Beacon Hill Lane.

Figure 32: only the side elevation of **Exton House** appears prominently from the roadside. The south facing garden façade is a far more imposing elevation

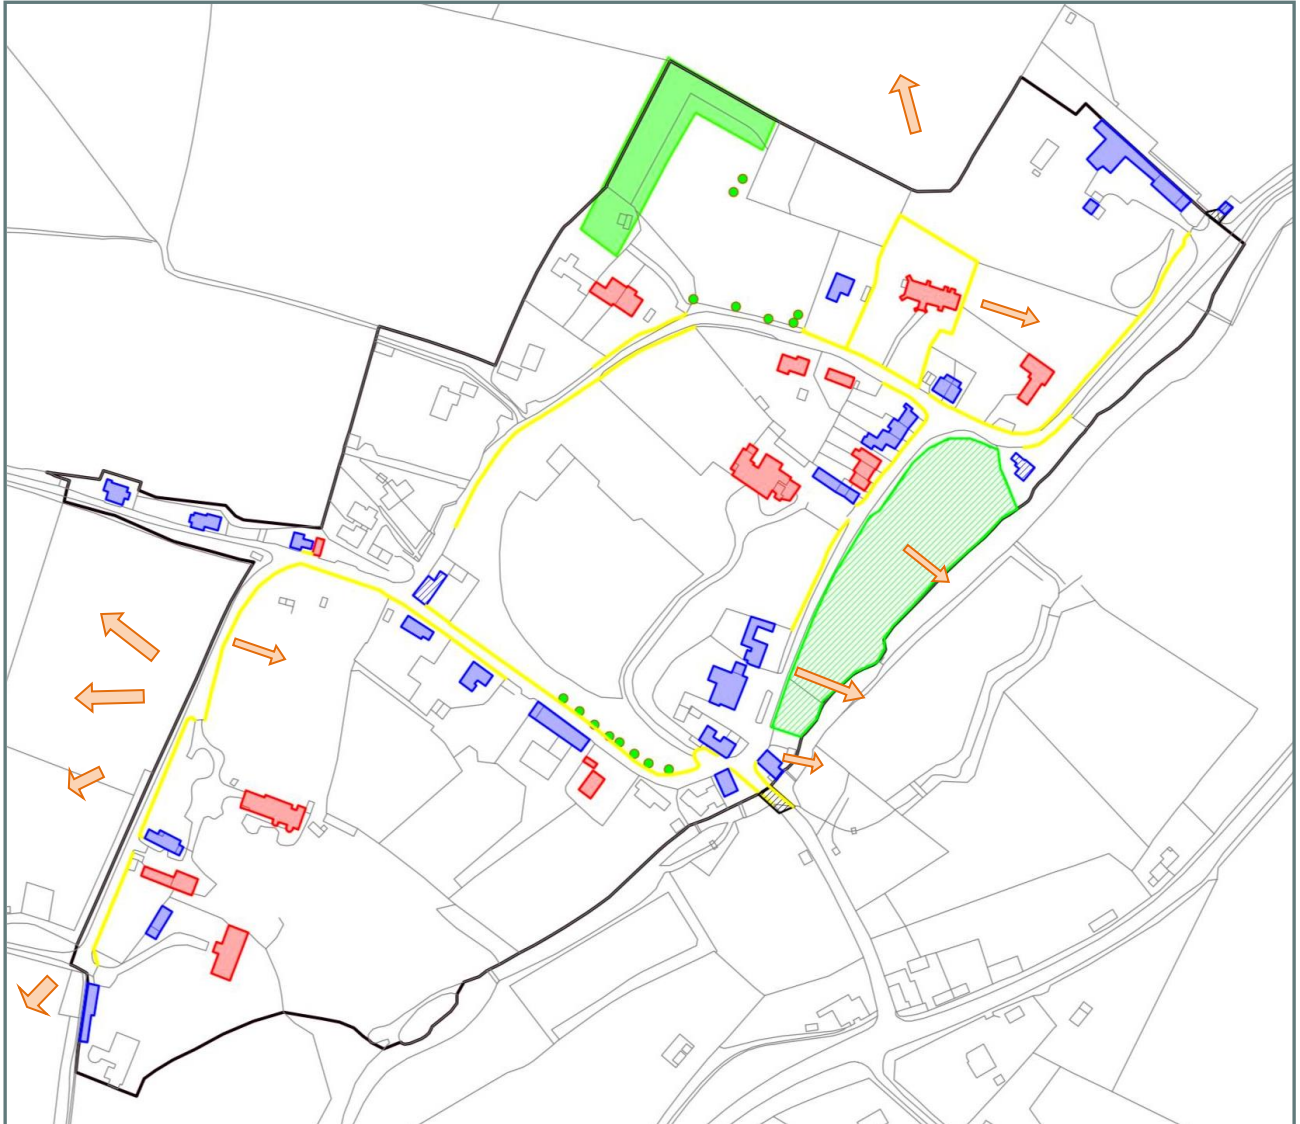
Figure 38: **Map** showing the elements which make a positive contribution to the character of the Conservation Area, including listed buildings (red), positive unlisted buildings (blue), significant boundaries (yellow), tree preservation orders (solid green areas and spots), important open areas (shaded green), and significant views (orange arrows). Buildings eligible for the Local List are shaded in pale blue.

The small extensions to bring the village pond and bridge within the Conservation Area boundary are shaded in black.
