# Conservation Area Character Appraisal and Management Plan

## Fulking

December 2019

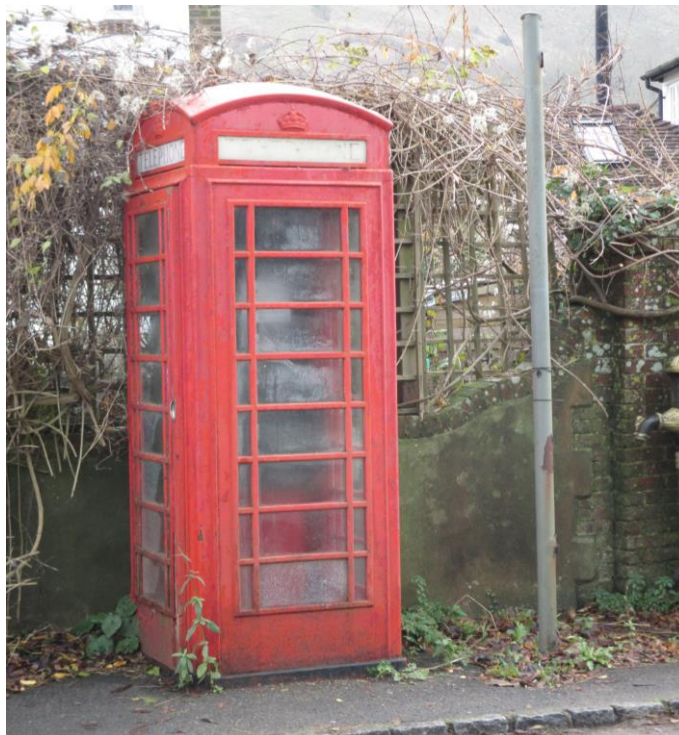
4.17 Street furniture features on the pavement in front of *Broadreeds*, firstly a listed K6 'Jubilee' telephone kiosk, as designed by Giles Gilbert Scott in 1935, installed across the nation by Royal Mail Telephones until the 1960s, but now becoming rare. Secondly, the other surviving water pump of 1886, this one with a fluted and domed top with finial and an embellished feature spout with the cast letters 'Warner' and 'London'. The shaft displays a plaque stating 'C.A.Wells Engineers, Lewes'.

*A K6 telephone kiosk and water pump are located fronting Broadreeds*

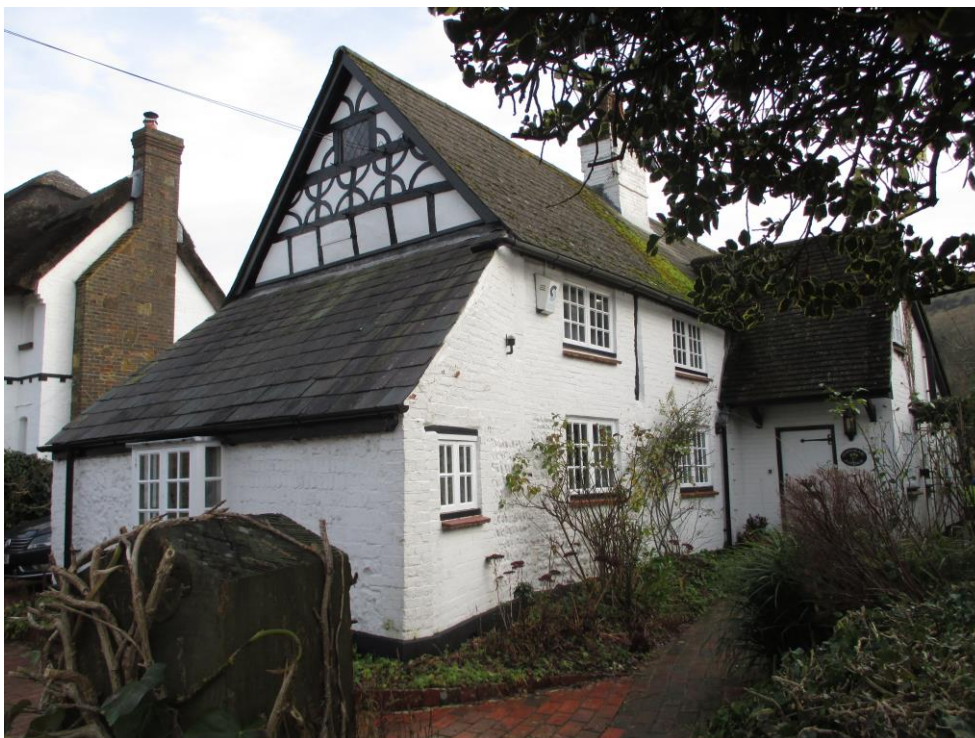
*Customary Cottage*

4.18 Located next to these relatively modern houses is the far older *Customary Cottage* dating back to the Seventeenth Century. Timber-framed, it incorporates brick and flint facings. The north gable end, facing the road exhibits decorative framing reminiscent of Northern traditions. Some contend that the small upper opening is an 'owl window' built to encourage owls into the loft to catch mice feeding off grain once stored there. Over the years, this building has had many functions; a communal wash house, office for the Registrar and Relieving Officer and as a weekly surgery for a visiting doctor.

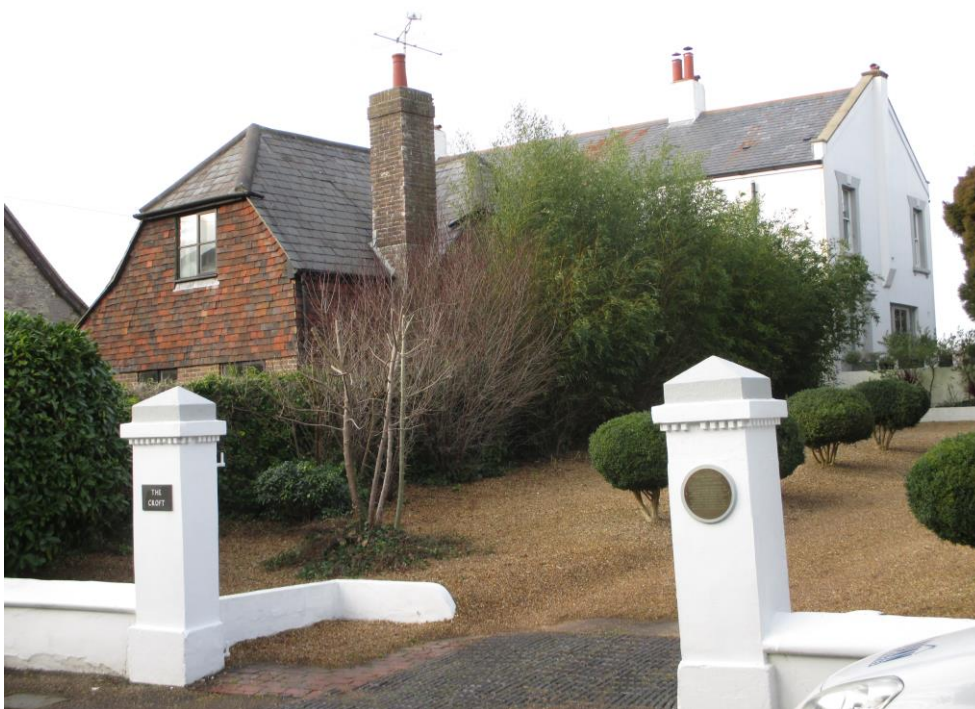
*Painted gate piers mark the entrance to The Croft*

4.22 The imposing gate piers and gravelled driveway next door lead to *The Croft*, a large Victorian house of 1890, set back but quite prominent from the road. It has a generous three-bay front with central entrance, faced in smooth stucco. The building used to have a large conservatory located on its eastern wall. A brass plaque commemorates the residence of Dr William Moon during the final years of his life, inventor of an embossed alphabet designed to enable the blind to read by touch. Because of its relatively late date, *The Croft* is not a listed building but officers consider that it should be considered for inclusion on a future Local Heritage List.

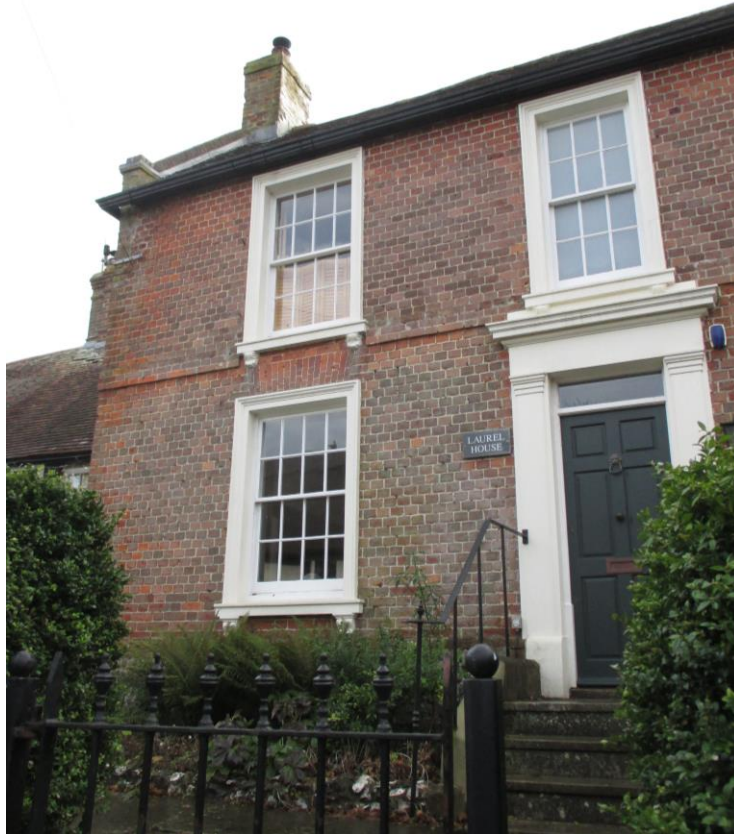
4.31 Next door is the Georgian elegance of *Laurel House*. Over two hundred years old, the header-bond brick façade is graced by moulded surrounds for the five sash windows and an attractive pilaster doorcase with cornice and fanlight. The window heads suggest that the window openings were originally a little narrower and were elaborated in the mid-Nineteenth Century.

*Georgian frontage of Laurel House*

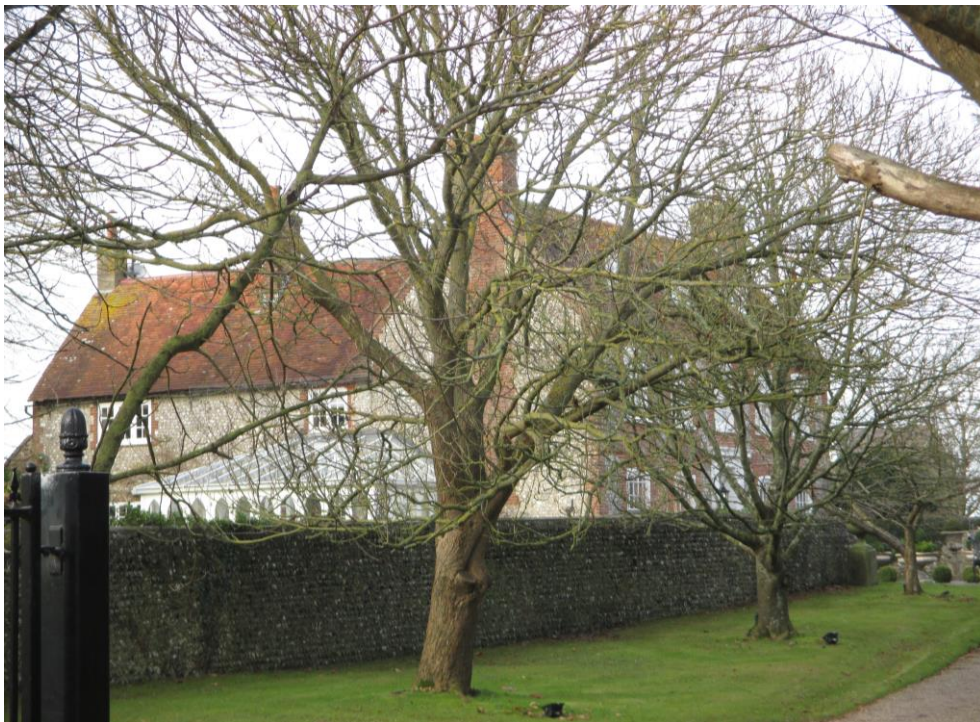
4.43 Though beyond the current boundaries, it is only appropriate to mention *Perching Manor Farmhouse* a little to the west, the only Grade II\* listed building in Fulking. This is a fine Eighteenth Century house on an L-shaped plan faced with very fine, labour-intensive, square-knapped flints with brick dressings and stringcourse. The primary elevation windows are sashes incorporating 'Gothick' glazing bars. The doorcase is pilastered and the fanlight repeats the highly characteristic fenestration. The front door itself is of six fielded panels.

*Perching Manor Farmhouse, already Grade II\* listed and now proposed for inclusion within Fulking Conservation Area*

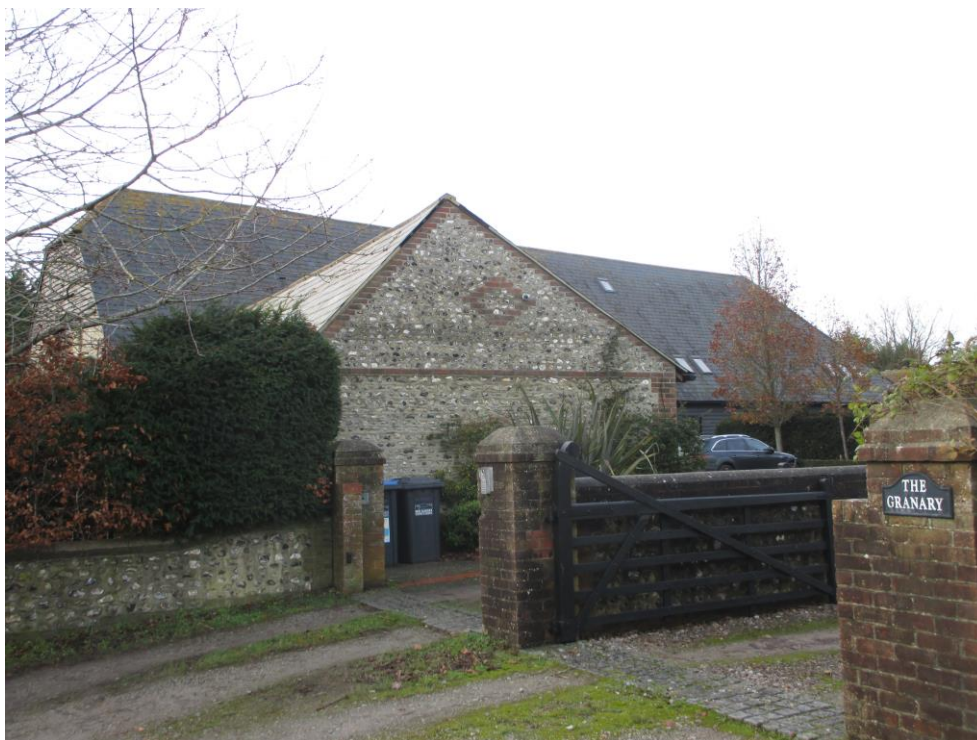
*The listed Perching Barn (above) with The Granary (below).*

4.44 The farmstead survives in a recognisable form, though is now wholly converted to residential uses. *Perching Barn* is Grade II listed, but suffered severe damage in the Great Storm of 1987. After several years in a vulnerable state it was converted to a large house in the 1990s, though the restoration looks a little heavy-handed. It is a particularly large barn to find in Sussex; most of the internal frame survives.

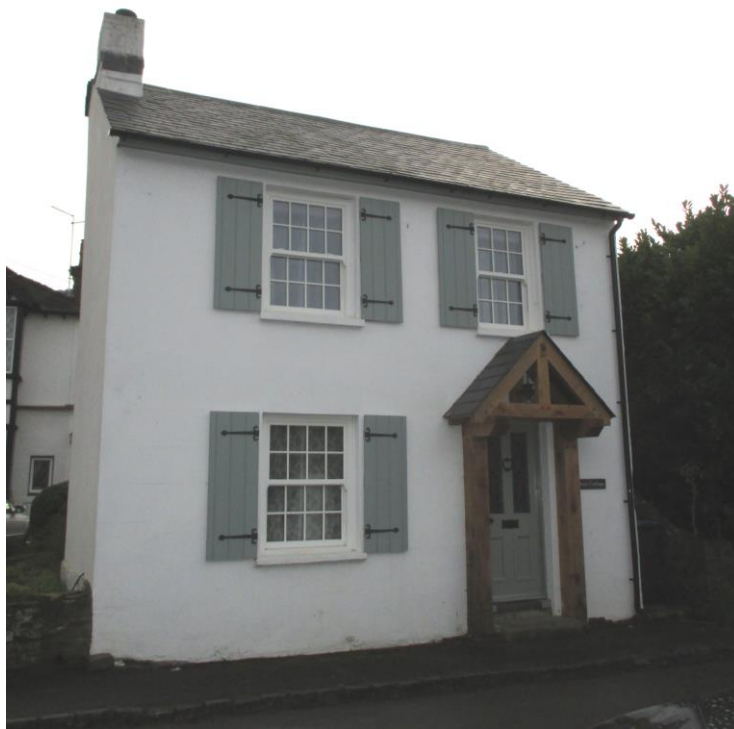
*Porch or other additions and replacement of fenestration cause cumulative harm.*

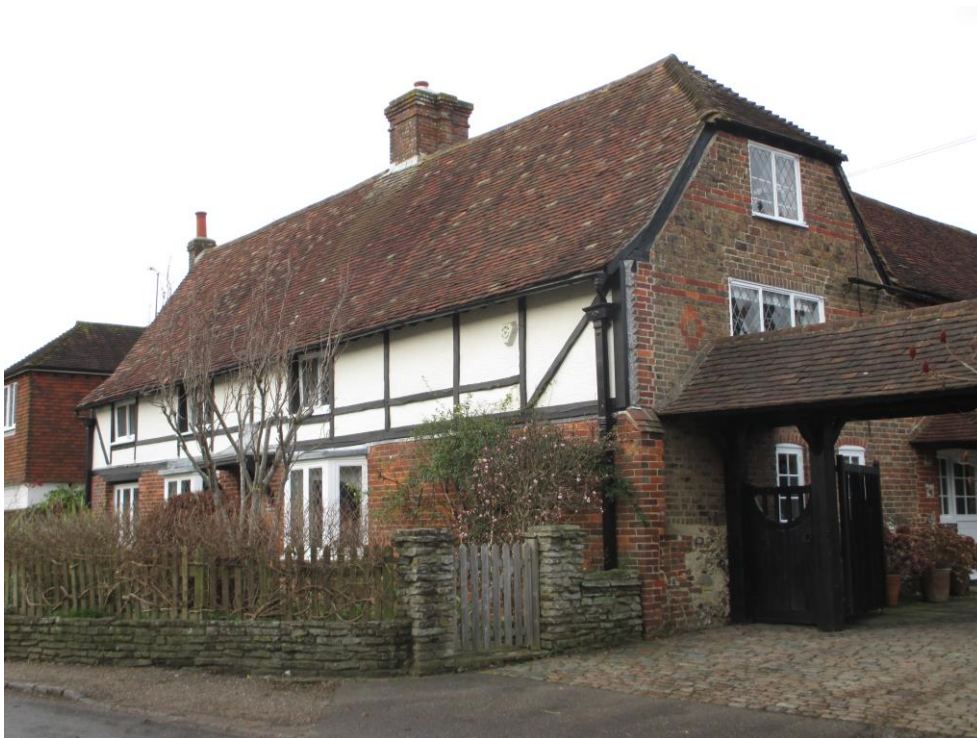
Figure 3: **Fulking Farmhouse** has a Seventeenth Century core. The frontage was heavily remodelled inter-war, when a plain Georgian façade was removed.

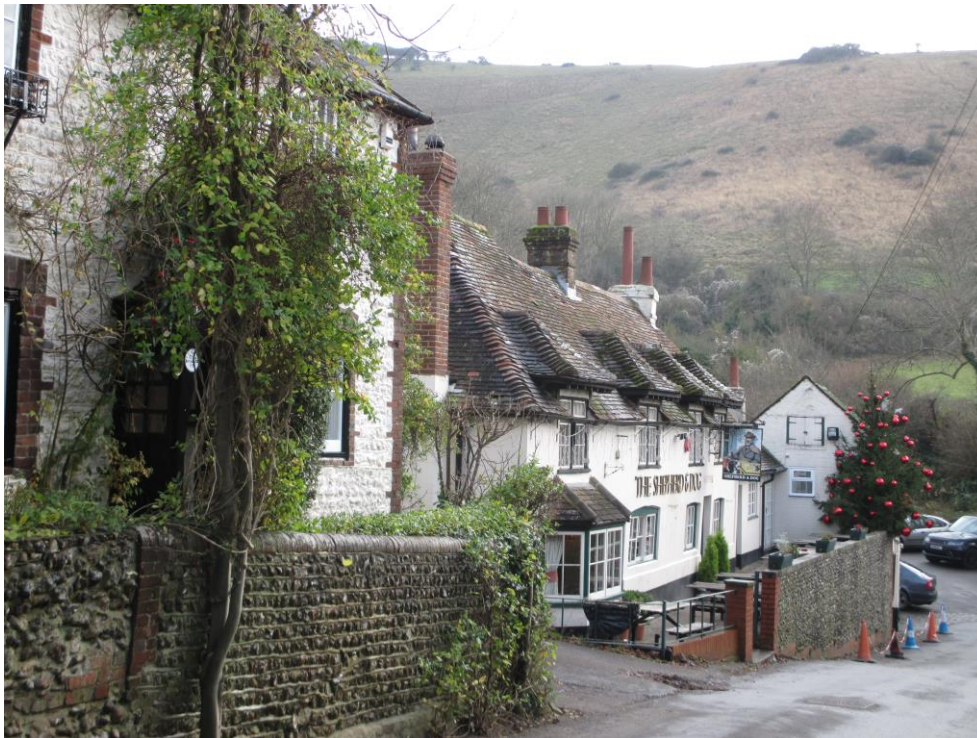
Figure 17: **The Old Bakehouse** and **The Shepherd and Dog Public House** form a picturesque grouping of listed buildings descending the hill.

4.37 Descending the slope to the left-hand side stands the *Old Bakehouse*. The current house dates back to the mid-Eighteenth Century and is faced in painted flintwork. The timber Gothic porch is a relatively rare example of a porch which enhances an entrance, rather than detracting from the original visual appeal of the facade. The bakery referred to in the name was established in the Nineteenth Century and required an excavation of the rock face to accommodate construction of a wood-fired oven. The successful business was transferred to the

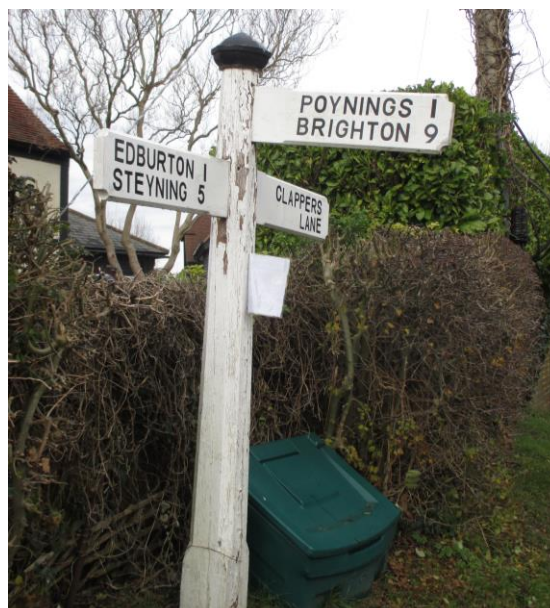
Figure 22: **Timber Directional Finger Post** is an attractive survival.

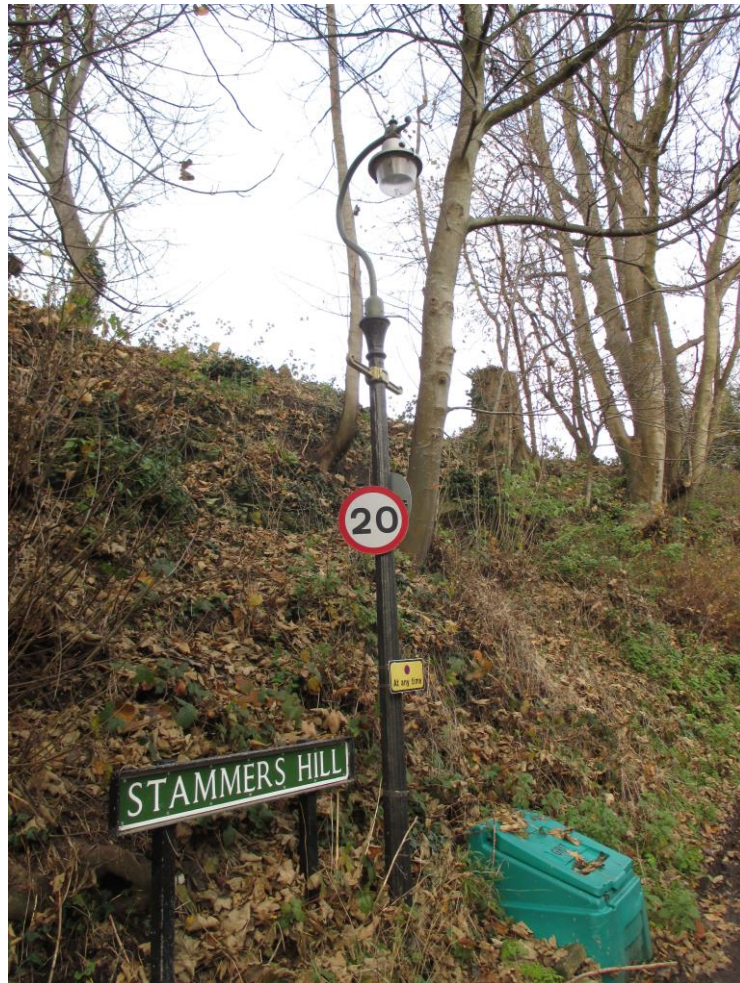
Figure 23: One of three surviving **Pre-War Lamp Posts**. While the use of existing street furniture to install supplementary signage is usually a sensible thing, it is less desirable to clutter a surviving historic feature with extraneous items.

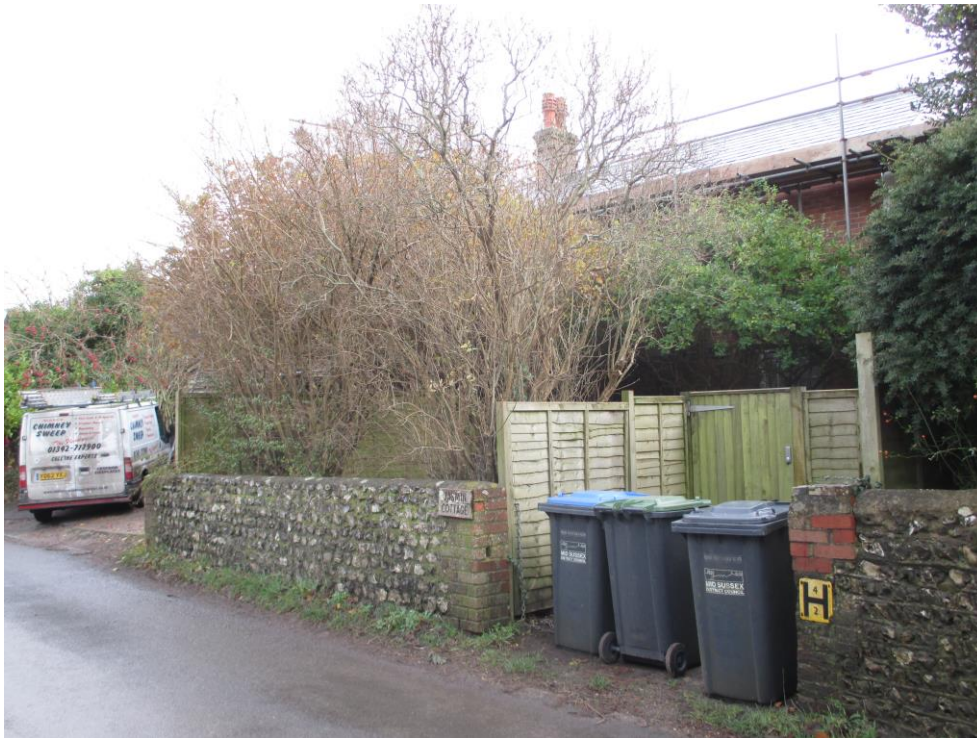
***Jasmine Cottage** has an overgrown frontage, needlessly high timber fence and gates, a boxy side extension visible from the road and an unsightly timber garage, all of which combine to form a significant visual detractor to The Street.*

4.29 *Jasmine Cottage* was an attractive Nineteenth Century dwelling in brick, now rather hidden by an overgrown hedge to the front. Unfortunately, the most prominent part of this house from The Street is a rather ugly, boxy extension to the eastern side and a dilapidated timber garage.

6.19 As reported in paragraph 5.7, the historic building stock in Fulking is generally in good condition but there is a building which requires enhancement, this being **Jasmine Cottage** and the timber garage adjacent to it.
