Conservation Area Character Appraisal and Management Plan

Fulking

April 2020

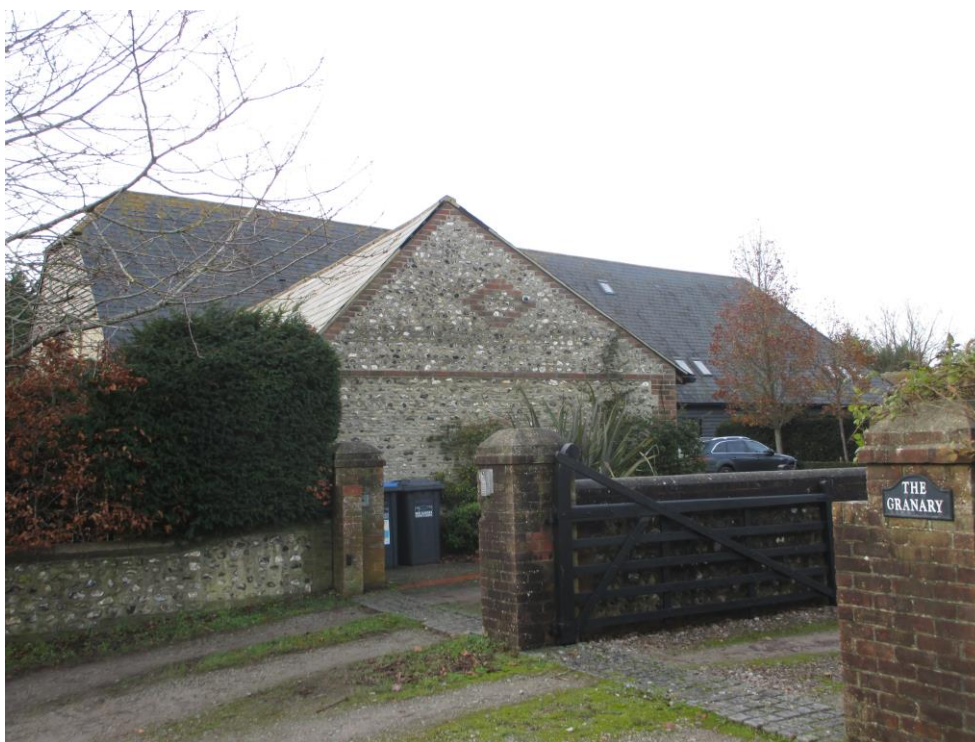
The listed Perching Barn (above) with The Granary (below).

4.44 The farmstead survives in a recognisable form, though is now wholly converted to residential uses. *Perching Barn* is Grade II listed, but suffered severe damage in the Great Storm of 1987. After several years in a vulnerable state it was converted to a large house in the 1990s, though the restoration looks a little heavy-handed. It is a particularly large barn to find in Sussex; most of the internal frame survives.

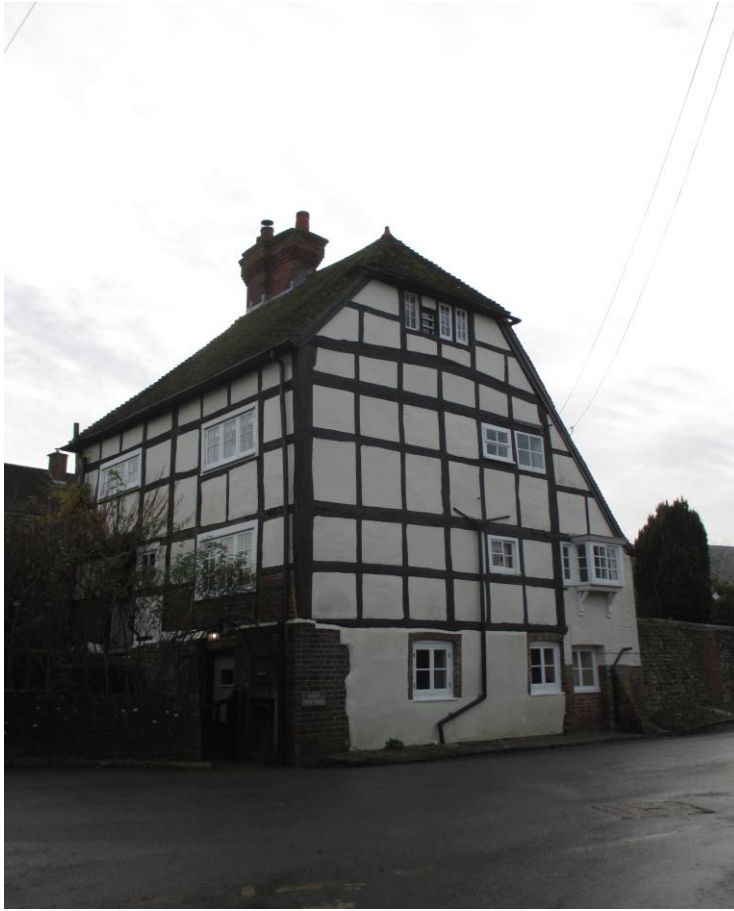
Figure 1: **Kent Cottage**

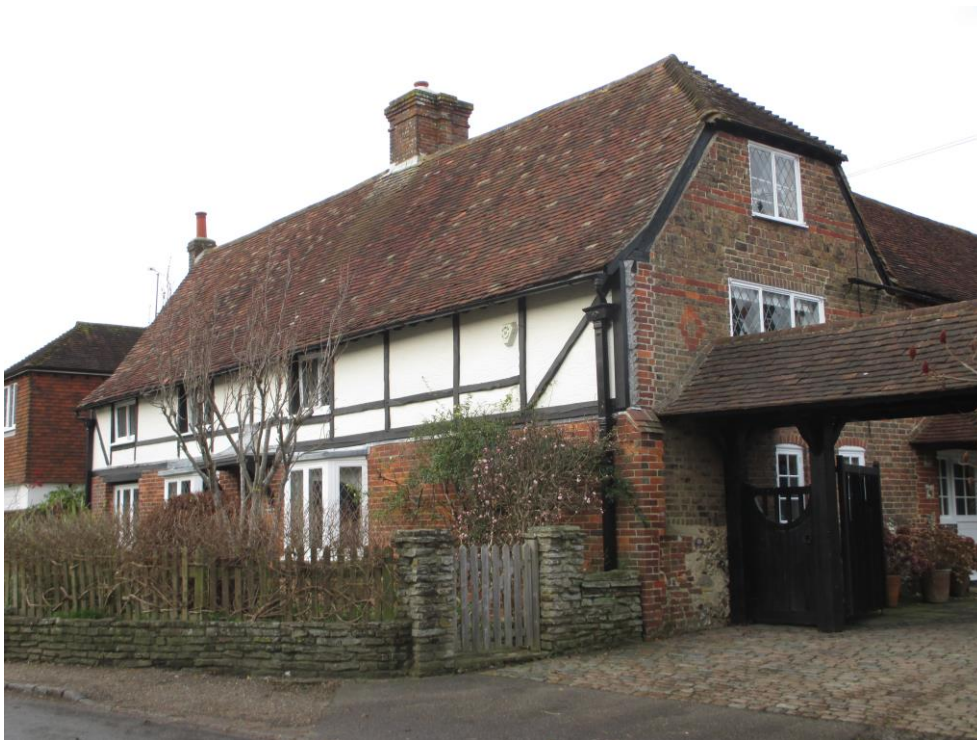
Figure 3: **Fulking Farmhouse** has a Seventeenth Century core. The frontage was heavily remodelled inter-war, when a plain Georgian façade was removed.

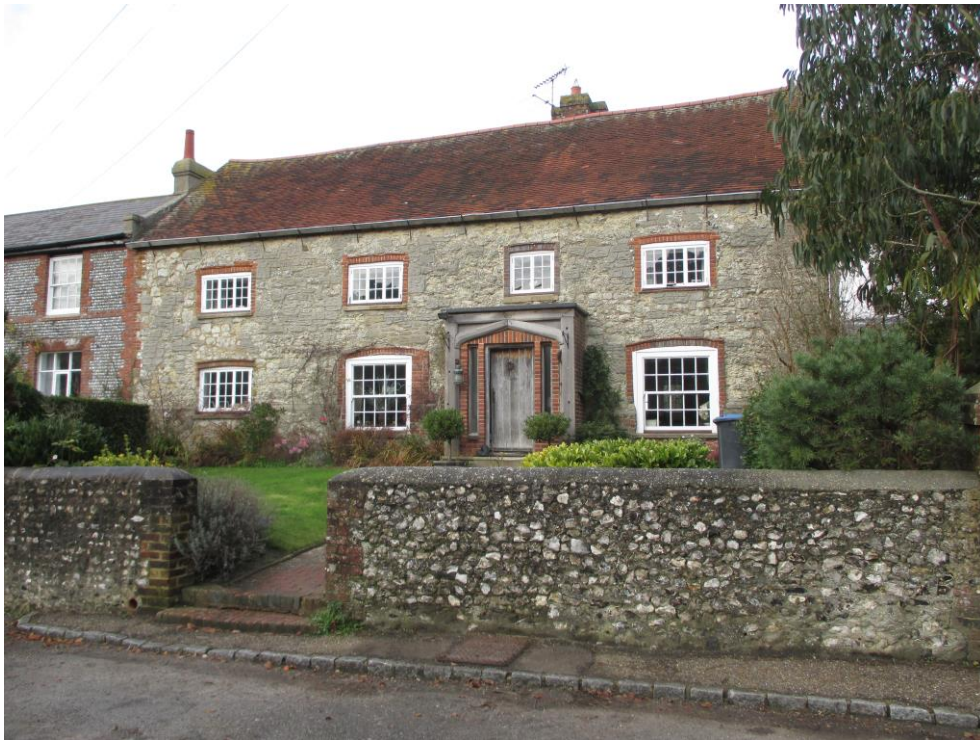
Figure 8: **Flint Boundary Walls** form a strong unifying element within the village and care should be taken to preserve and maintain them in original form.
