HAZARDOUS MATERIALS (CHEMICAL) and DEMOLITION COSTINGS SURVEY

**SHOREHAM CEMENT WORKS
UPPER BEDDING
WEST SUSSEX
BN44 3TX**

REFERENCE: REP202-1 Rev 1.0

DATE OF ISSUE: 07 FEBRUARY 2022

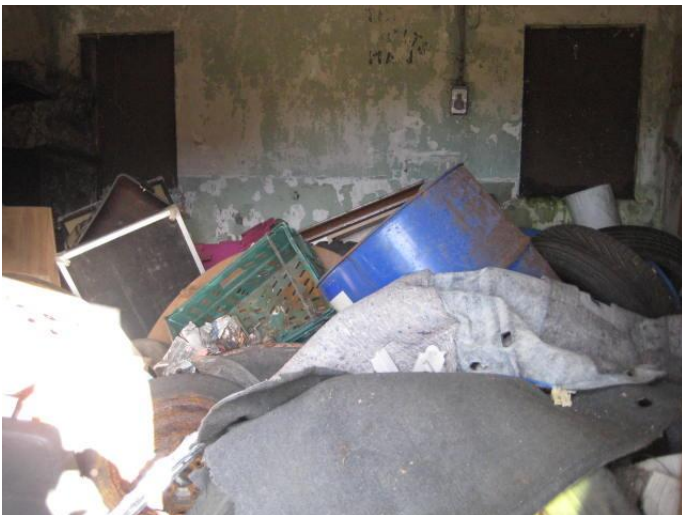
Plate 8: Former Yard amenities buildings – discarded contents internally

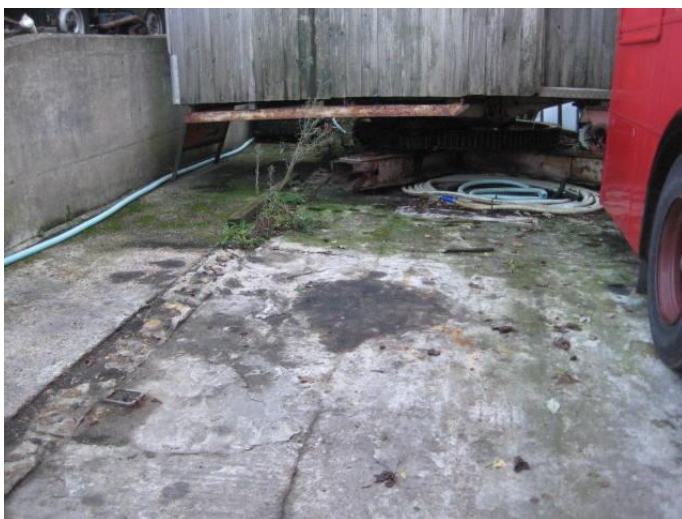
- The vehicle maintenance area/workshops in Area A are likely to have an interceptor, but this part of Area A was covered over with materials and equipment and clear sight of the slab surface in this location was not possible. No evidence of USTs was observed in these locations.

Plate 18: Vehicle Maintenance Area – likely site of interceptor/drainage sump

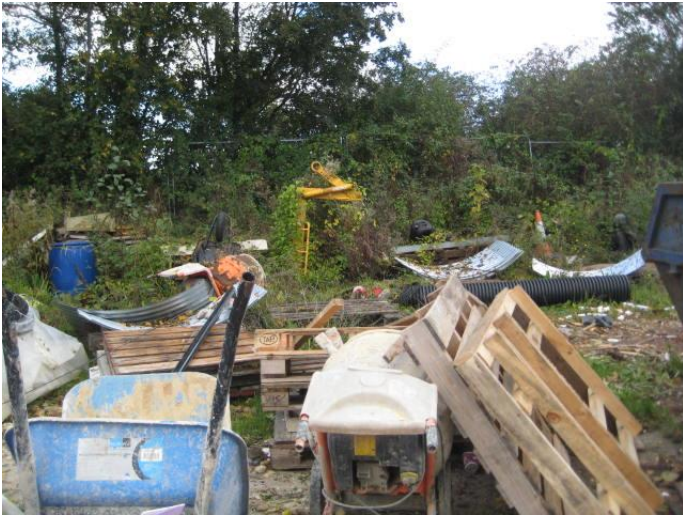
Plate 25: Discarded materials and equipment opposite Former Vehicle Workshops

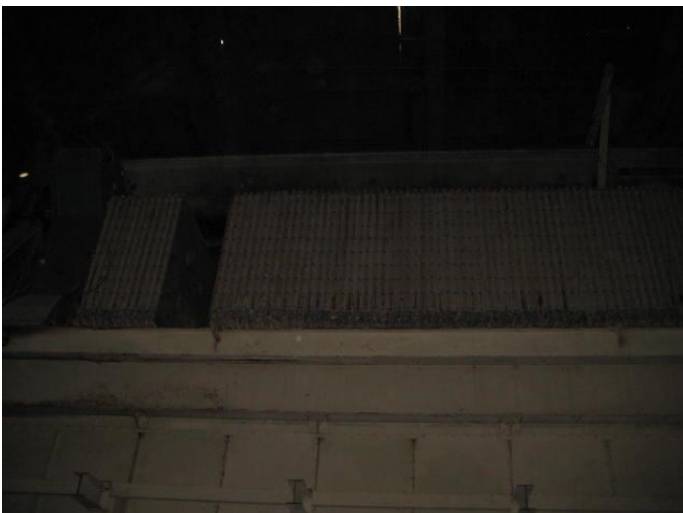
Plate 30: Filter Press – plates still in-place

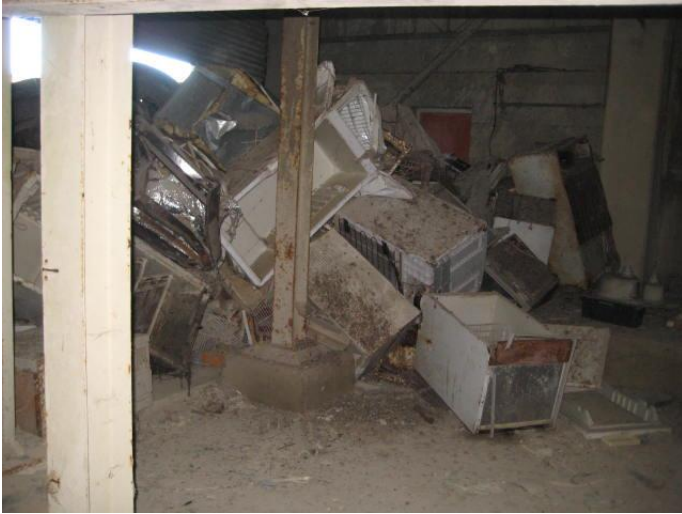
- Oils to motors/gearboxes etc. remain in much of the abandoned equipment.
- One location of discarded household refrigerators was observed, but this was limited in quantity.

Plate 31: Filter Press House – discarded fridges

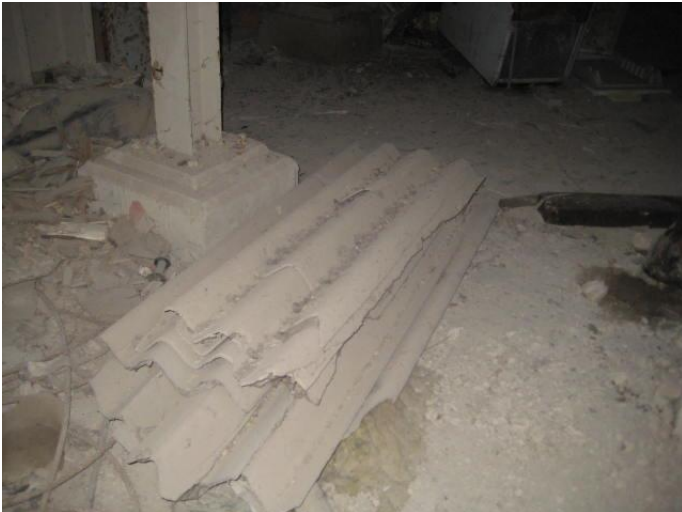
- Asbestos cement sheet debris is present in many locations, but no great stockpiles of this material were observed. This type of loose asbestos cement debris is routinely hand-picked to remove it during demolition works.

Plate 32: Filter Press house – example of loose corrugated cement sheet

- For the purposes of demolition, all Asbestos Cement is to be demolished Mechanically due to its poor condition. This Method is in-line with Industry Standards where the Asbestos Cement is not in good condition with Dust Busters being used throughout to damp down the sheets during the Demolition operation. The sheets, once at ground level, to be loaded straight into skips (sheeted) for disposal to Landfill.

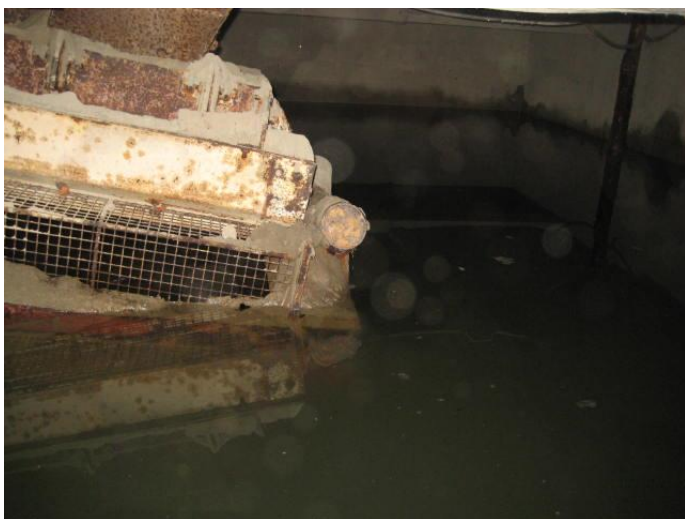
- Cellars/pits (i.e. sub-surface rooms) were invariably waterlogged, preventing access/observations.
- Many different businesses operate in Area A. Whilst general views from outside premises were possible, inspection of conditions inside occupied buildings/areas was not generally possible.

Plate 42: Handling Shed – flooded pit

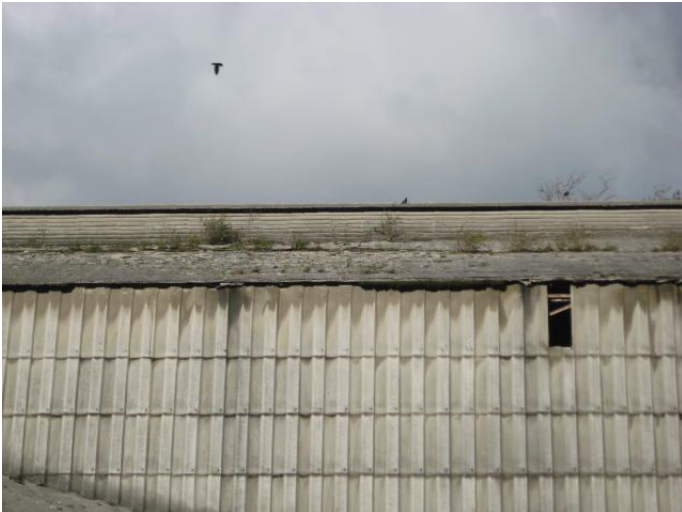
- Access to Buildings was limited and no access above ground level was available during the survey due to stairways being removed to prevent access of intruders. However, based upon our past experience, having priced several Cement Works over the years, won Contracts at Cement Works and completed the Demolition works, we have used some good bench marks obtained from those past experiences to aid the Survey exercise.
- Buildings generally have tin-sheet roofs, but asbestos-cement cladding to the walls. These surfaces are coated in a layer of solidified cement dust that increases the sheet weights. It is most likely that mechanical demolition of these features will be the appropriate method of asbestos cement sheet recovery. Many of the roof areas

are in a poor condition and having demolition workers at height, recovering cement sheets in these unstable surroundings is considered to be an unacceptable risk.

Plate 44: Bunker House – roof in poor condition and breaking-up

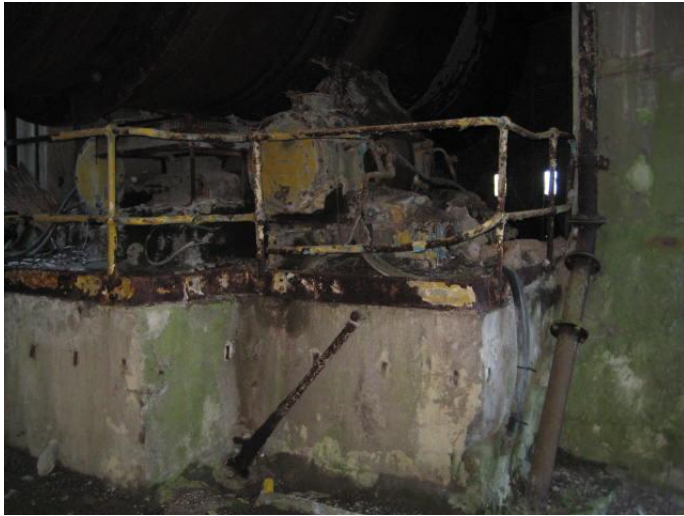
Plate 49: Kiln Shed – motors and gearboxes to kilns

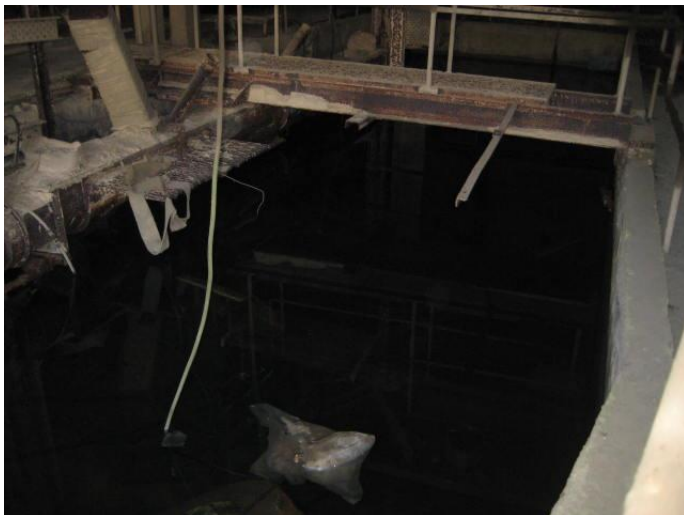
Plate 50: Kiln Shed – flooded pits

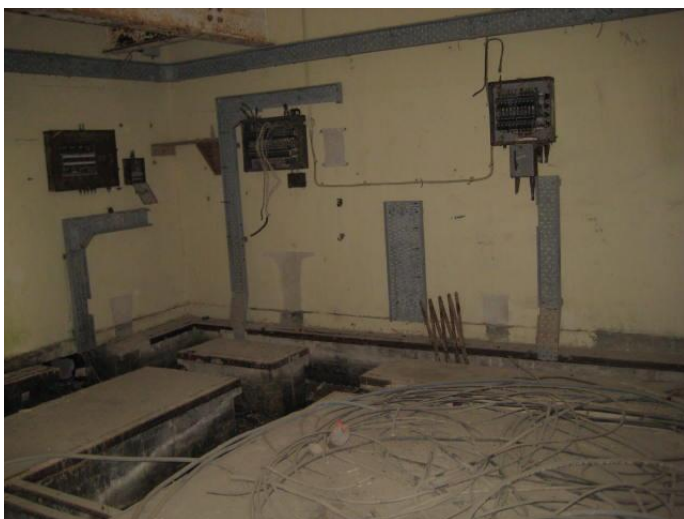
- The site has already been stripped of valuables/cable/non-ferrous items, including transformers and switchgear. These potential scrap credits are therefore reduced accordingly.

Plate 51: Kiln Shed – electrical equipment has been stripped and removed

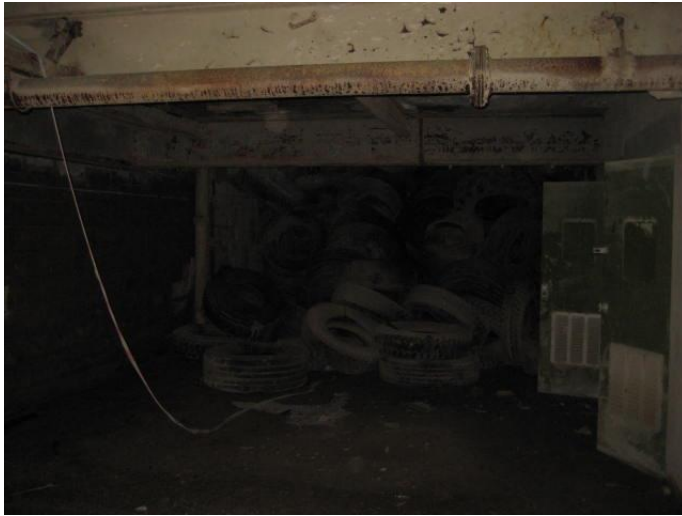
- No glaring/large stocks of Haz Waste/Contamination were observed to be present.
- Occasional stockpiles of discarded tyres are present, mostly in the Cement Kiln building. These are a mix of car/van, commercial vehicle and plant equipment tyres.

Plate 52: Kiln Shed – example of tyre stockpile

4.4 An exception to this is the disposal of the tyres at site. There are many different tyre sizes present, ranging from car tyres through to 25-tonne dumper tyres. The individual disposal costs differs between the different tyre sizes, and it is not possible to identify all tyres in the different stockpiles. An allowance of £10,000 has been calculated for tyre disposal.

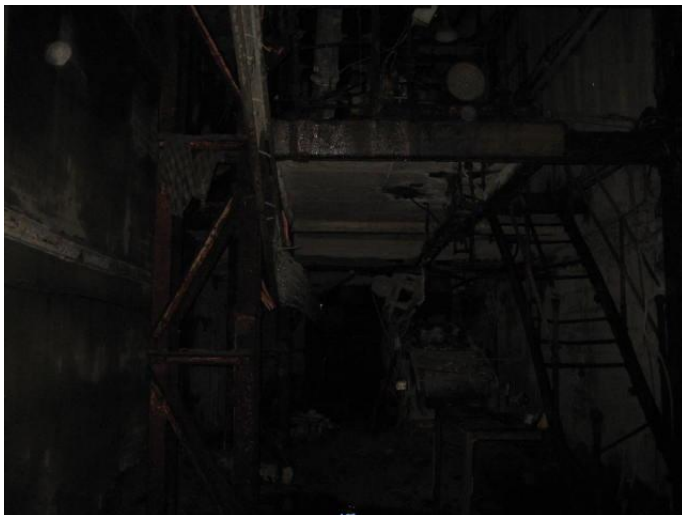
Plate 53: Kiln Shed – side rooms areas in poor condition

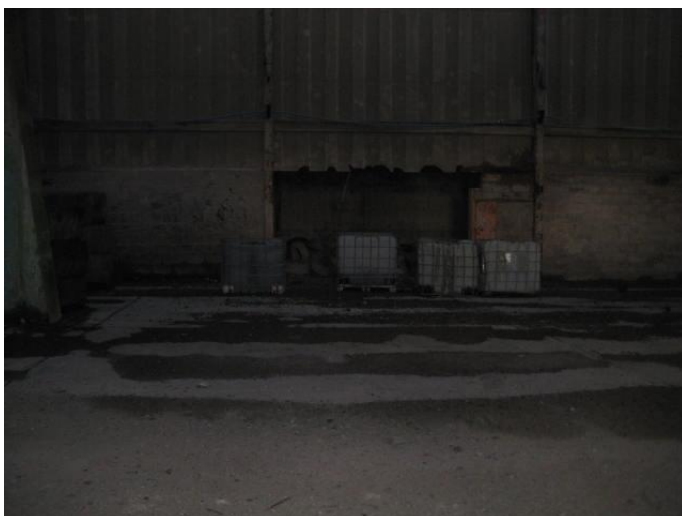
- Occasional drums/tubs of lubricants/greases were noted. This is typical for such an industrial site.
- Some additives used in the current concrete batching process were also observed (IBC containers).

Plate 54: Kiln Shed – examples of part-full IBCs

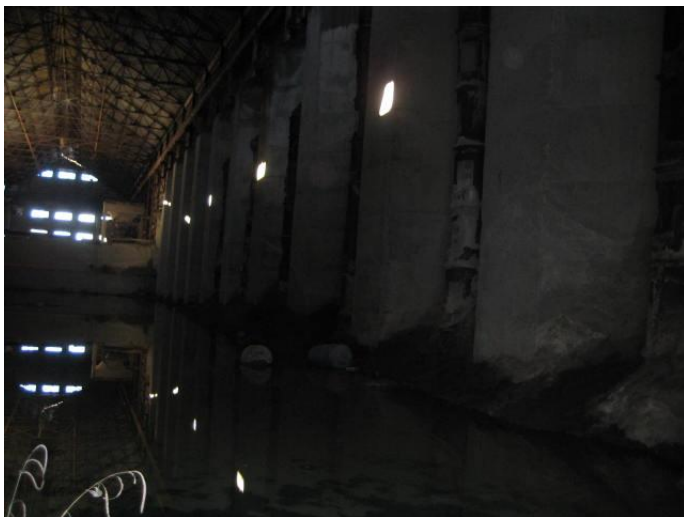
Plate 56: Bunker House – flooded floor and waste drums

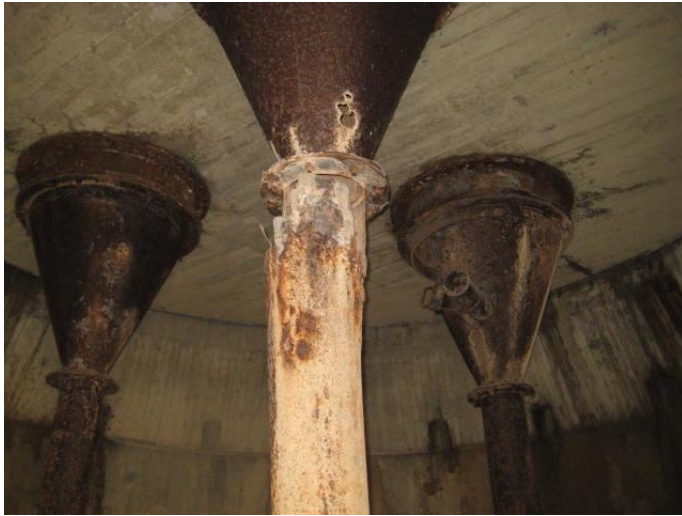
Plate 61: Chimney Stack – internal base, underside of stack

- The demolition would be carried out using mechanical excavators fitted with demolition tools and to demolition specifications. A blow-down of the Chimney Stack is included as part of the demolition works.

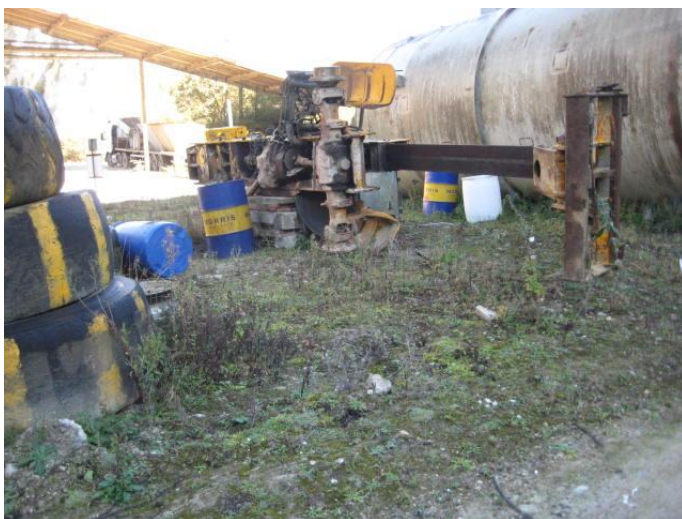
Plate 63: Plant and Equipment Graveyard – occasional drums and tyres

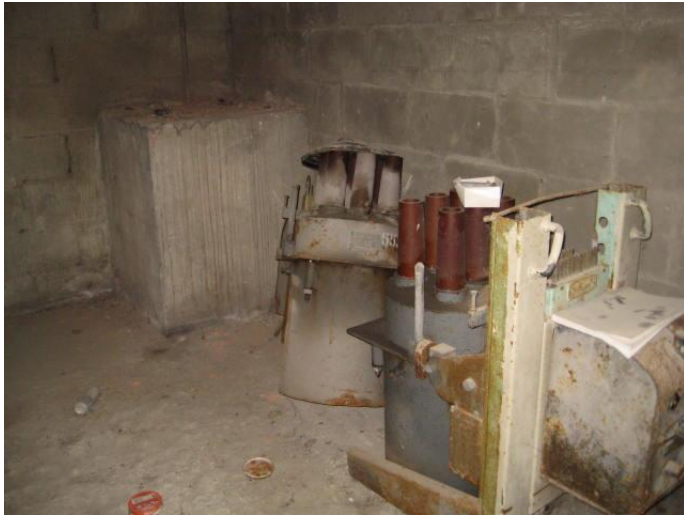
Plate 73: Workshops – discarded electrical switchgear equipment

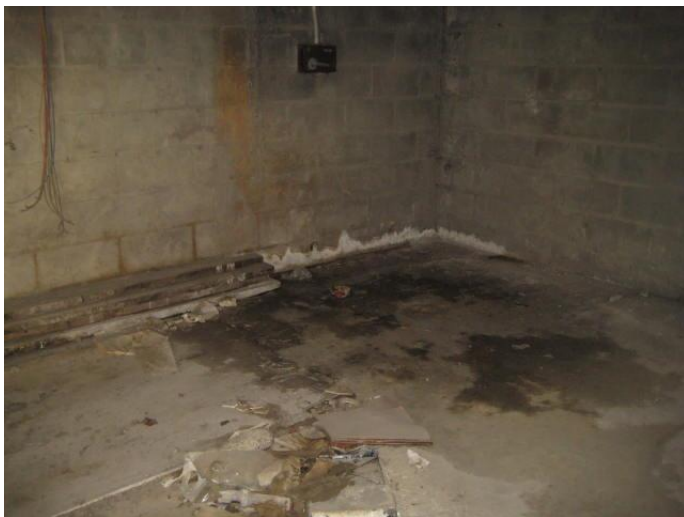
- It is likely that some contamination (petroleum hydrocarbons etc.) pockets will be found when these areas are vacated by existing tenants. Vehicle maintenance/workshops are likely to have additional pockets of contamination from those operations.

Plate 74: Workshops – oil and chemical staining to cleared room

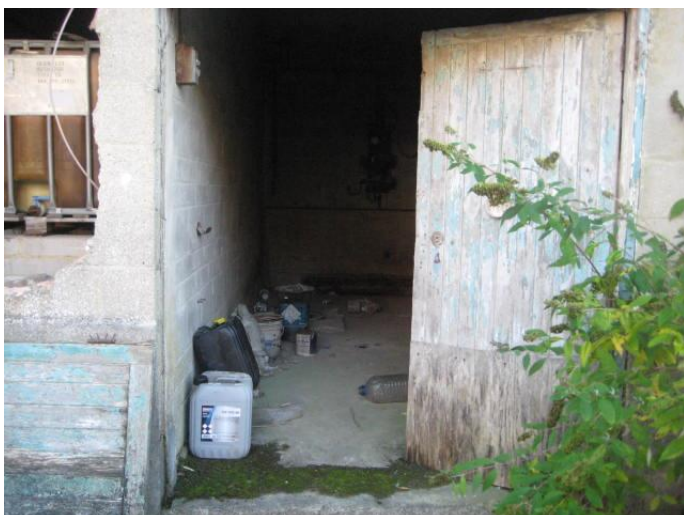
Plate 75: Workshops – used chemical containers
