Rampion I Onshore Windfarm Cable Corridor

Officer Explanatory Note to Accompany Aerial Photography

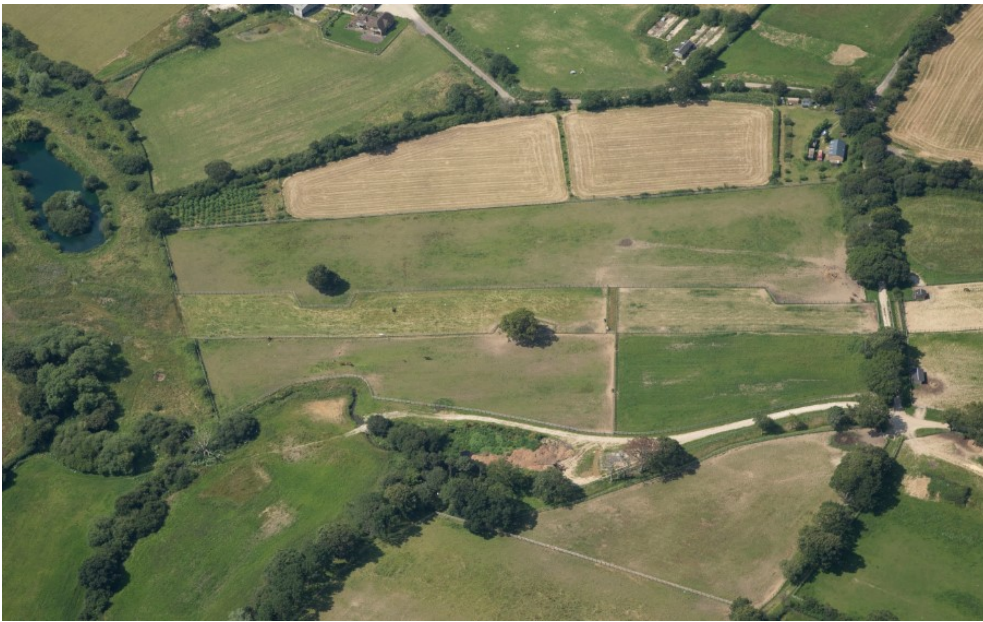
Fig.1

The cable route enters the National Park south of Horn Lane, Henfield and continues south past Truleigh Manor Farm and onwards to Edburton Road. In this section, the cable route is visible above ground and significant runs of fencing remain on either side of the cable corridor. Further divisions along this part of the route appear to be intensively grazed (Fig.1) Hedgerows and other field boundary planting still demonstrate visible gaps, where new planting has either not been implemented or has not been successful.

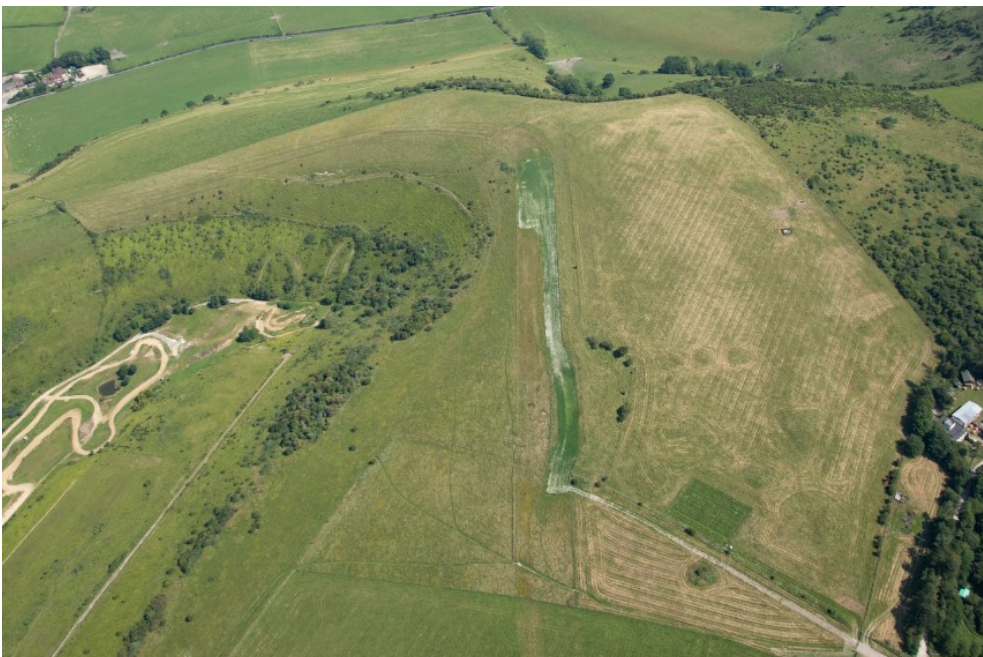
Fig.2 – looking east

As the corridor travels up the scarp slope and over to towards the South Downs Way (past Tottington Mount and the Site of Special Scientific Interest), there remains clear evidence of the works. However this is where further works following the failure of previous attempts at reinstatement have recently taken place and so there has been less time to recover. Parts of this section also remain fenced (Fig.2).

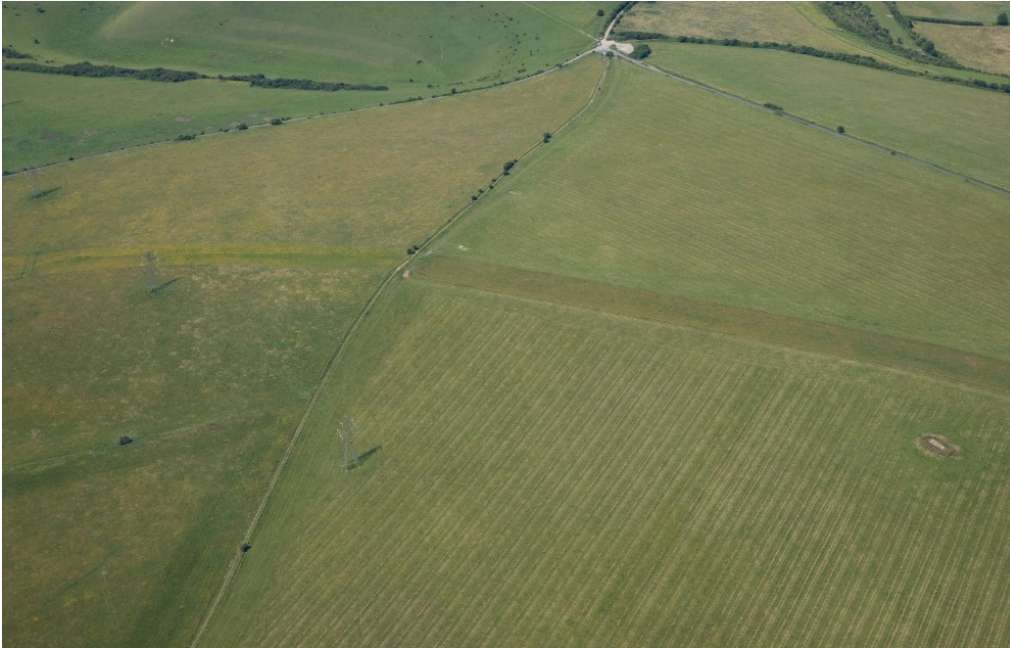
Fig.3

Fencing appears to have been partially removed and the cable corridor managed as part of the wider land use between the South Downs Way and Mill Hill (Fig.3). Despite this, the cable route remains evident above ground.

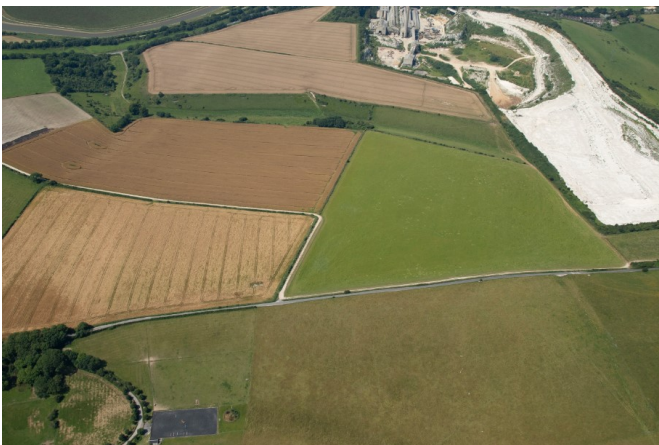
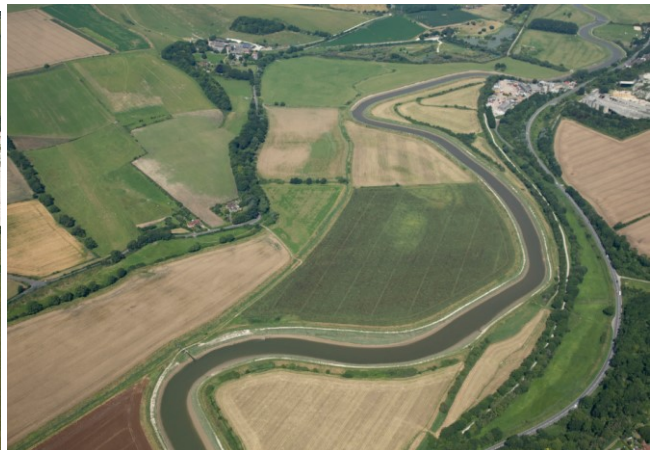
Fig.4

As it crossed Mill Hill (south of Shoreham Cement Works) and into the Adur Valley, the route is not readily discernible (Fig.4 and 5). This is also where it moves through the Old Erringham Farm and Road Cutting Local Wildlife Site. It remains relatively discreet as it moves up the western valley side.

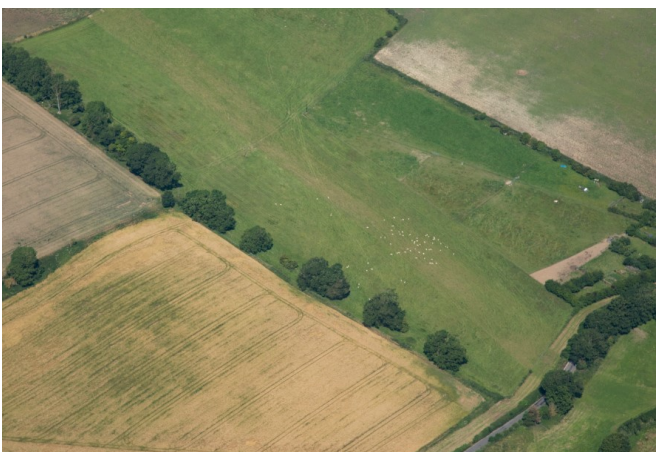
Fig.6

The cable route becomes more visible as it crosses Coombes Road – due to the gaps in the hedgerow and differentiation in the grassland quality (Fig.6). This improves as the corridor becomes less obvious before it heads south at Beggars Bush/Titch Hill (Fig.7), skirting round Applesham Farm Bank and Steep Down Local Wildlife Sites, at which point the route is easier to follow.

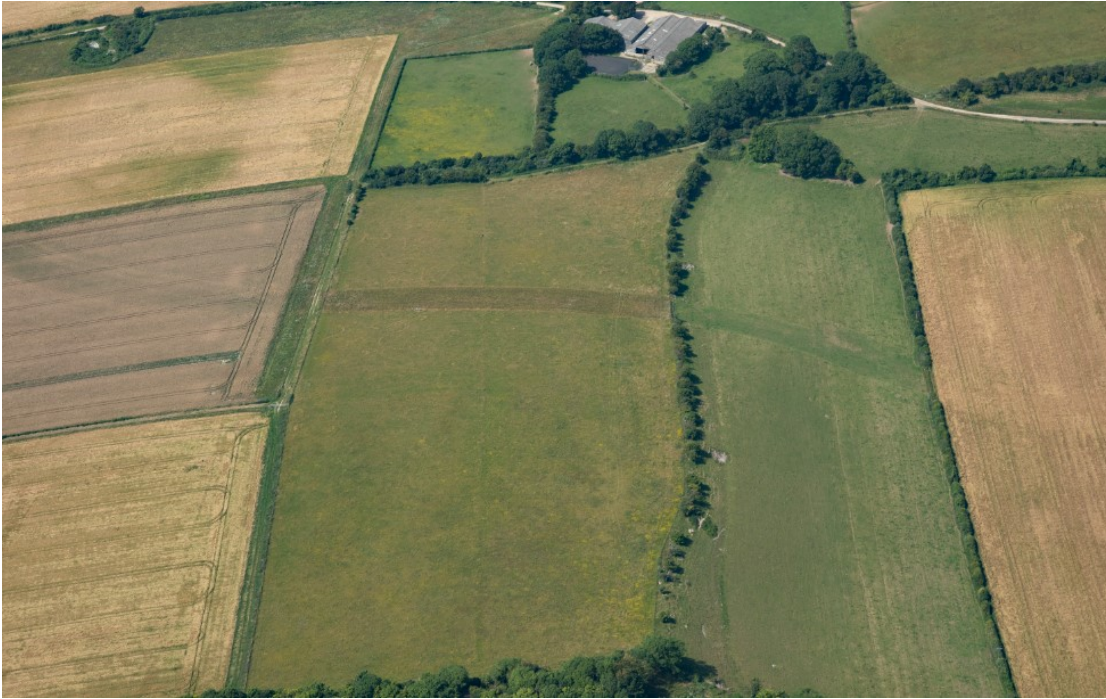
Fig.8

As the corridor passes Lambleys Farm, despite a mix of crops and uses, the cable route is clear and gaps in the hedgerow are highly visible (Fig.8).

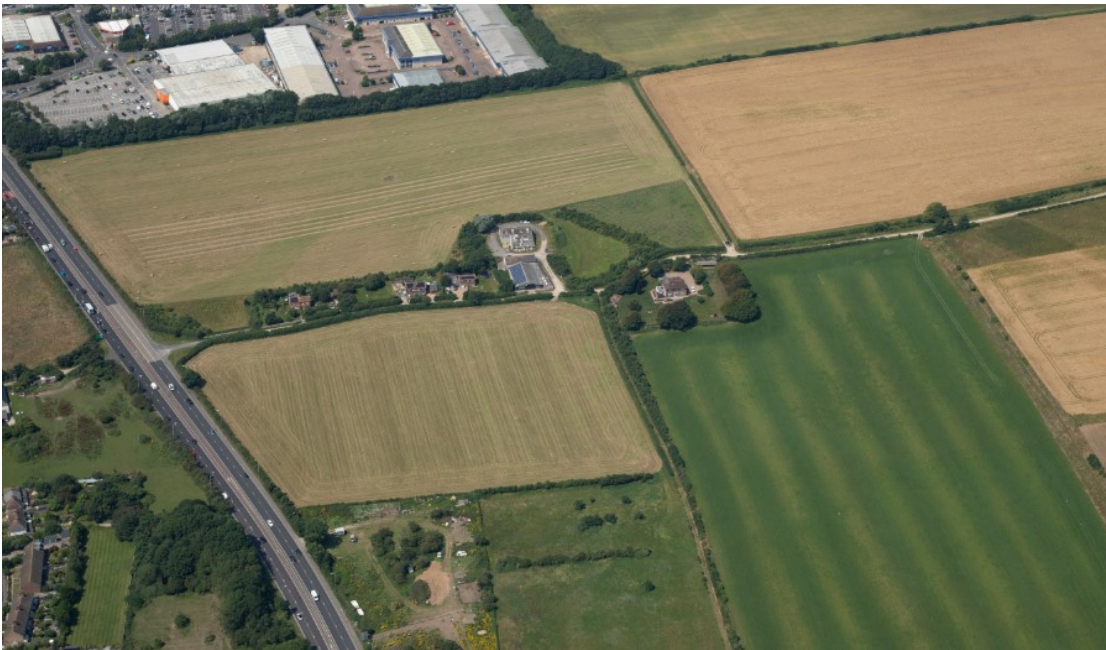
Fig.9

Prior to leaving the National Park at the A27 east of Lyons Farm, the route crosses Lambleys Lane, through the fields where the corridor is only notable as a result of the gaps in hedgerow (Fig.9).
