Case Study

Headstone Copse: Pond Restoration

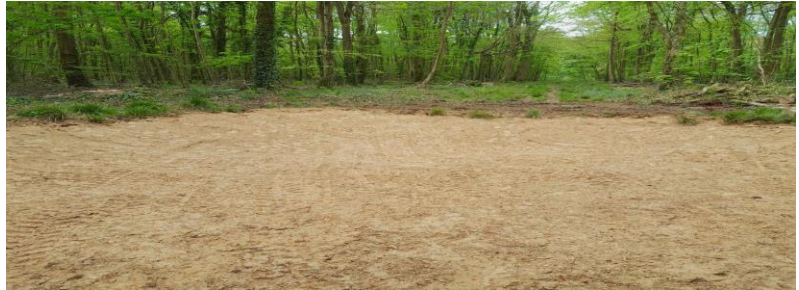
Post construction, still dry powder

The final stage of the restoration was to spread the 25 bags of Bentonite powder onto the prepared surface of the pond. This was an 'all hands to the deck' approach with the bags being sited within the pond and spread at around 5cm depth to give good coverage. The final stages were to stamp in or, in this case, utilise the tracks of the digger, to bed the powder into the structure of the soil. With the pond restoration complete, the landowner has also sown some wildflower seed to re-establish the pondside vegetation.

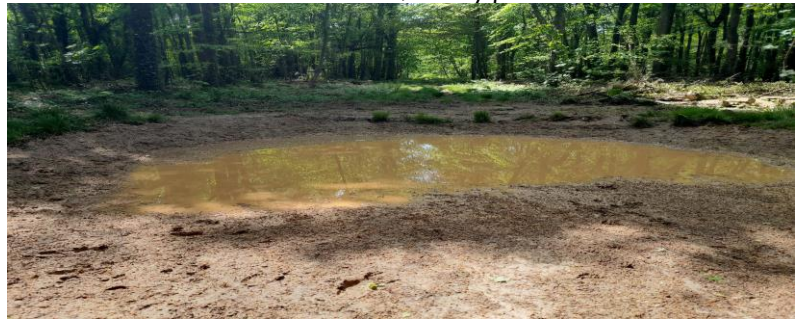
Wetted Bentonite, forming the clay liner

On contact with water, Bentonite expands, transforming into a thick gel that seals the soil making it watertight. In contrast to a traditional butyl liner, it can also 'self-heal', expanding around the small gaps and crevices in the soil. Bentonite powder was also considered to be the most practical option in terms of being able to access a remote location in the centre of the copse.
