## **SCHEDULE OF CONDITION**

The Old Post Office and attached house, West Ashling,  
Chichester

June 2017

**JULIAN RA LIVINGSTONE CHARTERED ARCHITECT**

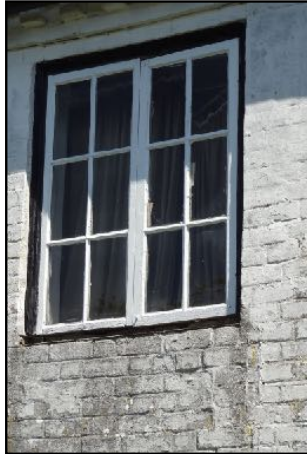
**West face, North first floor window**

Bow to window head; cill rotted away completely; frame jambs rotting; right hand casement dropping and pegged joints failing as peg ease out; left hand casement bottom rail not connected to styles; glazing putty failing

Check lintel in case it has failed; remove casements and remains of frame, construct new frame and cill; scarf in new sections of bottom rail; re-fit pegs and re-glue joints remove glazing putty where failing and re-putty; redecorate and re-fit.

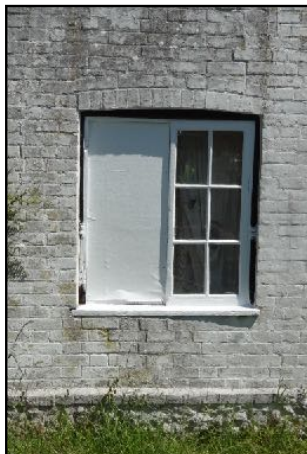
**West face, North ground floor windows**

Cill rotting out; jambs rotting back; left hand casement missing; right hand casement painted shut; glazing putty failing

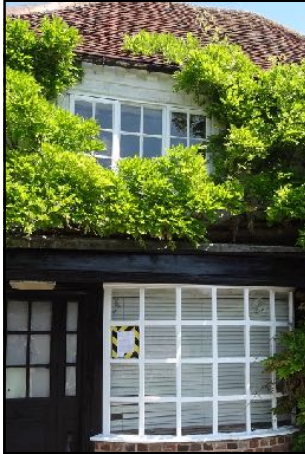
### West face, North ground and first floor, Post office windows

First floor casements dropped; cill damaged and rotting; jamb bases rotting; glazing putty failing in places; ground floor bay window cill rotting in central section and South jamb rotting

Remove first floor casements repair; make new cill to first and ground floor and scarf in sections of new jambs; clean off, re-putty where disturbed and re-fit; redecorate all round

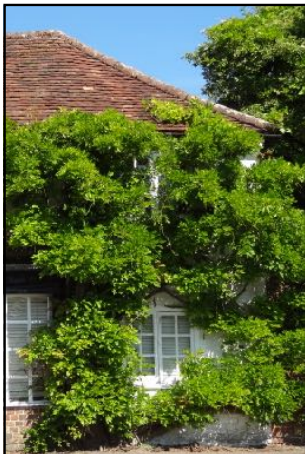
### West face, South ground and first floor Post office windows

Cill to first floor rotted away; ground floor head rotted in part; casements dropped; joints to bottom rail and styles failing; glazing putty failing

Remove casements and window frame; make new cill and scarf in sections of new jambs; re-make casement joints and ease out existing glazing; clean off, re-putty and re-fit; redecorate all round

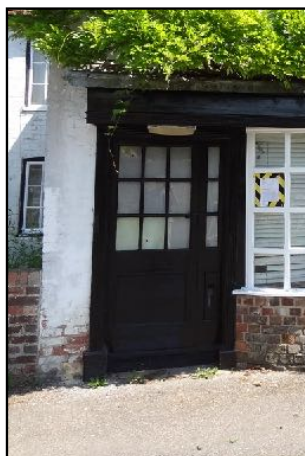
### West face, South ground floor Post office door

Cill and jamb base rotting in sections; decorations failing; glazing putty failing; ironmongery inappropriate plastic handles, letter box cover missing and damaged

Repair frame and cill with new sections scarfed in to match existing; strip decorations and ease door; overhaul ironmongery and fit new where damaged or missing; redecorate door, frame and cill.

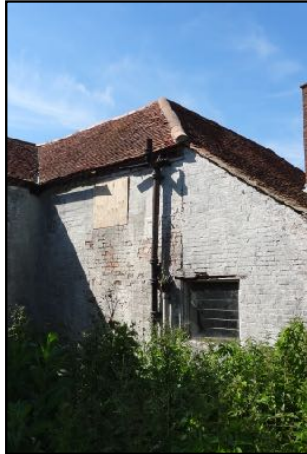
### South face of house roof

Roof tiling poor, tile and batten nails rusting and slipping; gutters broken and missing; gutter brackets missing; first floor window boarded; ground floor window poor condition; head of window rotted, lintel failing; masonry loss at base of wall which bulges; unbonded junction with outshot; wall decorations poor; soil pipe decorations poor and missing bird guard

Strip existing tiling and battens and re-tile; take down gutters, take apart, sand blast clean, redecorate, re-fit; fit new gutter brackets, decorate existing, fit new downpipe, clear gully and surface water drainage; replace ground and first floor windows; fit new ground floor window lintel; stitch vertical crack; rebuild wall base; remove existing wall paintwork where not lime based and redecorate brickwork;

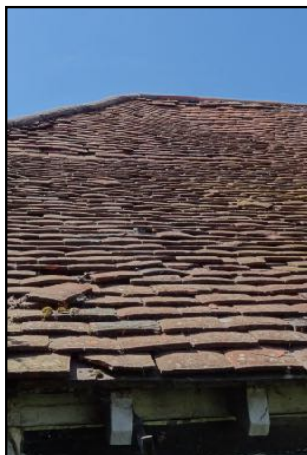
### South East roof slope of house and outshot

Roof tiling poor, batten nails rusting and slipping; tile nails rusting; gutters are missing;

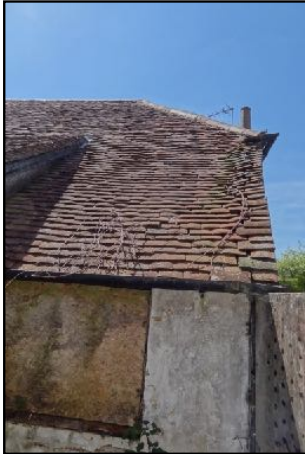
### North East roof slope face generally

Roof battens and tiling have rusting nails and are failing; tiles are slipping; gutters failing; window boarded up; wall decorations poor

Strip roof battens and tiling; strip, sand blast, decorate and re-make gutters; replace window with new; strip wall decorations and redecorate

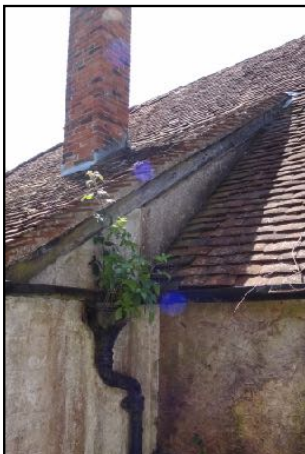
### East roof slope

roof tiles slipped and missing; batten and tile nails are rusting; chimney lead flashing looks in poor condition, open joints in brickwork; decorations poor and failing to chimney; hopper blocked with vegetation; gutter

Strip roof tiling and re-tile; strip chimney lead flashings and re-make back gutter; repoint open joints in chimney; strip gutters, hopper and downpipe and sand blast, redecorate and re-fix; clean off gutter brackets and redecorate; re-fit gutters, hopper and downpipe to gully; check surface water

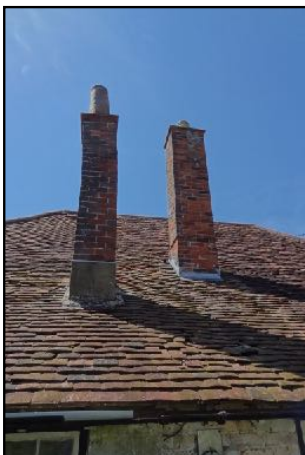
### East face chimneys

South chimney twisted, open brickwork joints; no lead flashing, cementitious flashing to chimney base; suspect rear gutter; failed launching with roof tiling;

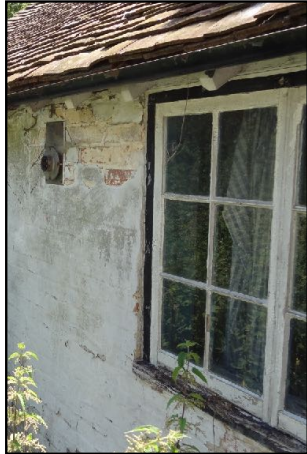
## East face of outshot, North end

North window cill rotten and insufficient overhang of masonry below; casement joints loose and open; glazing putty missing, cracked and in poor condition

Remove window and frame and repair all round adding a new cill; reglaze and re-putty

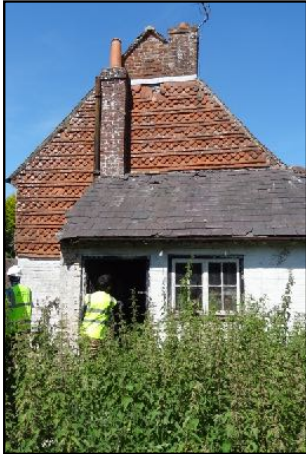
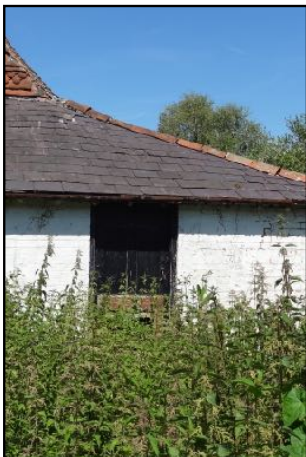
Roof slating and battens nails rusted and slipping, rafters rotting at abutment; ; neighbouring property requires maintenance; gutter broken; gutter bracketry poor and missing; chimney brick work at top opening up and joints open; flaunching to pot and to slates failed; West side of wall cracked; window cill and bottom rails rotten; lintel over failed; glazing putty failed; door and frame base rotting to West and East door; window and wall decorations poor; decorations to soil pipe failed and bird guard missing

Strip and re-batten and re-slate roof; replace rotten rafters; rebuild chimney top 900mm, re-point open joints in brickwork chimney and install new lead flashings; enable maintenance of neighbouring property; take down gutter and shot blast clean, redecorate and re-fit; clean off brackets and redecorate; remove existing window and rebuild, re-putty glazing, redecorate; repair lintel over; remove existing doors and frame and re-make, repair and replace, redecorate; overhaul ironmongery and fit new if damaged or missing

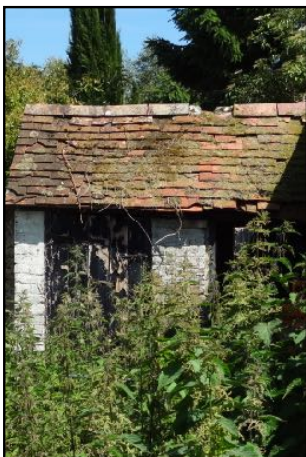
### Eastern outbuildings

Roof tiling and battens failed and slipping, broken, ridge tiles missing; no gutter or downpipe; door and frame rotting at base and decorations failed; wall decorations failed

Strip roof of tiles and battens and re-roof; install new cast-iron gutters, downpipe, gully and surface water drainage to new soakaway; remove doors and frames and repair, redecorate and re-fix; strip of paint and redecorate walls; overhaul ironmongery and fit new if damaged or missing

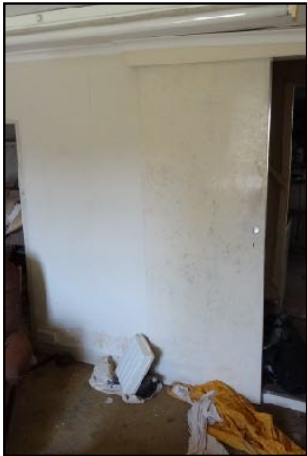
Ground floor house, northern front room, staircase and back room in outshot (pantry)

<p><b>Condition:</b> Decorations poor, staircase weak and flexible, some plaster loss in pantry but generally appears in sound condition</p>	C
<p><b>Repair Needs:</b> Patch plaster failed areas consolidation masonry with deep pointing; strip existing decorations and redecorate; strengthen stair with additional glued and screwed blocks.</p>

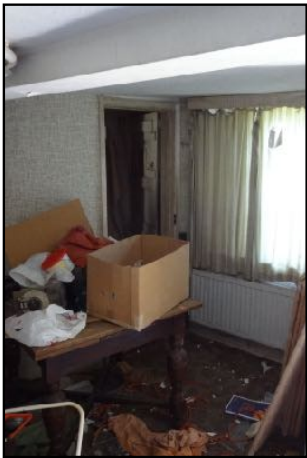
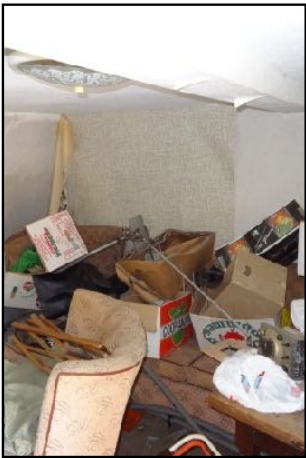
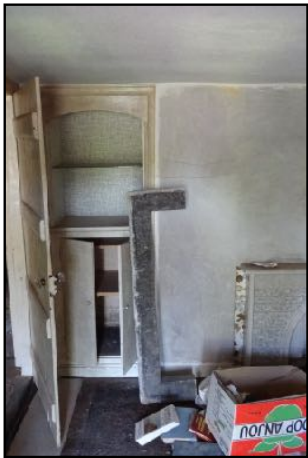
Ground floor house, middle front room

<p><b>Condition:</b> Decorations poor in middle front room; chimney breast has been re-plastered in hard plaster, cracked; ceiling boards partly collapsed in kitchen, no insulation; decorations poor, damp staining on walls; boiler falling off wall</p>	C
<p><b>Repair Needs:</b> Strip all decorations in front room; strip ceiling and walls in kitchen and reform ceiling with insulation; strip all paintwork and redecorate</p>

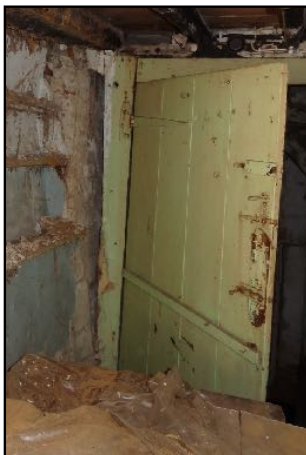
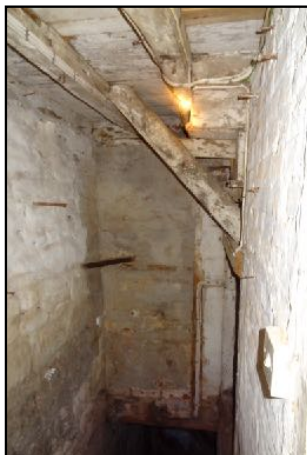
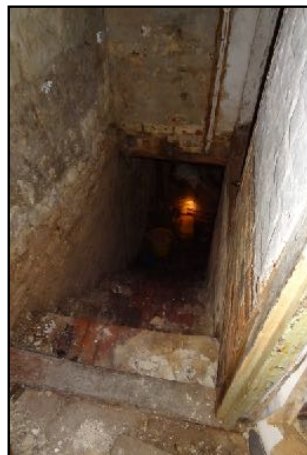
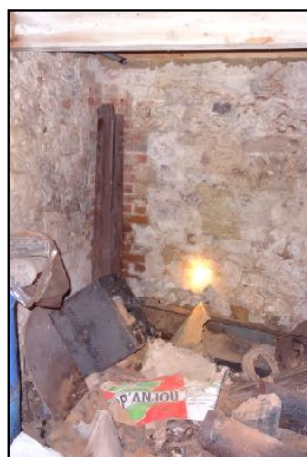
Cellar Post office, below northern half of front room

<table><tr><td><b>Condition:</b> Cellar door frame rotted at base; access steps damp and salting; cellar ceiling has been replaced but beams built into wall with no damp proof protection; cellar window bricked up and ventilation grill broken; chalk rubble walls appear sound and relatively dry; beam over cellar steps has rotten bearing to cellar wall.</td><td>C  C  A</td></tr><tr><td><b>Repair Needs:</b> Repair cellar door frame; overhaul door and</td><td></td></tr></table>		<b>Condition:</b> Cellar door frame rotted at base; access steps damp and salting; cellar ceiling has been replaced but beams built into wall with no damp proof protection; cellar window bricked up and ventilation grill broken; chalk rubble walls appear sound and relatively dry; beam over cellar steps has rotten bearing to cellar wall.	C  C  A	<b>Repair Needs:</b> Repair cellar door frame; overhaul door and	
<b>Condition:</b> Cellar door frame rotted at base; access steps damp and salting; cellar ceiling has been replaced but beams built into wall with no damp proof protection; cellar window bricked up and ventilation grill broken; chalk rubble walls appear sound and relatively dry; beam over cellar steps has rotten bearing to cellar wall.	C  C  A					
<b>Repair Needs:</b> Repair cellar door frame; overhaul door and
