Shoreham Cement Works - Area Action Plan - Evidence Base

**Preliminary Building Condition,
Safety and Demolition Assessment**

Draft Report

September 2018

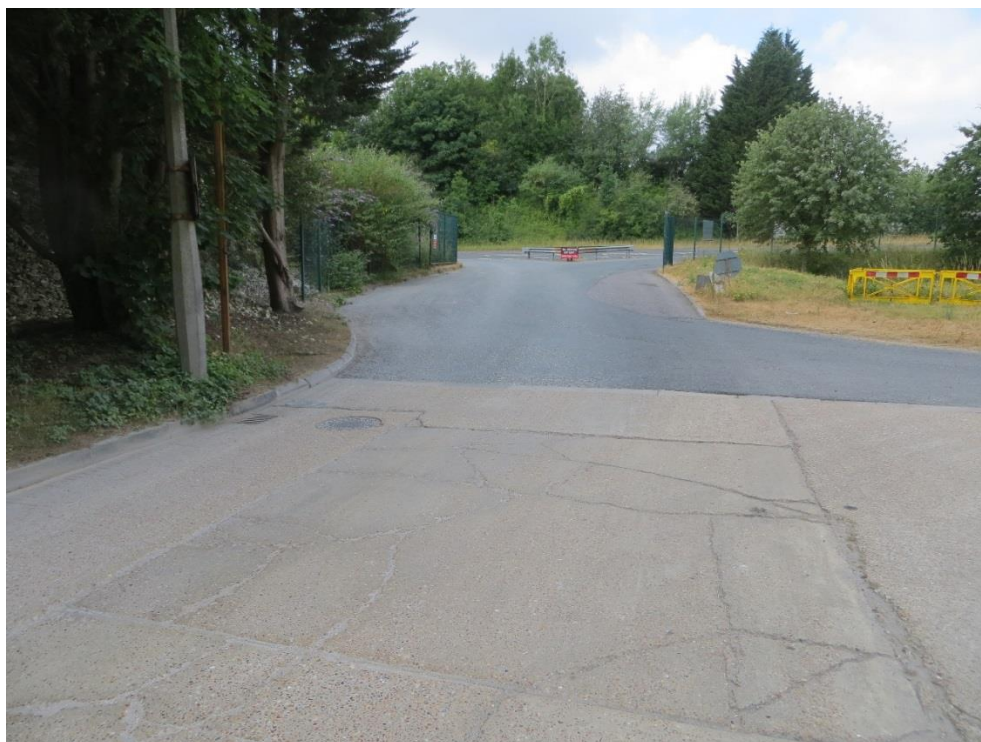
Photograph 1 - Access road entrance from A283

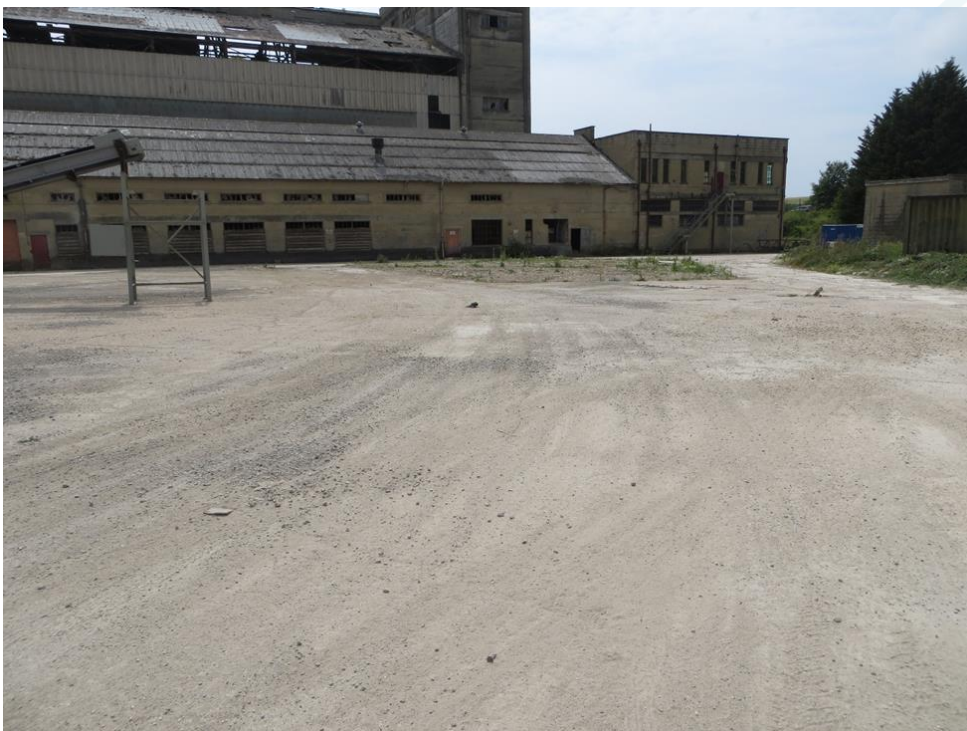
Erosion of the external blockwork wall faces was visible on the workshop and store building. In addition, some fine cracking was observed in the external blockwork walls around windows. As per 3.1.4, it was not possible to inspect the internal parts of the building.

Photograph 3 - Workshop left foreground, Offices right foreground, Kiln House background.

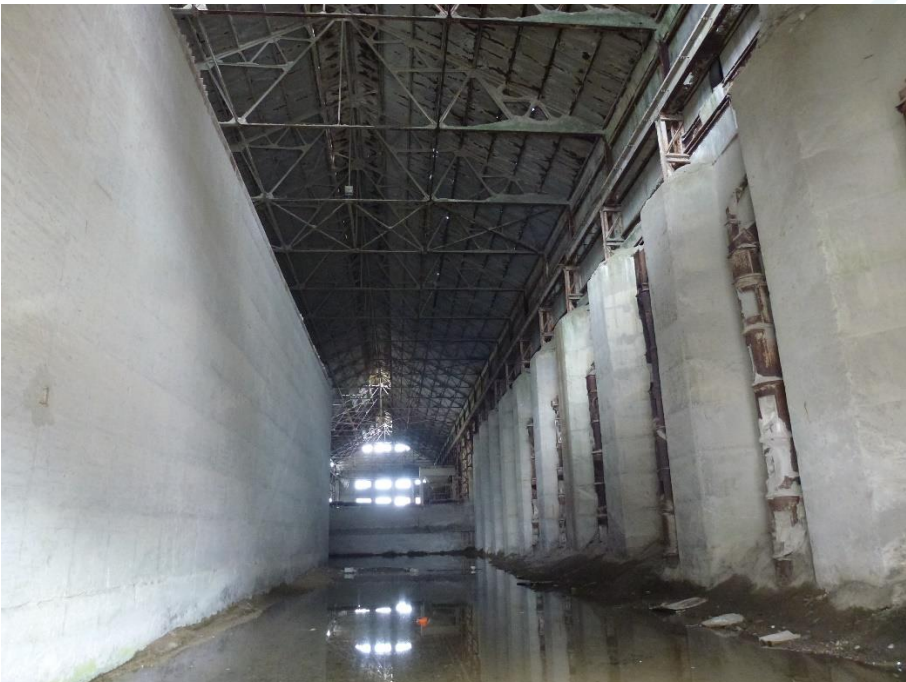
The roof sheeting, cladding and glazing to the Kiln House and Coal/Clinker Store complex have extensively failed. Large areas of standing water were observed at several locations, most notably in the Clinker Store. A continuous stream of running water was flowing from the higher levels of the Kiln House concrete structure during the duration of the inspection. It was not possible to investigate its source due to access restrictions. It is possible that large high level tanks have filled with water during wet weather and are leaking.

Photograph 18 - Clinker Store
