Surface condition report for the South Downs Way (Restricted Byway 2760) at Truleigh Hill, West Sussex.

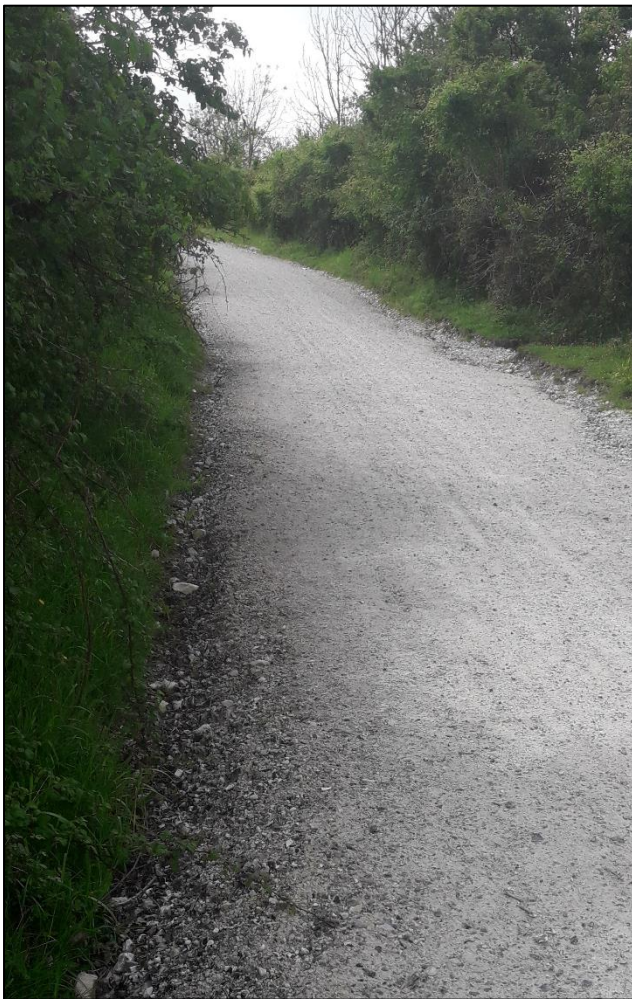
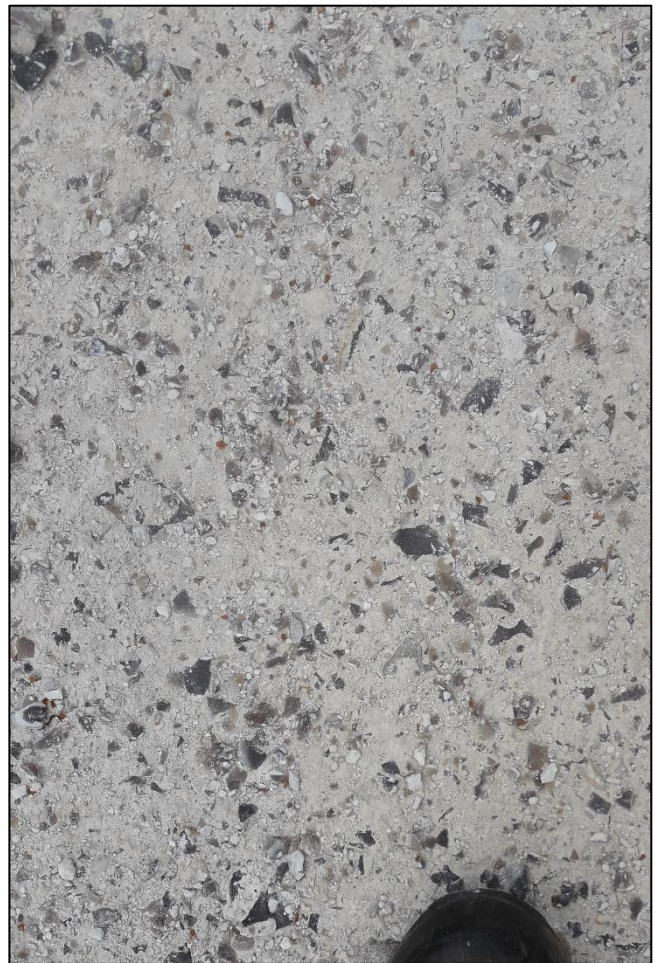
Cobbled Chalk and Flint Mix

For exposed downland locations, surface repairs should be as landscape-sensitive as possible. Using local materials that blend into the existing surroundings is preferable and retains landscape character. Cobbled chalk is a cheaper material to build up low points and the mixture of crushed and/or whole field flints in the upper profile of the surface provides grip and durability. Please see photos below.

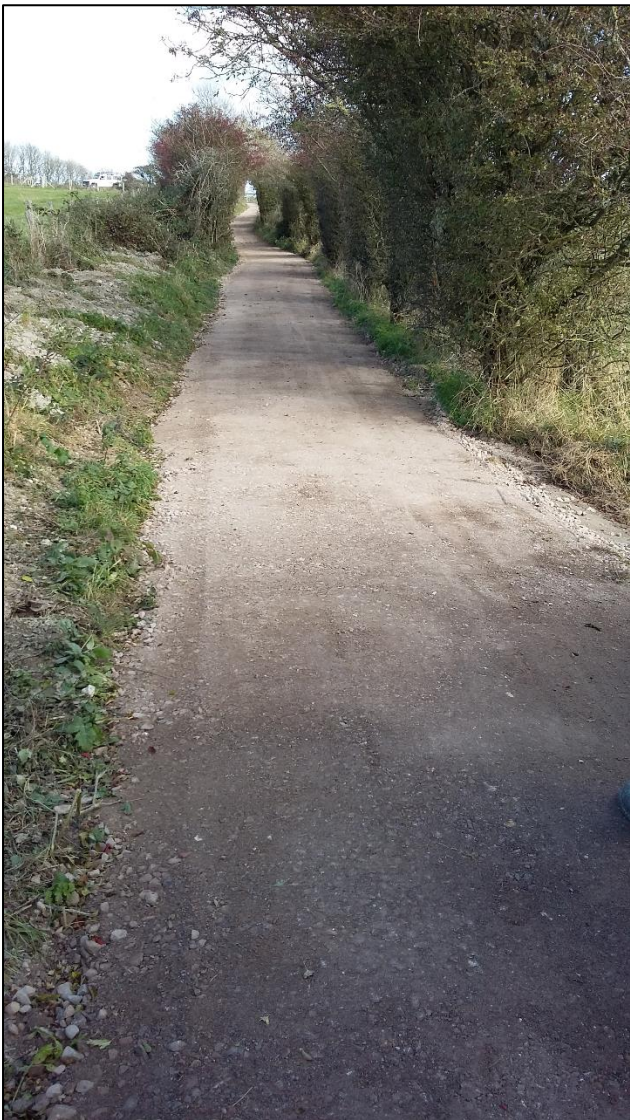
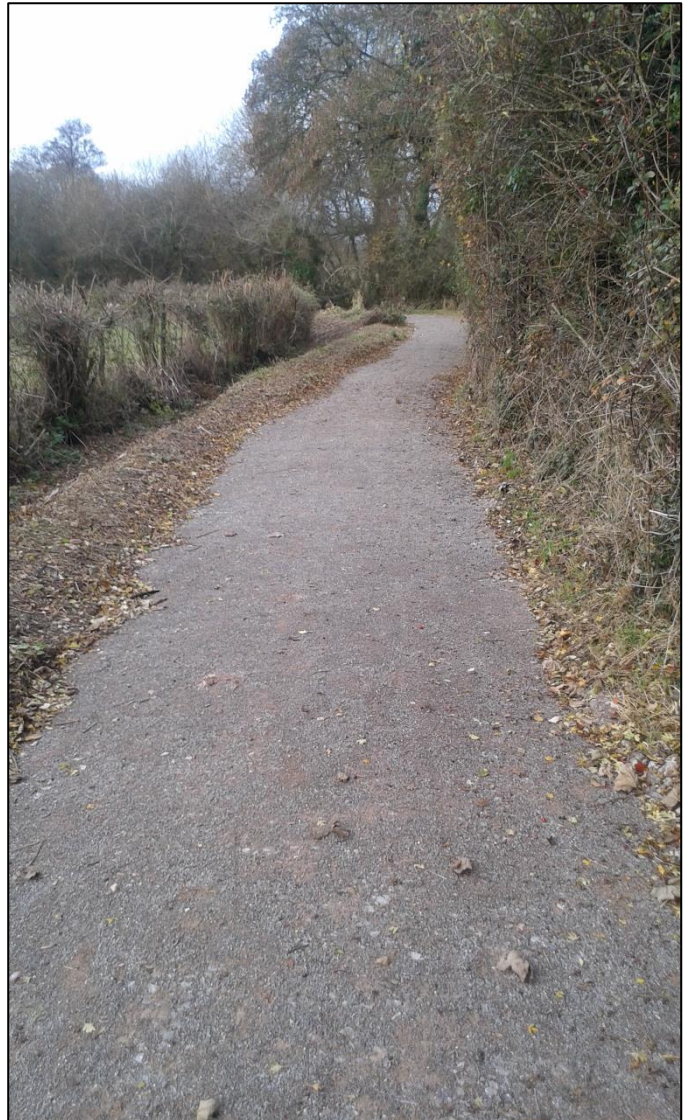
Crushed Limestone

In locations that are less sensitive and receive higher levels of traffic (public and private use), crushed limestone (Type 1 MOT) provides a suitable surface and retains a rural character. Limestone can come in many different colours, from dark grey to pink to sandy yellow, and therefore it might be worth considering what would look best at a particular location. This is dependent on the supplier and the initial colour will mellow over time. It is also worth finishing the surface with a thin layer of limestone dust to infill any small voids and to provide a smoother finish. Please see photos below of some examples of a limestone paths.

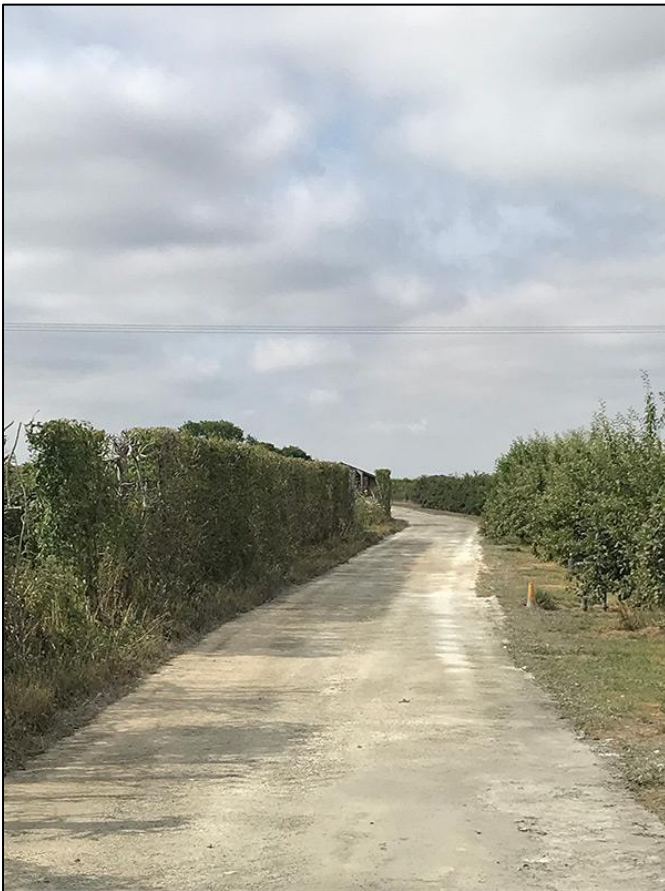
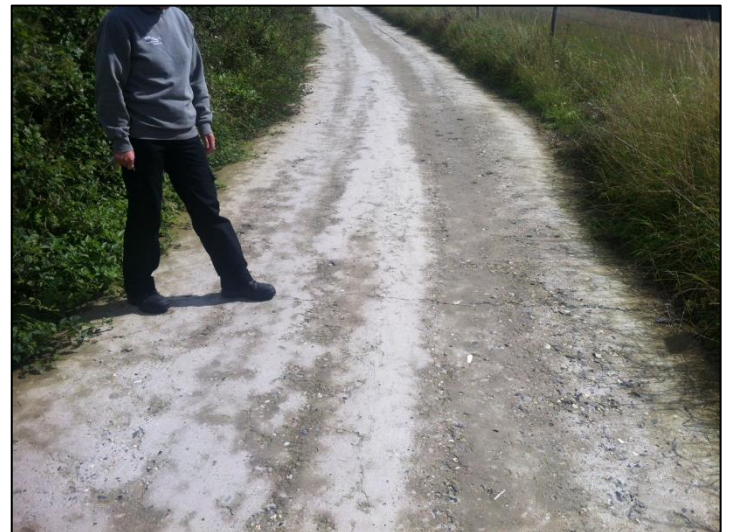
Track Stabilisation

For steep sections of path that are prone to erosion by surface water run-off and/or used by heavy machinery and vehicle use, we would suggest considering track stabilisation. Track stabilisation uses specialist machinery to rip up the existing surface and then mixes it with cement dust and water to provide a sealed surface that retains the character of a rural track. The finished surface sets like concrete making it durable and long lasting. This option is more expensive and needs to be planned, as there are not many companies that specialise in this technique. This can be the most cost-effective solution to tracks that traditionally require regular maintenance. Below are some examples of paths that have been stabilised.
