Conservation Area Character Appraisal and Management Plan

Slindon

November 2017

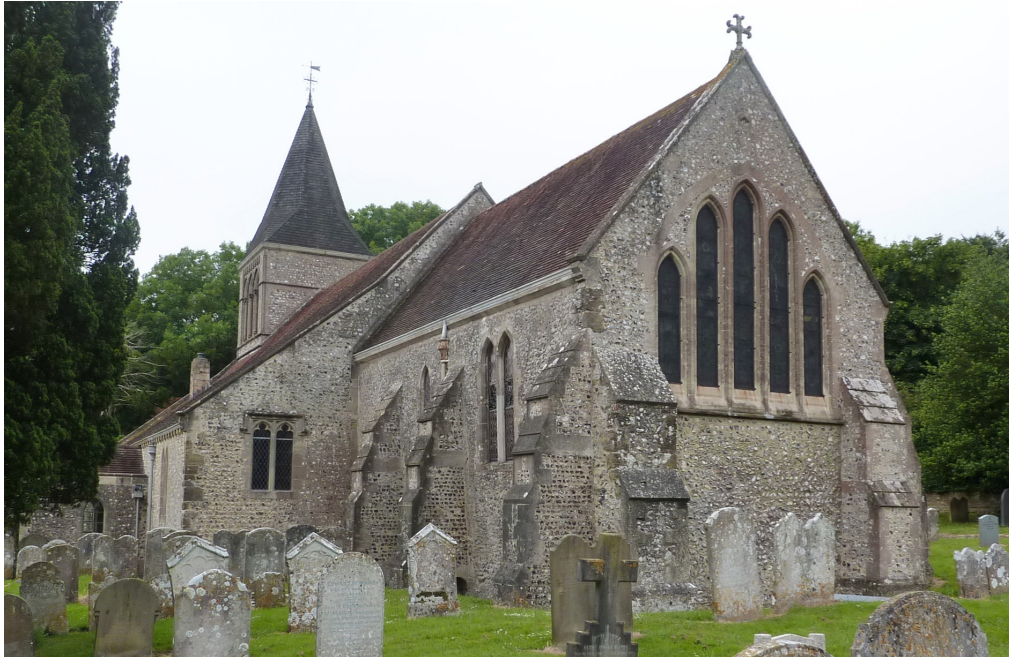
Figure 8: The Parish Church of St Mary

A medieval building comprising C13 Chancel, nave and south aisles, C15 north aisle, and north and south porches. The church was restored by Sir Thomas Jackson in 1866, when the tower was also added. Grade I listed building since 5 June 1958.

4.28 As is often the case, the Parish Church, in this instance dedicated to St Mary, is the earliest surviving building in the village (Figure 8). The church combines a 13th century nave and south aisle, a 15th century north aisle, and a tower added as part of a wider restoration in 1866. Finally a south porch was added in 1936.

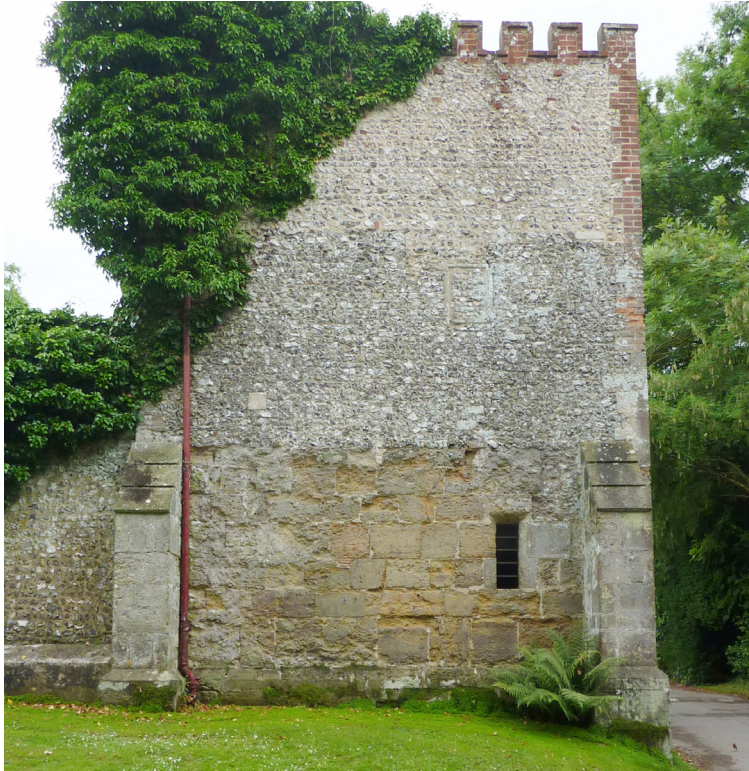
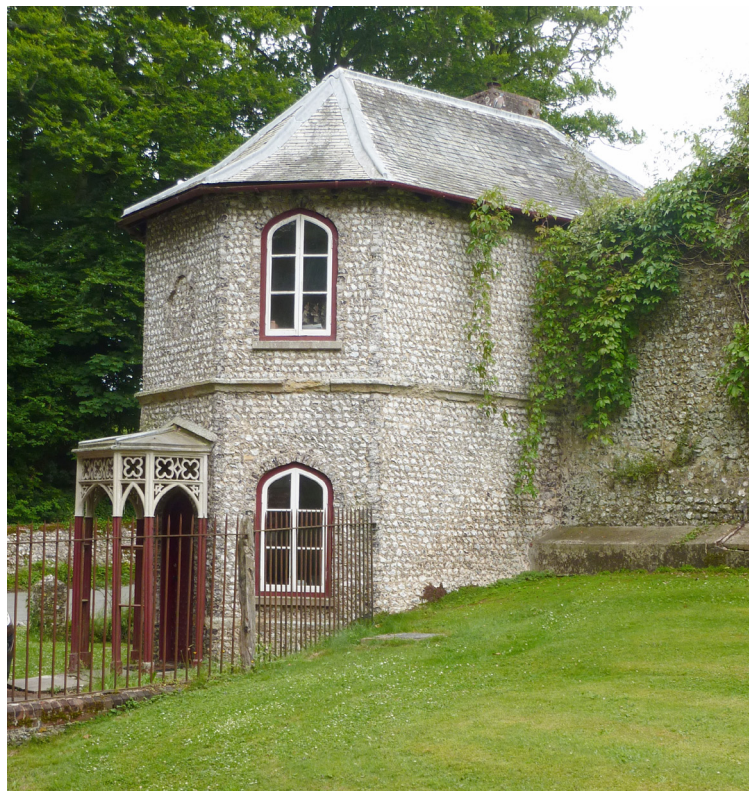
Figure 11: Slindon House.

The little obvious medieval fabric surviving can be found on the tower (above). The Lodge (below) is a Grade II listed building in its own right.

4.31 At the heart of Slindon House, however, are remnants, the exact extent of which are unclear, of the medieval palace of the archbishops of Canterbury. The most obvious surviving piece of medieval construction is the ashlar stonework forming the base of a square tower to the north-west of the house (Figure 11 top).

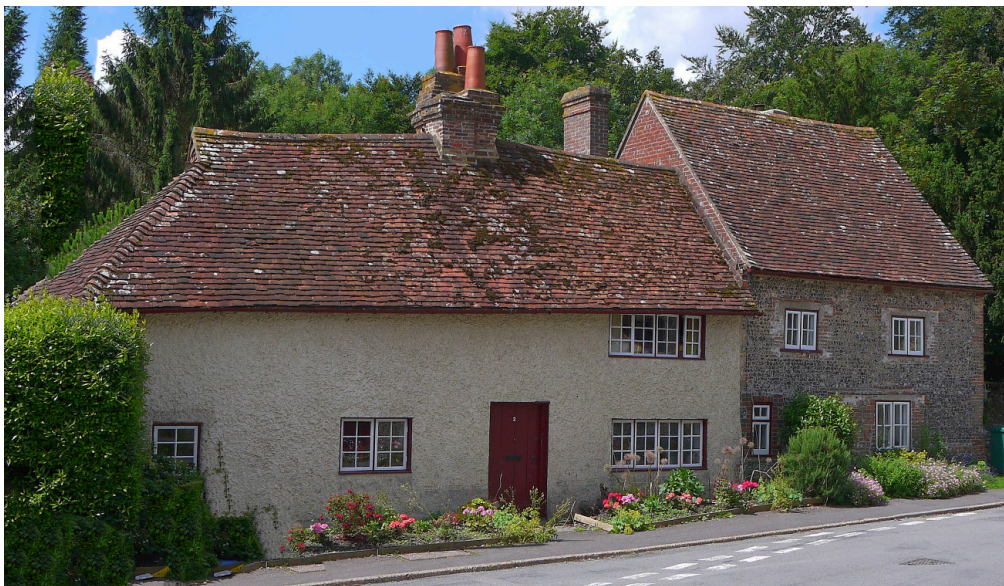
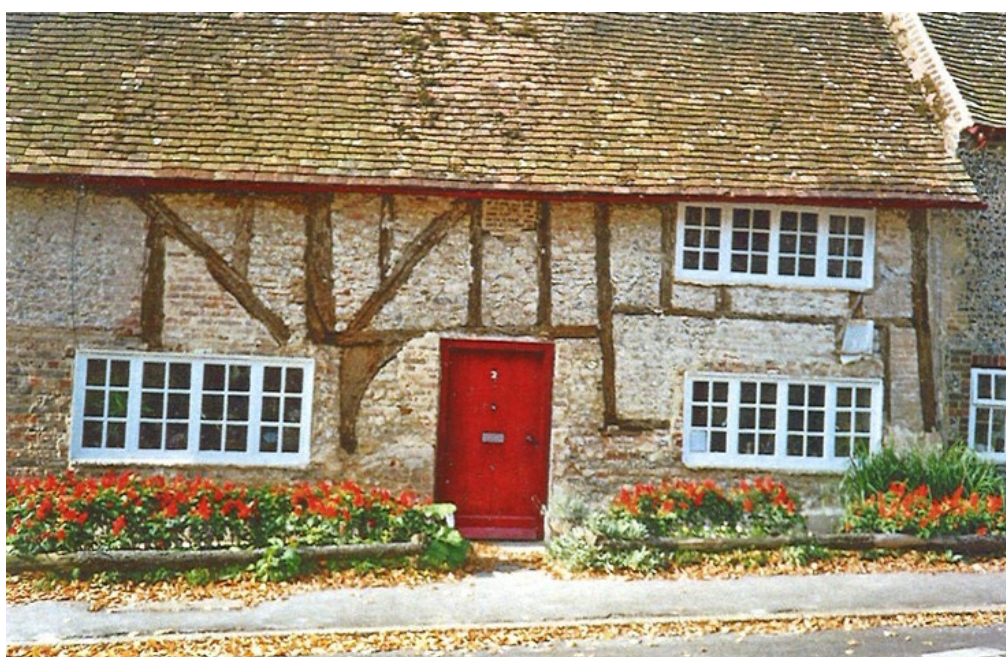
Figure 13: Nos 1 and 2 Church Hill

The jack rafters to No. 1 suggest an early date and this was confirmed when removal of the render revealed a timber frame. The building was subsequently re-rendered and the frame is no longer visible from the outside.

4.36 1 and 2 Church Hill is one such structure. Number 1 is a modest flint building with brick dressings and quoins, and a steeply pitched clay tile roof. Attached to, but separate, Number 2 is faced with a rough render but the replacement of this some years ago temporarily exposed a timber-frame and this, along with the jack rafters on the east end suggest a pre 17th century or earlier date (Figure 13). Its survival does pose the question of how many other timber-frames may survive encased in later work.

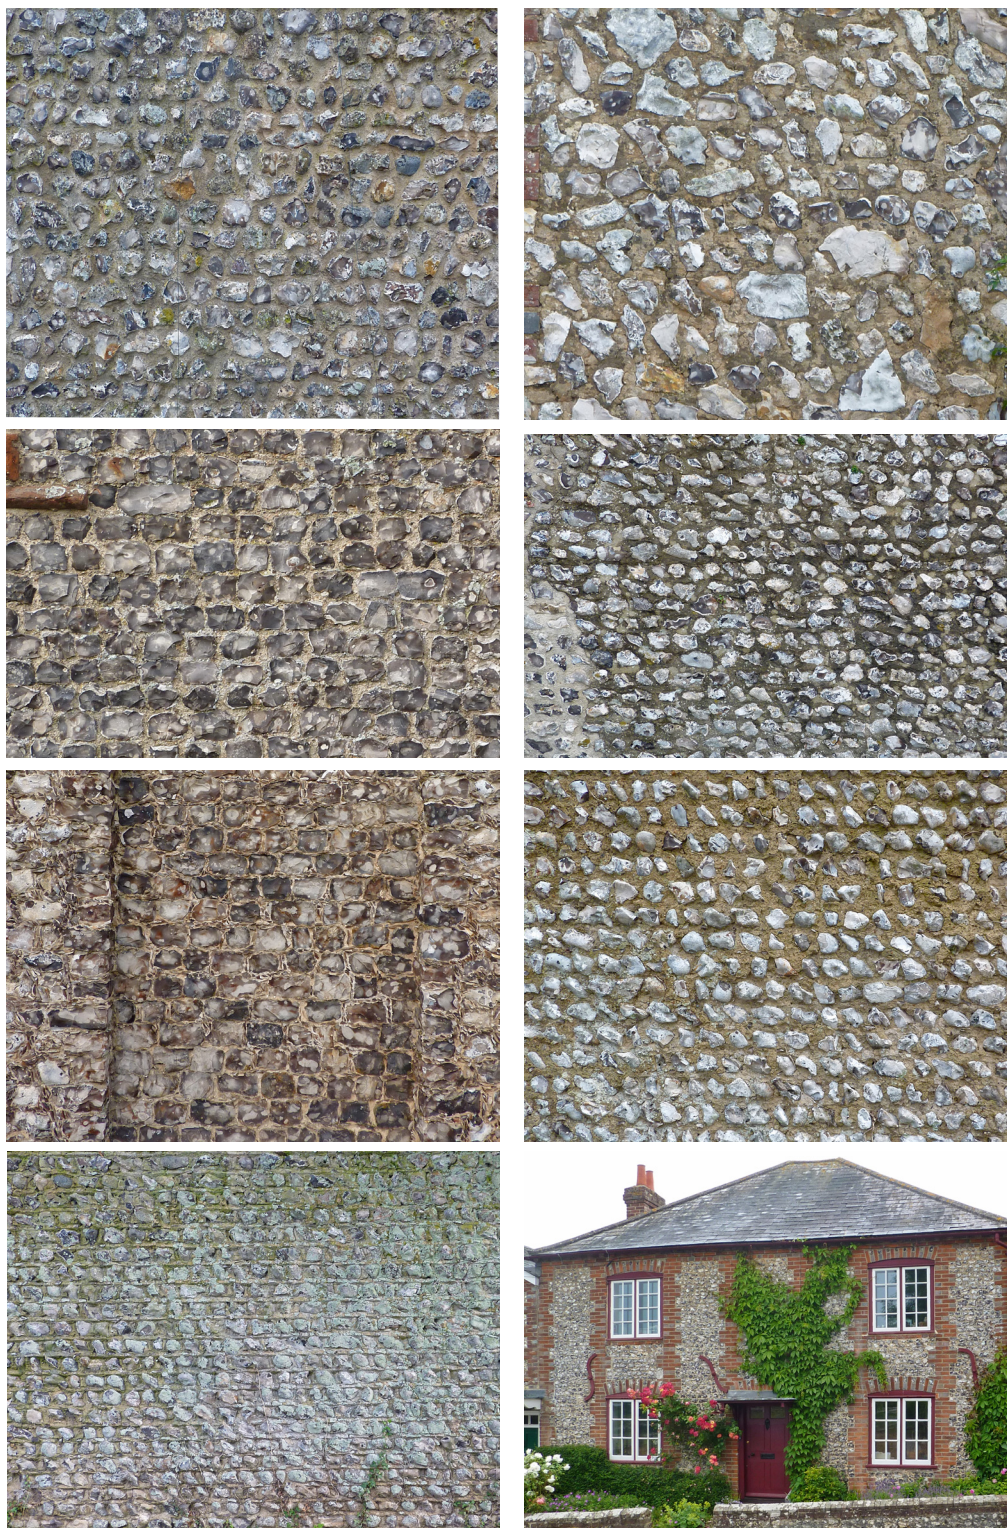
Figure 14: The appearance of the flintwork varies throughout the village; the panels above show some of this variety, which ranges from fairly rustic through to quite fine and includes some examples of galleting. The irregular nature of most flint requires the use of an alternative material to form corners. In Slindon this is almost invariably brick and it is often used in a distinctive fashion in which the brickwork jambs of the ground floor and first floor windows/ doors are continuous.

4.39 Flint is used within the village in a variety of forms, ranging from fairly rustic through to quite fine. In some cases galleting, the placing of small shards of flint into the mortar between the larger flints, can also be seen (Figure 14)

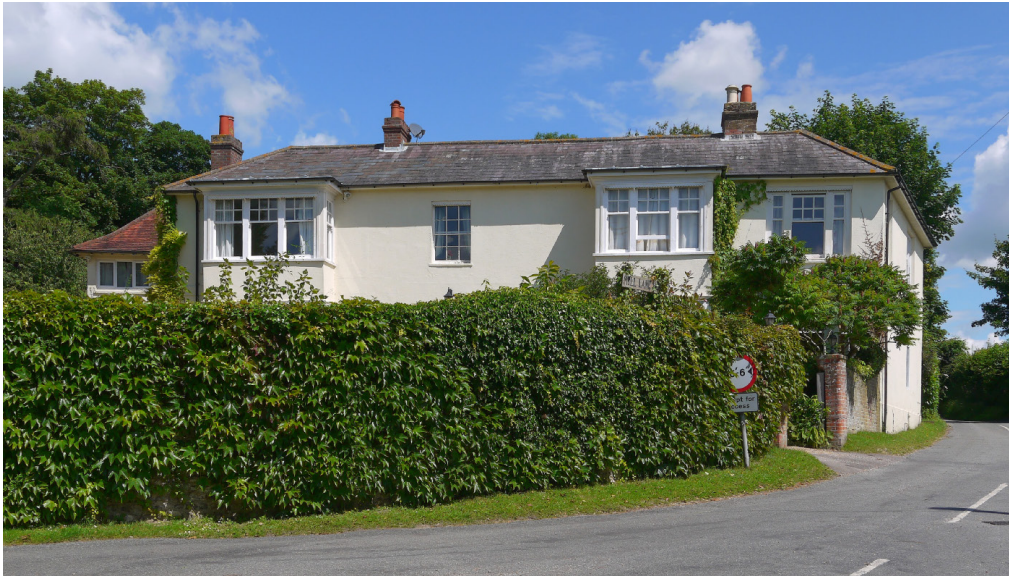
Figure 15: Mill Lane House, Top Road (above) and The Grange, Church Hill (below).

Both dwellings are examples of originally modest buildings being aggrandised in the 19th or early 20th centuries. This process shows up in other cases with brick re-frontsings and/or painting of the main elevation in a white or off-white colour.

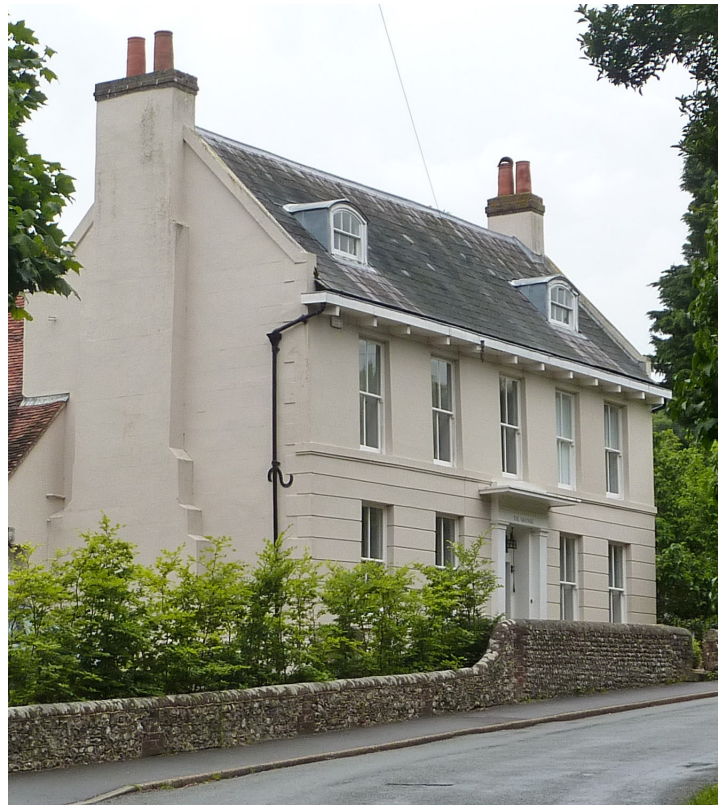
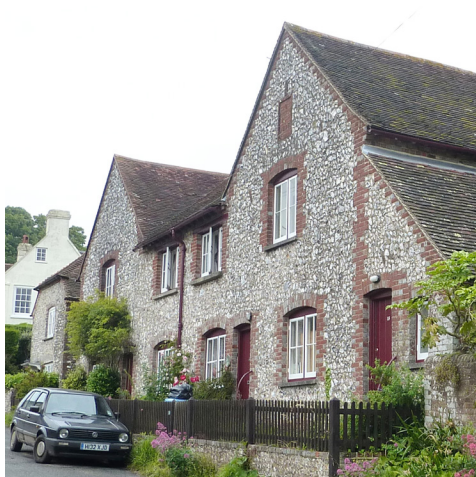
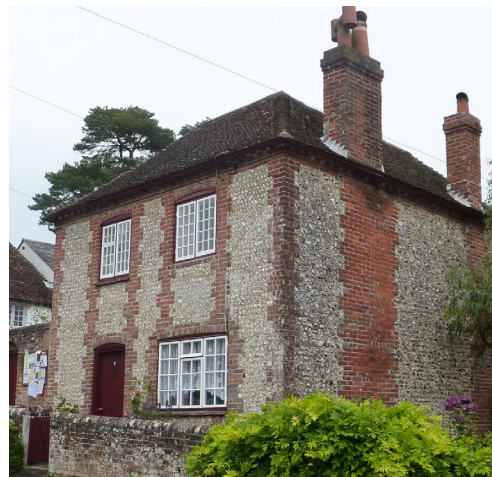
Figure 16: Church Hill

Typical Slindon Estate buildings, of flint with brick dressings and, for the most part, plain tile roofs, can be found at the top end of Church Hill, close to the junction with Top Road.

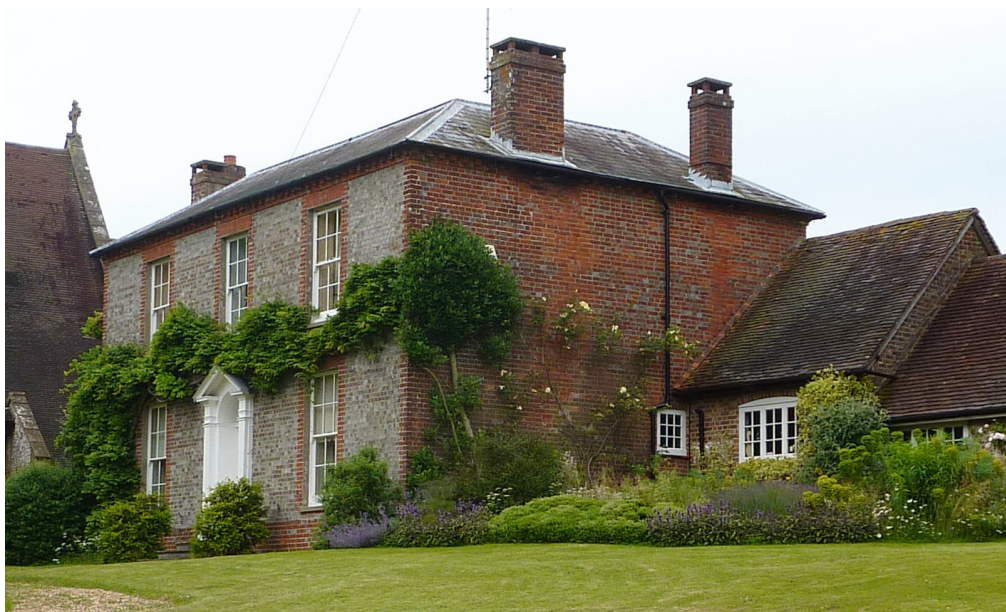
Figure 19:Top Road has a more mixed range of buildings, including large buildings.

St Richard's House, the former Presbytery, (above) is a 19th century brick building, combining grey headers with red brick dressings in an way found throughout Sussex & Hampshire, and neo-classical detailing. The Dower House (below) is also 19th century. In this example, squared knapped flints are combined with red brick dressings. Slate is used on the roofs of both houses.

4.47 Top Road contains a number of larger dwellings, including St Richard's House (the former Presbytery) and the Dower House, both early 19th century and Grade II listed. The former is the one example in Slindon of a construction style found throughout Sussex and Hampshire which combines grey bricks laid in header bond with red bricks used for the dressings (both Figure 19).

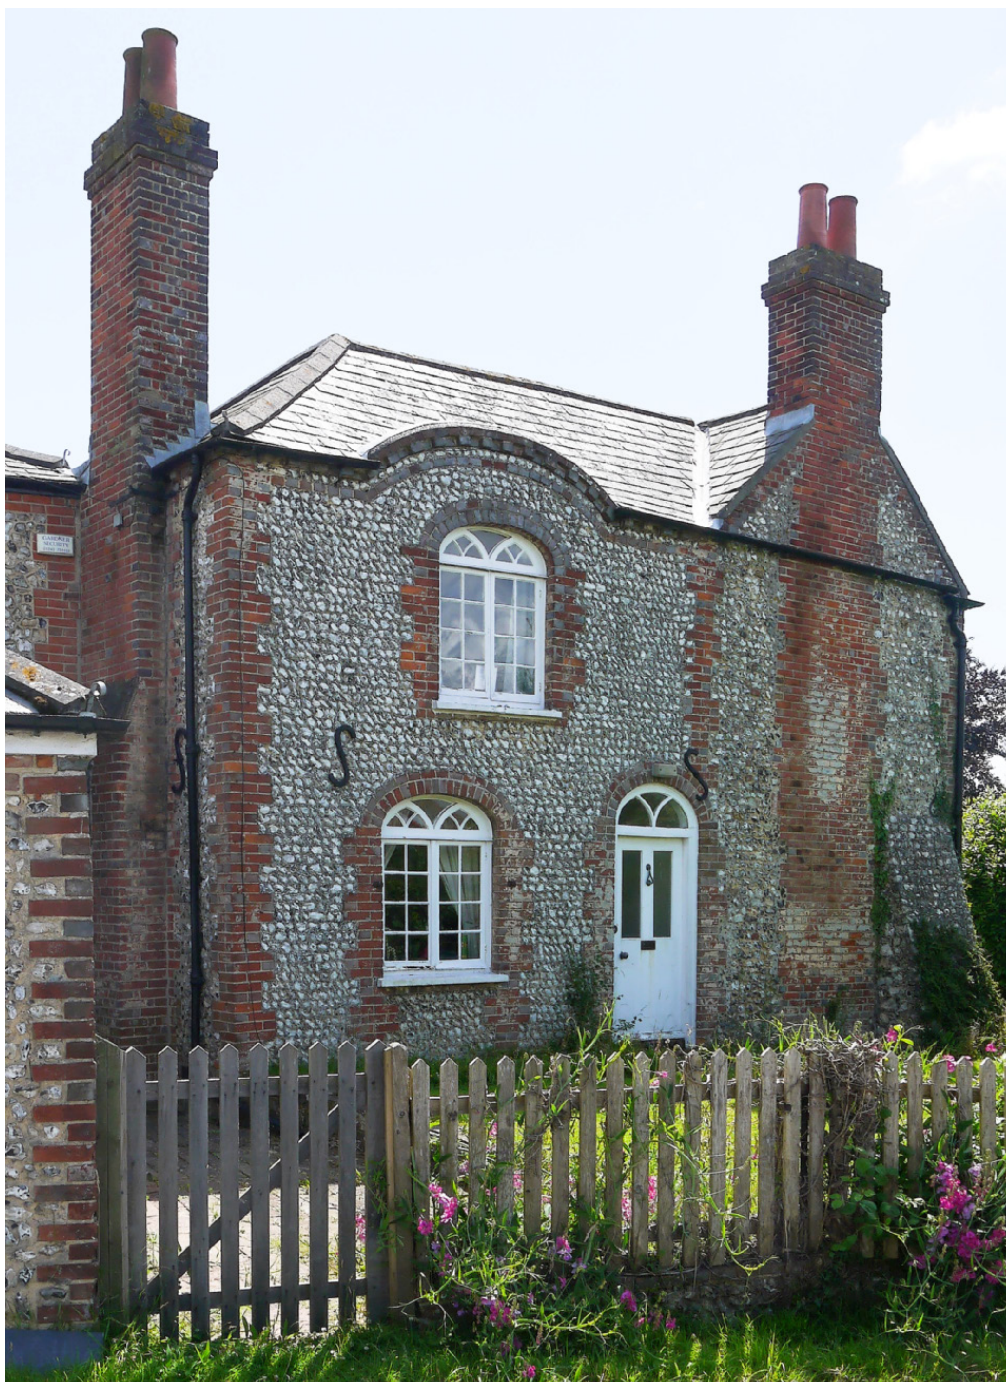
Figure 22: Elm Cottage on School Hill

Elm Cottage is an attractive two storey dwelling, faced with flints set in galletting (small flakes of flint set into the mortar between the larger flints) and with red brick dressings, quoins and modillion eaves cornice. Each front has a non-central small curved pediment. The west front has two windows with segmental heads and Gothic panes and a doorway with a similar fanlight. The list description describes it as early 19th century, although Jospehine Duggan Rees suggests that it has late 17th century origins.

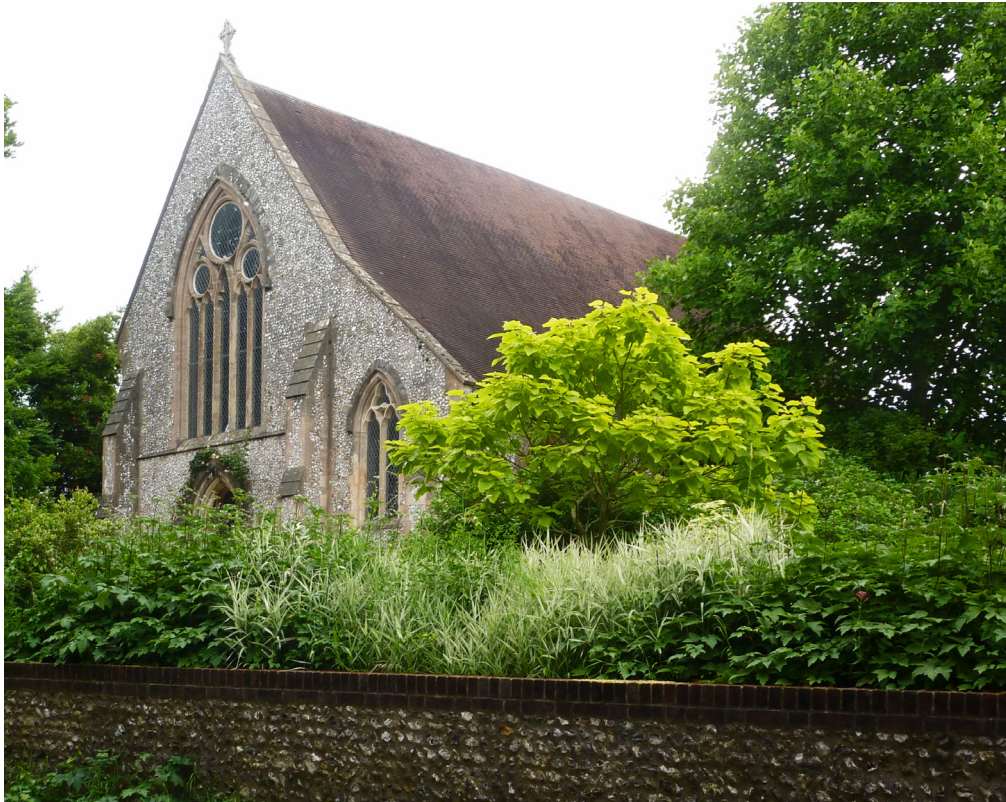
Figure 26: St Richard's Roman Catholic Church

Slindon is unusual in having a Roman Catholic Church in addition to the Anglican Parish Church. St Richard's, was built in 1865, in a Gothic style to the design of C A Buckler and endowed by the Countess of Newburgh. It is constructed of stone rubble with ashlar dressing and a slate roof. and has a four bay nave, lower two bay chancel, south aisle and north porch. Traceried windows with leaded lights are divided by buttresses.

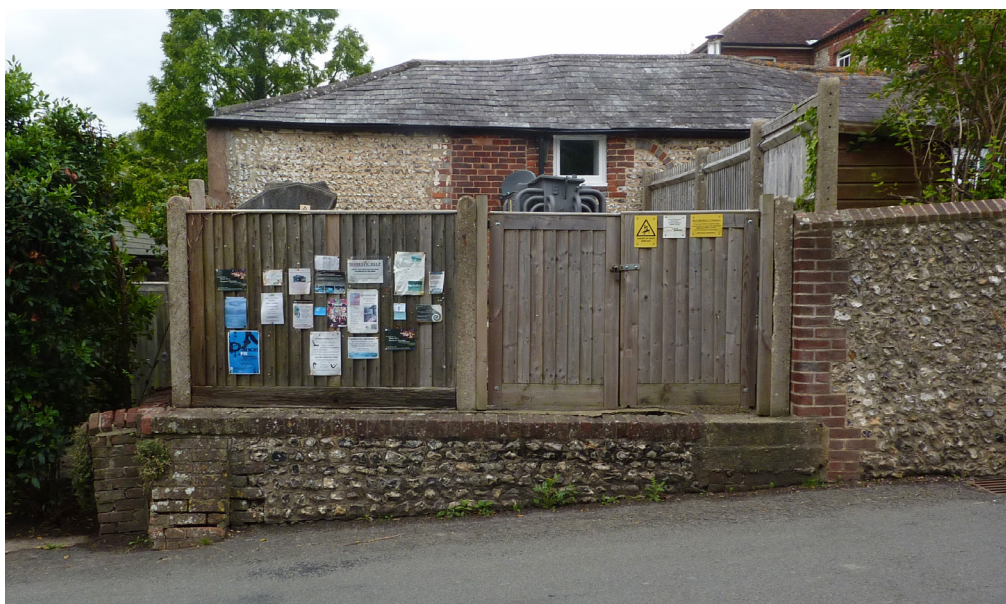
Figure 29: Replacement of the close-boarded fence by a flint or brick wall would be a small but significant improvement to the Conservation Area.

5.4 One improvement to the village (and Parish as a whole), however, would be the undergrounding of the overhead wires, which would improve both the Conservation Area and the setting of a number of historic buildings. A second, more minor, improvement would be to replace the timber close-boarded fence enclosing the sub-station on School Hill with something more attractive (Figure 29).

6.19 A significant and worthwhile improvement to Slindon would be the undergrounding of the overhead cables through the conservation area whilst another, more minor, improvement would be replacement of the timber close-boarded fence enclosing the sub-station on School Hill with something more attractive.

ACTION 6 – that the National Park Authority supports, in principle and in association with other partners, the enhancement of the Conservation Area by (1) the undergrounding of wires and removal of redundant poles, and (2) the replacement of the existing close-boarded timber fence at the electricity sub station with a more suitable boundary.
