## Case Study

# White Lion Dew Pond

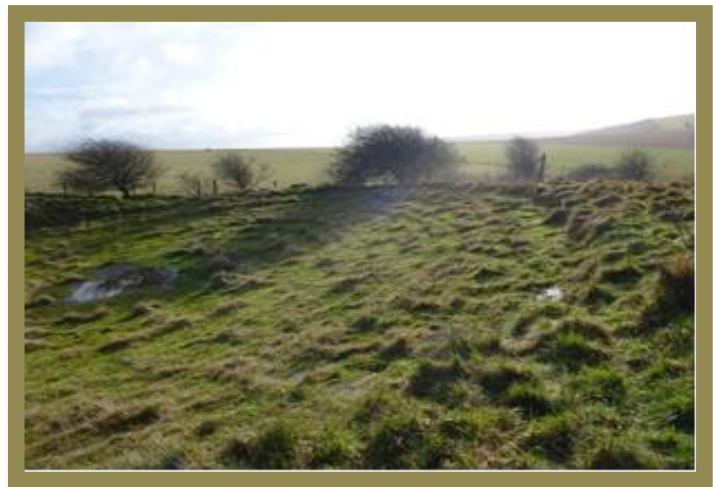
As part of our NIA project local Ranger, Jan Knowlson was researching areas to improve chalk grassland. Whilst looking at areas of access land that needed scrub clearance work on Beddingham Hill, Jan followed up a reference to a pond that was marked on the OS Map. The path to it was very overgrown and the pond itself hadn't held water for a long time. It was an old concrete pond that must have cracked a long time ago, grass and trees were growing on the surface.

The next task is to work out how to repair the concrete without poisoning the water and with something that will not crack again in the near future. Concrete can be sprayed over concrete but this will potentially end up with a cracked pond again. A sealant that expands and contracts with the varying water levels and temperature was the preferred option. The volunteers worked very hard, spending 2 days clearing the channels to the pond and another day clearing the pond itself. Once the concrete was cleared we used an angle grinder to clear out the cracks and apply the sealant. The sealant is quite expensive, so we applied 2 tins to start with and waited for rain in a few days time.

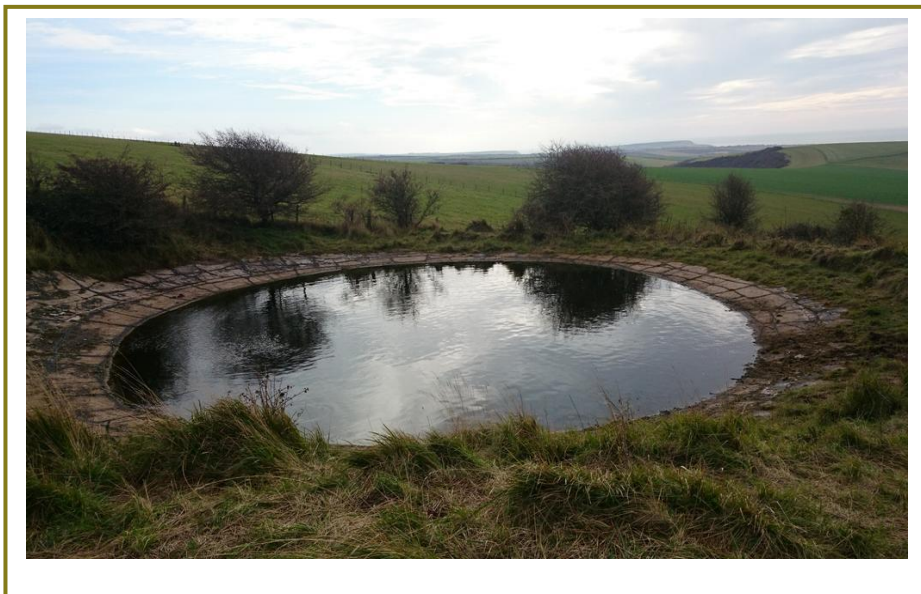
It was a pleasant surprise to find that the pond was brimming with water!

As you can see from the photo below, the pond is now a fantastic feature in the landscape and will hopefully become a valuable resource for the wildlife. The cattle and sheep belonging to the farmer will now be able to use it as well.

Jan had never repaired a concrete pond before so wasn't sure the sealant option would work, as it was applied to seal the cracks it looked too runny to be effective. Returning to the pond around a month later, after considerable rainfall, the hope was that the section of the pond we had repaired would be holding water at least.

So after spending £200 and about 3 days of volunteer work, we had repaired a pond for a very small percentage of the original estimated cost.
