Conservation Area Character Appraisal and Management Plan

Clayton

September 2018

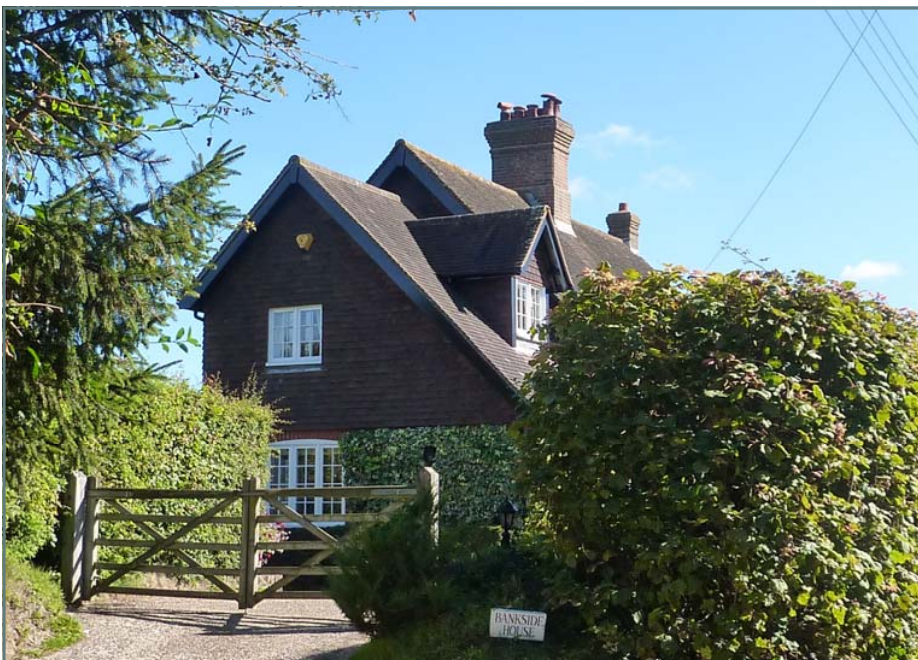
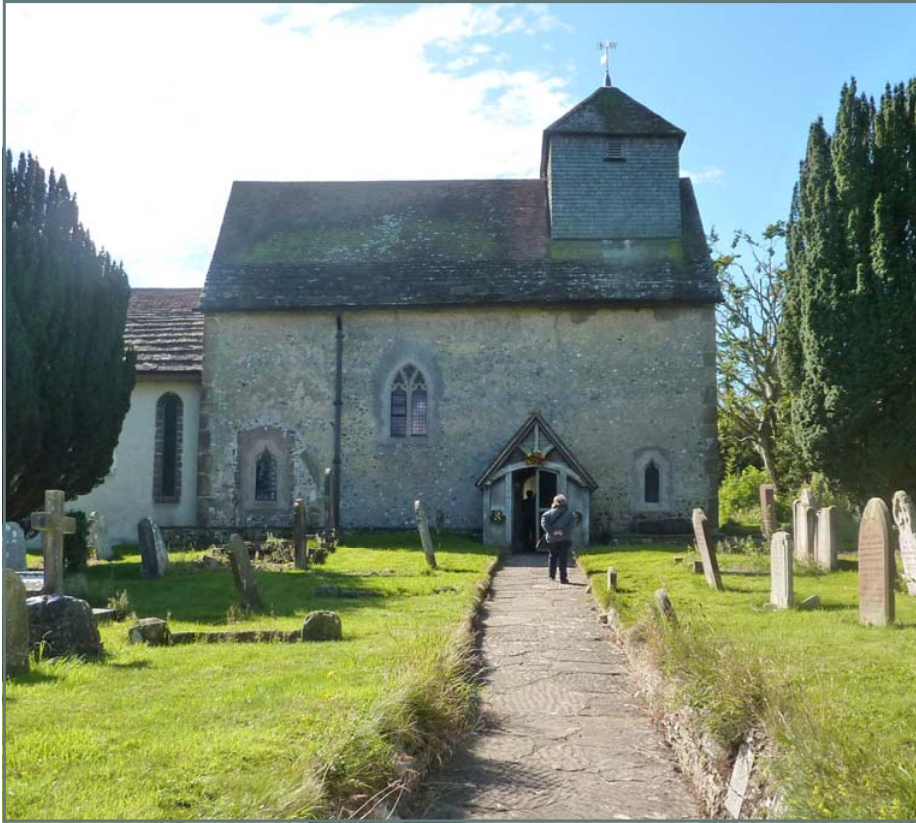
Figure 6: The Parish Church of St John the Baptist, a Grade I listed building of 11th century origin. North elevation (above) and south elevation (below). Note the mixed palette of building materials, including flint, Horsham stone slates, clay tiles, and wooden shingles.

4.13 When first seen, the Church of St John the Baptist is apparently a modest building, with nave, chancel, and bell turret. However, it is by far the earliest building in the village and the most important, which is reflected in its Grade I listing (Figure 6).

4.14 The origins of the surviving building are in the 11th century, with the nave built of coursed flints with sandstone quoins at the corners. Following recent renovation of exterior plaster, it was clarified that the north and south walls of the chancel belong to the same period. Originally there were chapels on either side of the nave at its east end. Nikolaus Pevsner speculated that these were both *porticus*, a type of side chapel entered from the nave and of Anglo Saxon origin.

4.15 Despite its modest size the church demonstrates an interesting selection of building materials. Flint and stone for the walls, albeit now largely covered in accretions of lime wash and render, Horsham stone and clay tiles for the roofs, and timber shingles for the bell tower.

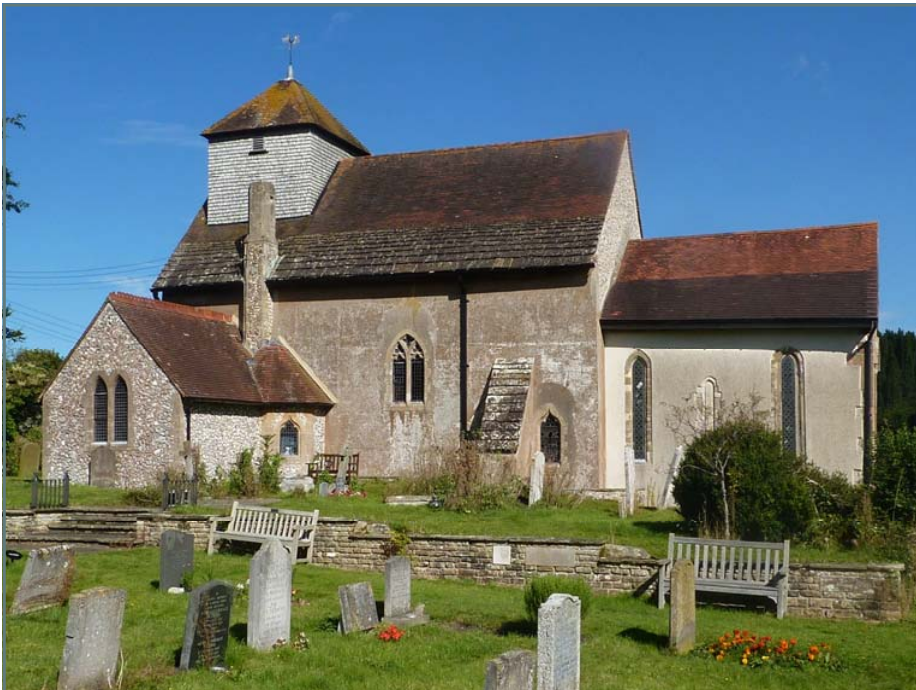
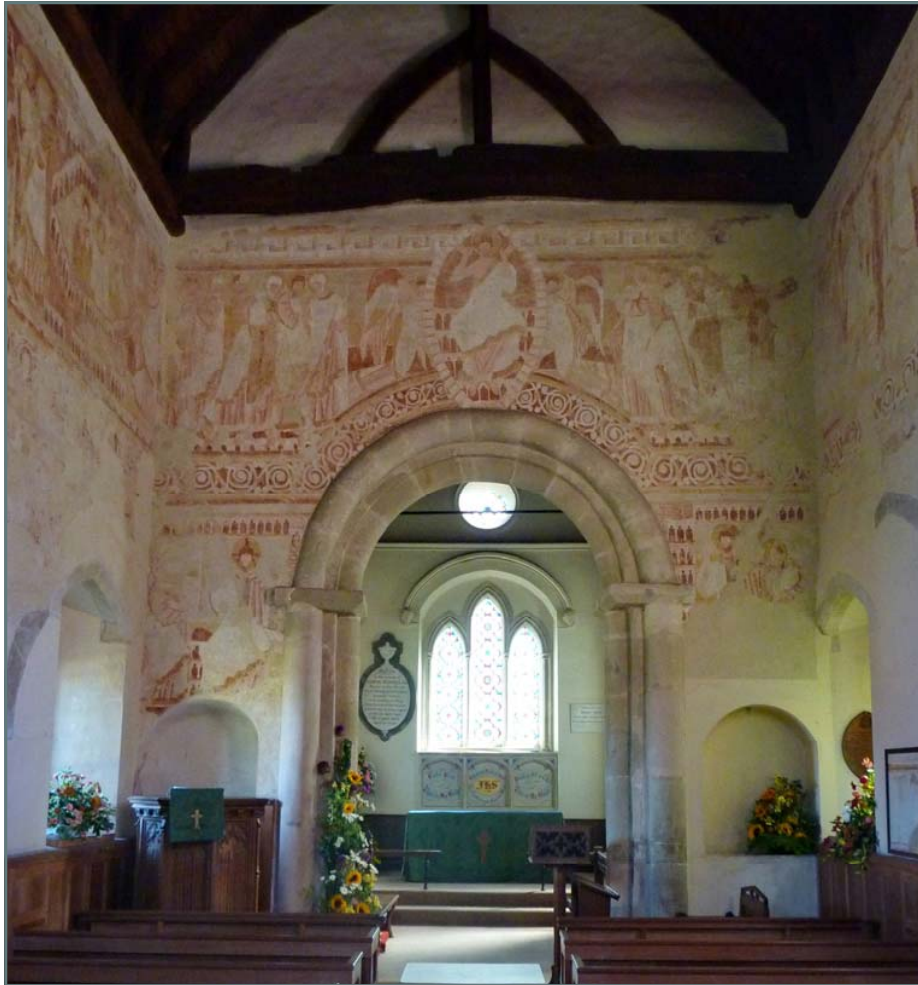
Figure 7: The Church contains a fine set of mediaeval wall paintings, belonging to a group with those in the churches at Hardham and Coombes. Christ in an almond-shaped glory (above), which inspired Graham Sutherland for his tapestry at Coventry Cathedral, and Heavenly Jerusalem, with three figures with haloes inside (below).

4.16 It is, though, the wall paintings inside the church that are particularly exciting (Figure 7). Only rediscovered during a restoration in 1893, the date of

the paintings is uncertain. However, they were painted directly onto wet plaster and no evidence of earlier plaster was found during restoration, which would suggest that they are contemporary with the building of the church in the 11th century. The influence of the medieval artists lives on, for the artist Graham Sutherland took inspiration from the figure of Christ above the chancel arch in producing his Christ in Glory tapestry for Coventry Cathedral.

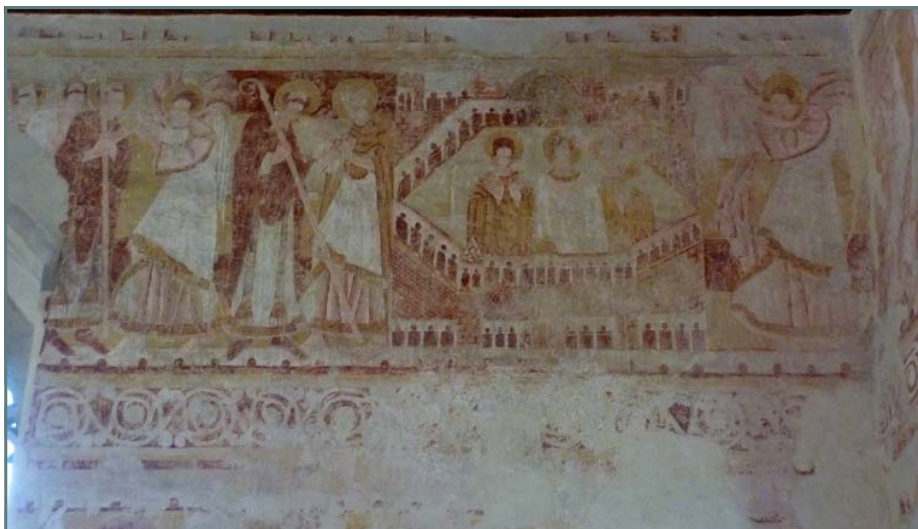
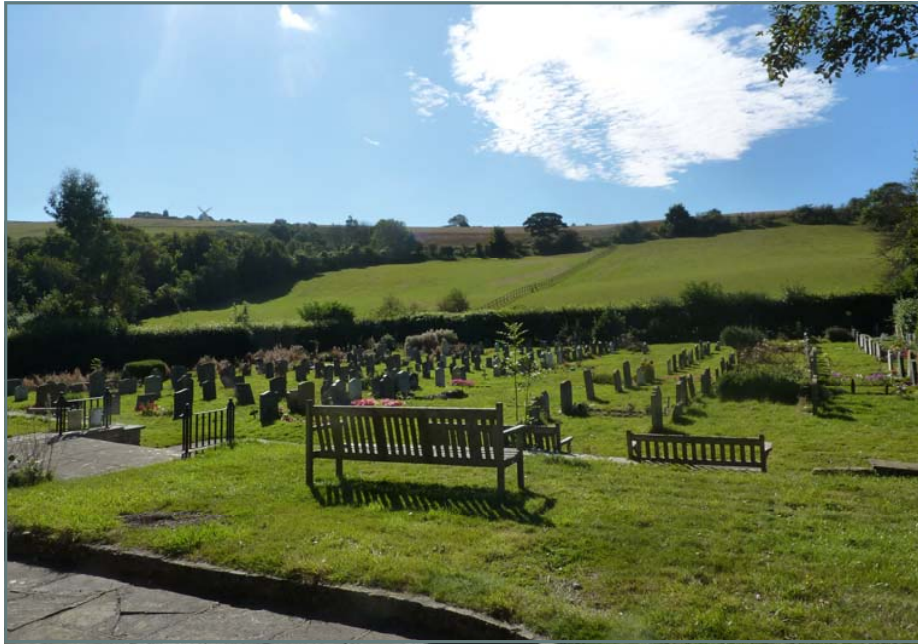
Figure 8: The churchyard to the south of the Church provides a good view of the Downs (above). The Lychgate, built in 1921 as a War Memorial (below).

4.17 At the entrance to the churchyard is the lychgate, built in 1921 as an impressive War Memorial to the men of Clayton who died in the First World and subsequent wars (Figure 8). The path from gate to church is paved with stone from the Horsham area which preserves the rippling of the sea on sand created when it was a beach (Front cover, right).

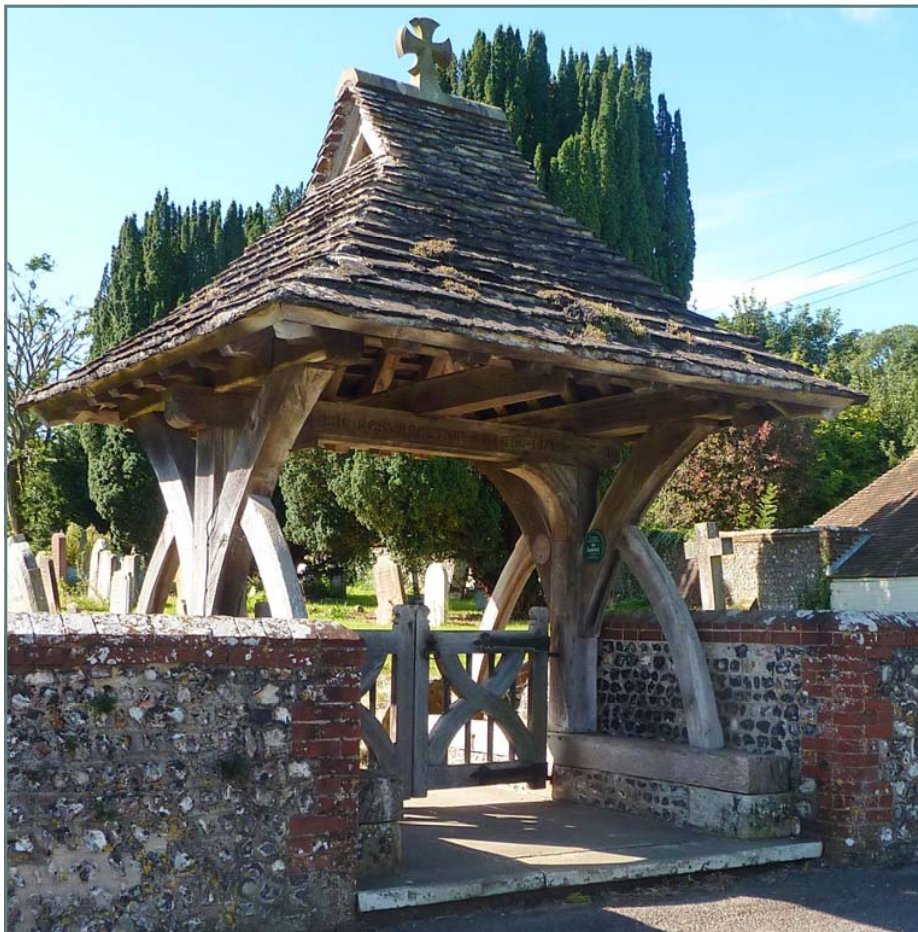
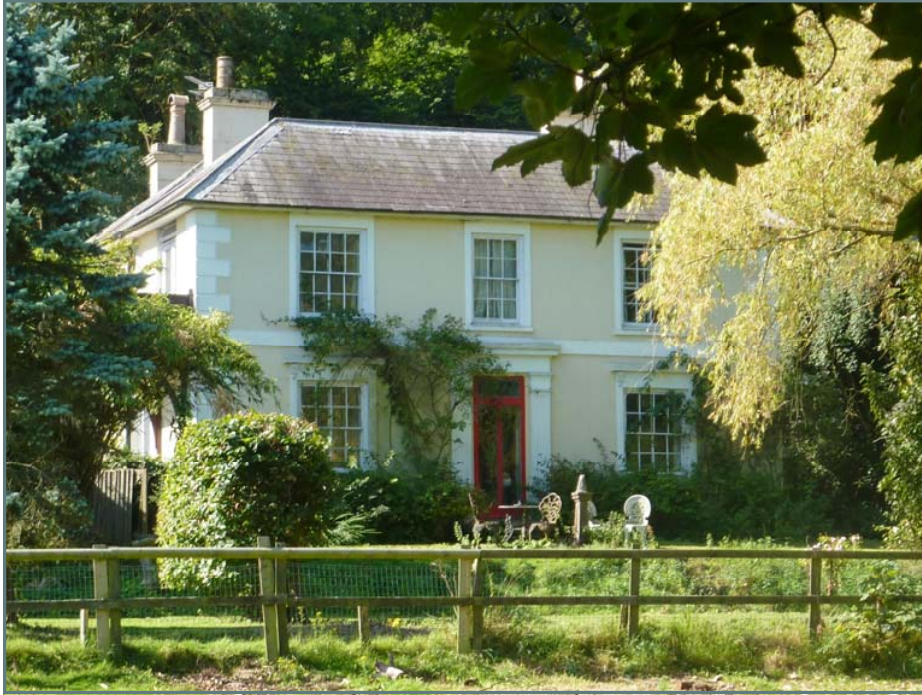
Figure 9: Grade II listed buildings at the west end of the village. Southdown Lodge (above) and Hillside (below) are both early 19th century in date.

4.18 Close to the church are Southdown Lodge and Hillside, both Grade II listed (Figure 9). The former is an early 19th century, stuccoed building with slate roof; the latter built of brick, which has subsequently been painted on the front elevation, with a tiled roof and tiled end gable. Millbrook is the other substantial house in this group. It combines a blue brick front elevation with rendered side walls and a slate roof. The prominent double height bow windows appear to be an addition. Neither it nor the village hall opposite the church are listed buildings but both can be said to make a positive contribution to the character of the Conservation Area.

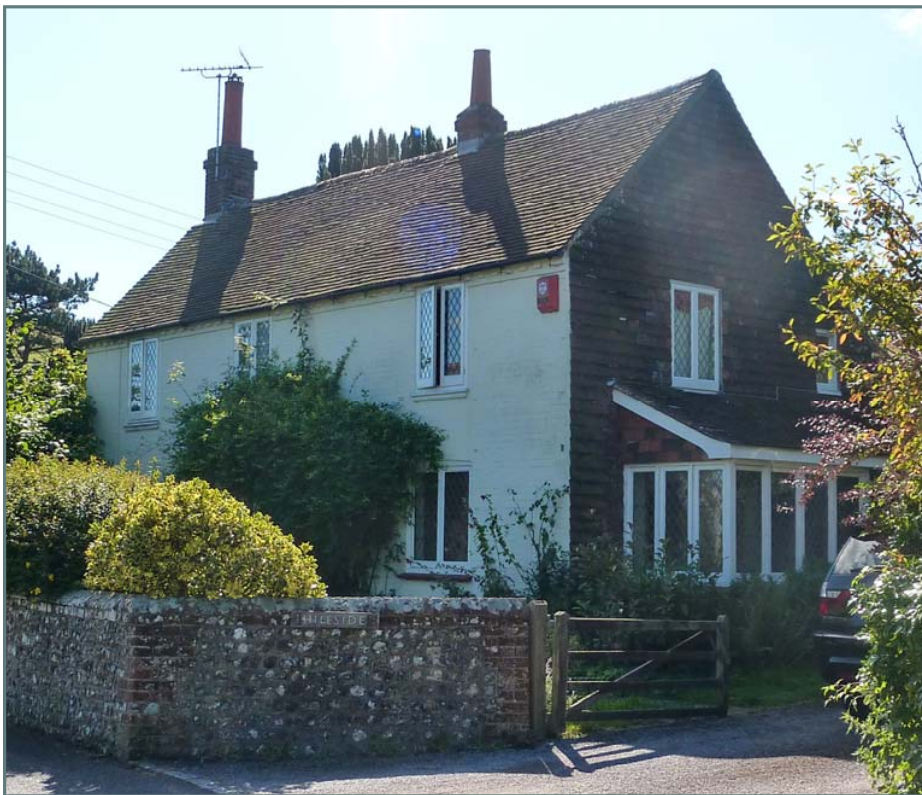
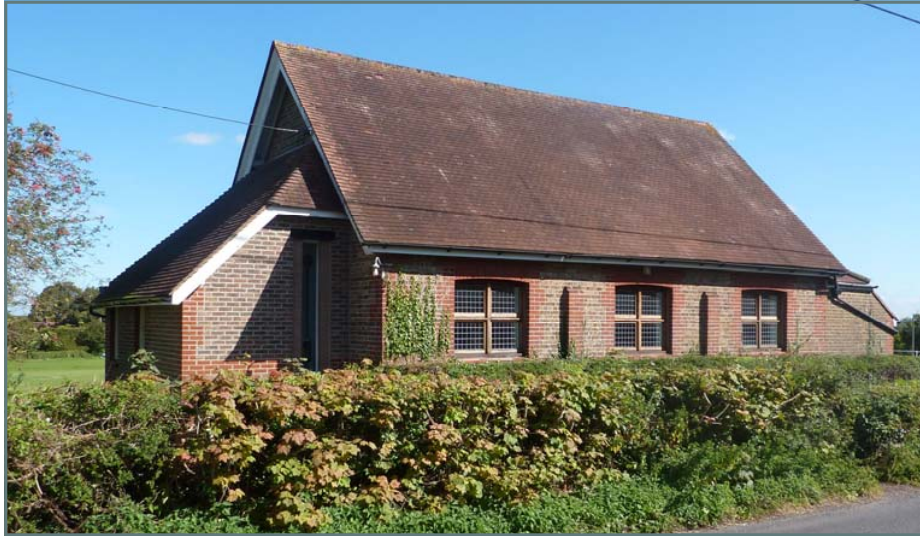
Figure 10: Unlisted buildings at the west end of the village which make a positive contribution to the Conservation Area. The Village Hall (above) and Millbrook (below).

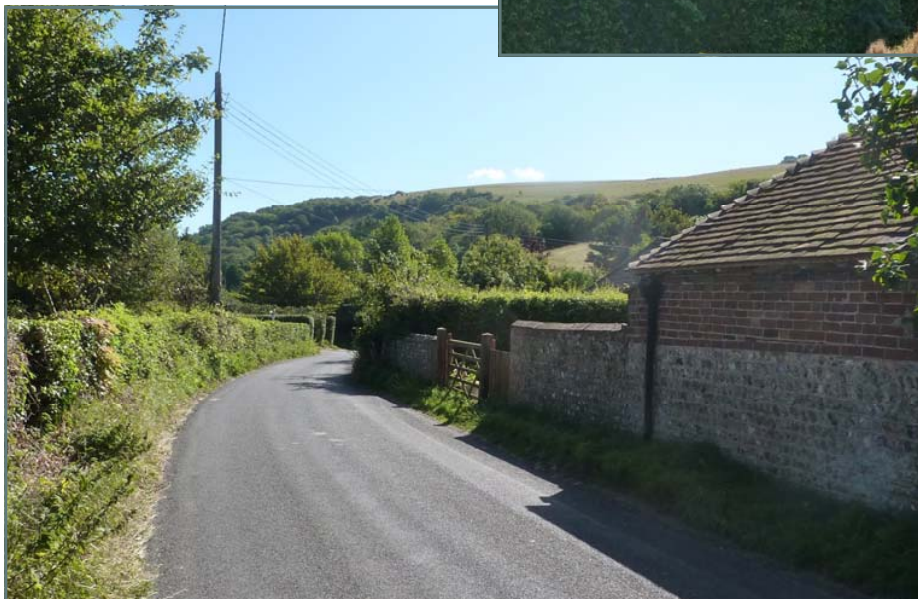
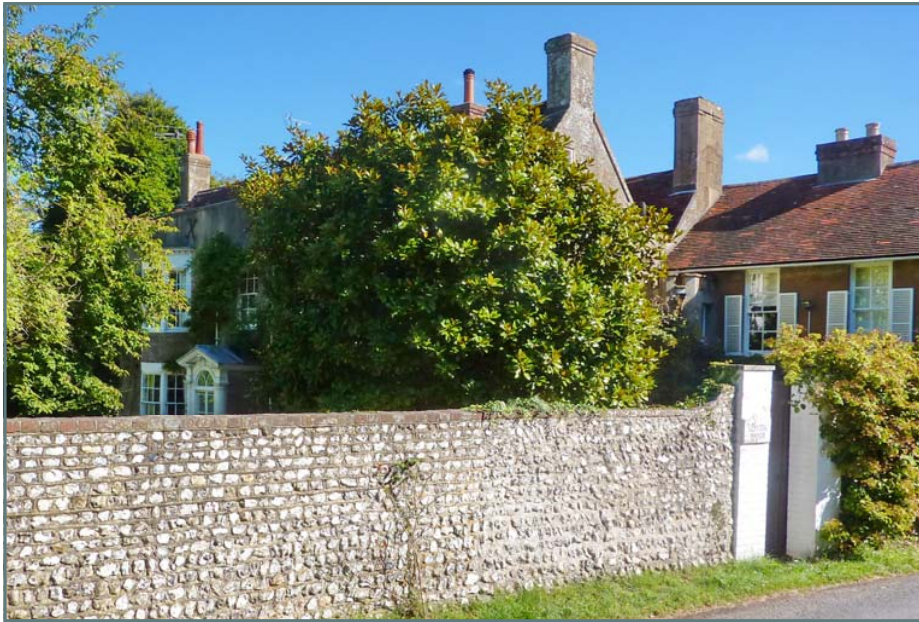
Figure 12: The Manor House, formerly known as the Parsonage, is late 18th century in origin, with 19th century extensions. The flint boundary wall is a particularly important element in the character of the Conservation Area and would be protected by the listing of the house as a curtilage structure.

4.21 There are two main historic buildings in the eastern part of the village. The Manor House, which was formerly the Parsonage, sits perpendicular to the lane and behind a good flint wall and substantial greenery (Figure 12). As a result, it is only seen in partial and glimpsed views from the lane. Nevertheless, it is a Grade II listed building first built in the late 18th century and extended from its south east corner in the 19th century; this later extension is rather more visible than the original 18th century part.

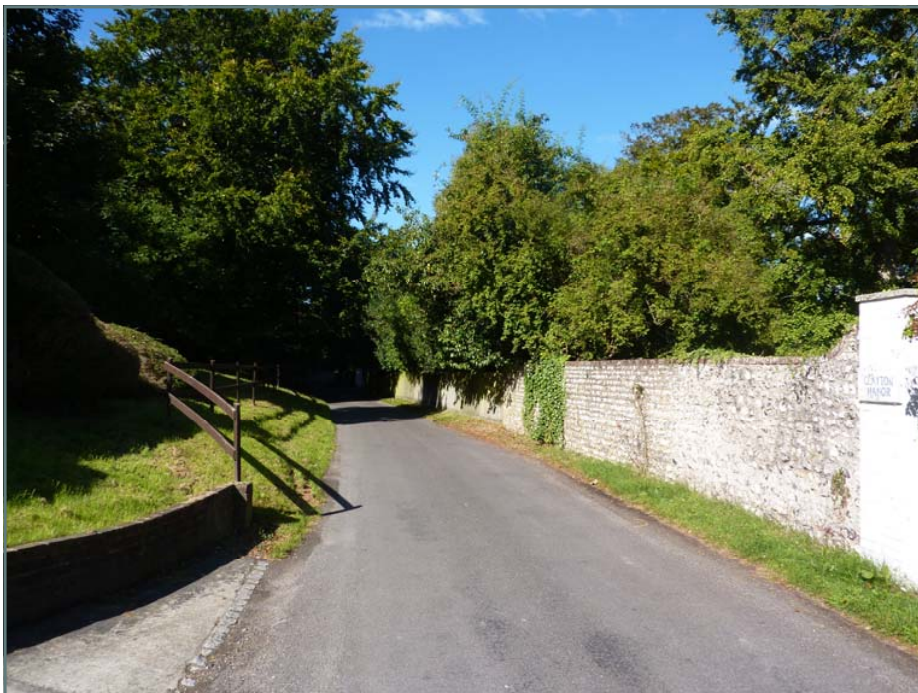
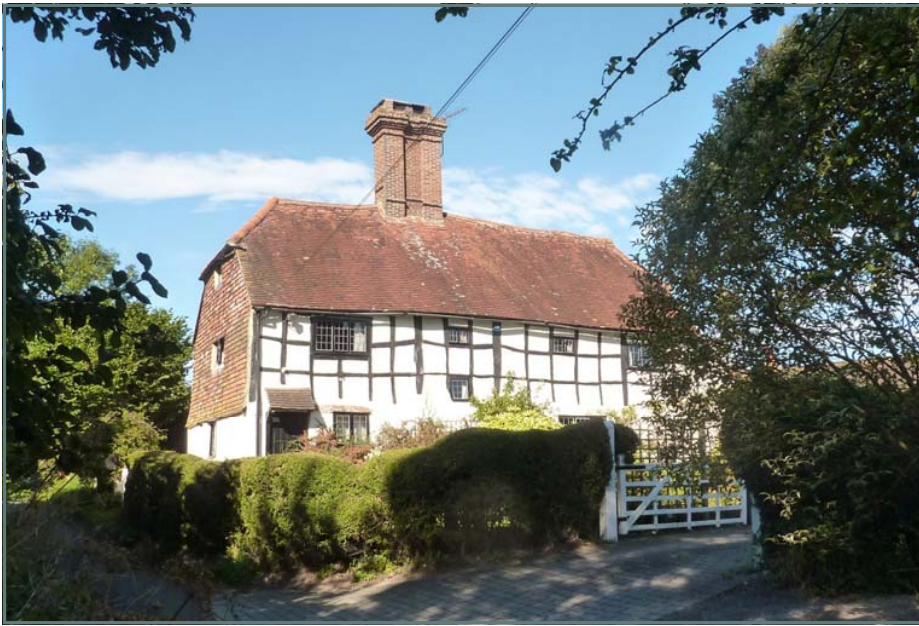
Figure 13: Clayton Castle is a timber-framed building of 17th century or earlier origins. The timber frames remains visible on the east elevation (above) but has been covered by tile hanging and brickwork on the west elevation. It was formerly a pub.

4.22 Clayton Castle is the final listed building (Grade II) and is a fine mix of timber-framed construction with some brick rebuilding and tile hanging. The roof is also tiled and there is a splendid chimney stack. (Figure 13)

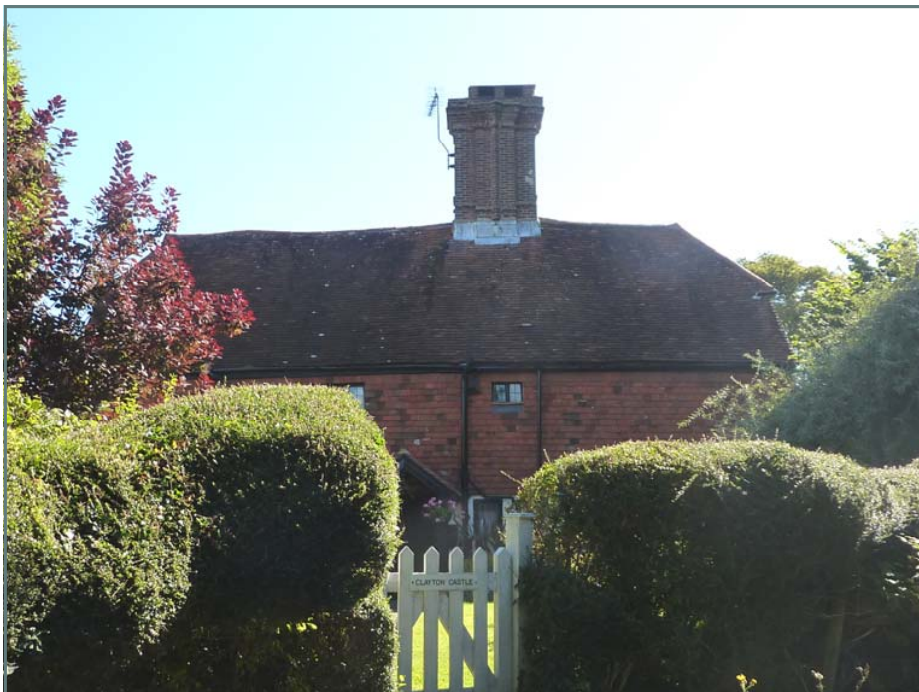
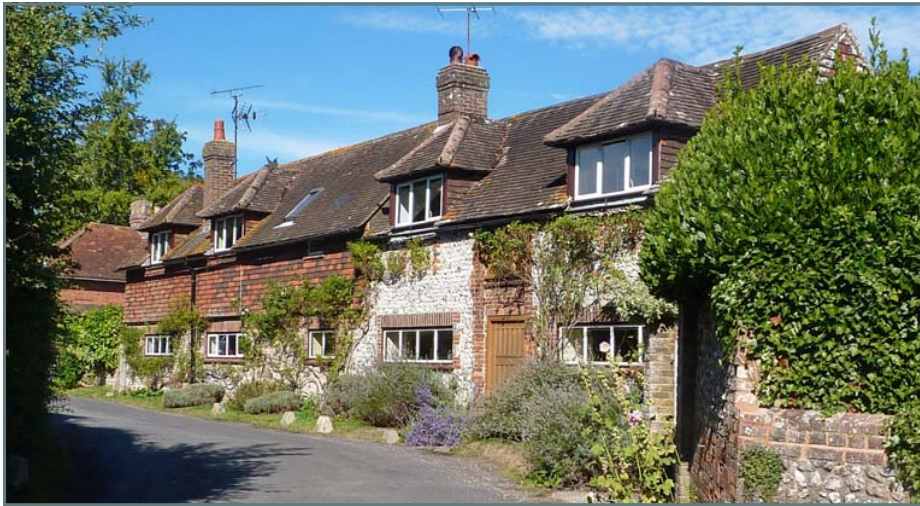
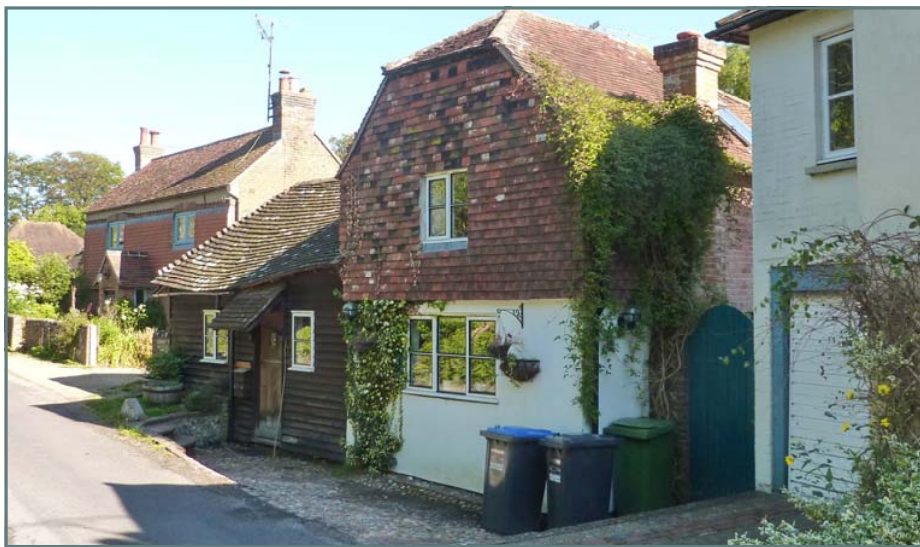
Figure 14: Modest buildings and boundary walls at the east end of the village still make a positive contribution to the Conservation Area. Their position at the back of, or close to, the lane gives this part of the village a more enclosed, intimate feel.

4.22 Between Clayton Manor and Clayton Castle, Underhill Lane curves and rises. Together with the cluster of more modest structures sitting at the back of

or close to the lane, this produces a more intimate and enclosed feeling to this part of the village. As elsewhere in the village there are no pavements or street lights and the lane retains a very rural feel. These modest structures do make a positive contribution to the Conservation Area, by virtue of their familiar palette of building materials - flint, brick, hanging tiles and roof tiles - and scale if no other (Figure 14). Boundary walls are important, particularly the substantial brick wall to Clayton Castle.
