REPAIRS SCHEDULE

West Ashling Post Office and Cottage

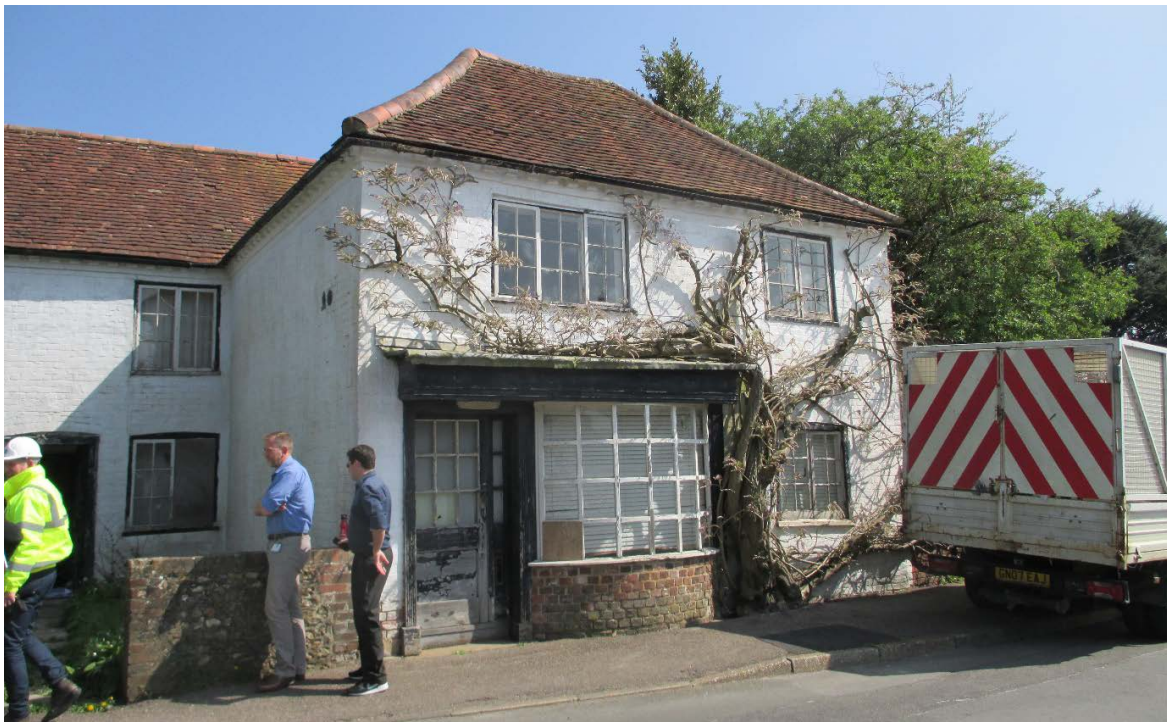
Post Office elevation to West (front) and hipped roof above

1. Trim high-level Wisteria growth to West (Front) Post Office elevation, sufficiently clear of the eaves line to allow free access to gutters.
2. Take down existing cast gutters, lower carefully to ground level and separate individual components. Where assessed capable of further service, sand-blast iron sections to remove loose decoration or rust and repaint in a red oxide primer, followed by grey undercoat and black top-coat. Label each element to facilitate reassembly, using locations invisible from ground level. Furnish new or good second-hand sections of matching cast-iron guttering to replace any sections assessed incapable of repair.

3. Strip roof tiling to this face, inspect and re-make back gutter if necessary. Redecorate gutter bracketry if found in serviceable condition, or renew to match. Take care to remove ridge tiles intact for re-use. Renew battens and felt and re-tile using reusable clay tiles from this pitch, supplemented by good tiles from other pitches where any shortfall occurs. All tiles without nibs shall be fixed with two stainless steel nails.

4. Re-bed original ridge and hip tiles, taking care to minimise evidence of revealed mortar at joints.
5. On completion, refit refurbished or replacement gutters, re-making all joints and sealing against leaks. Remove any identification tags or labels visible from the ground.

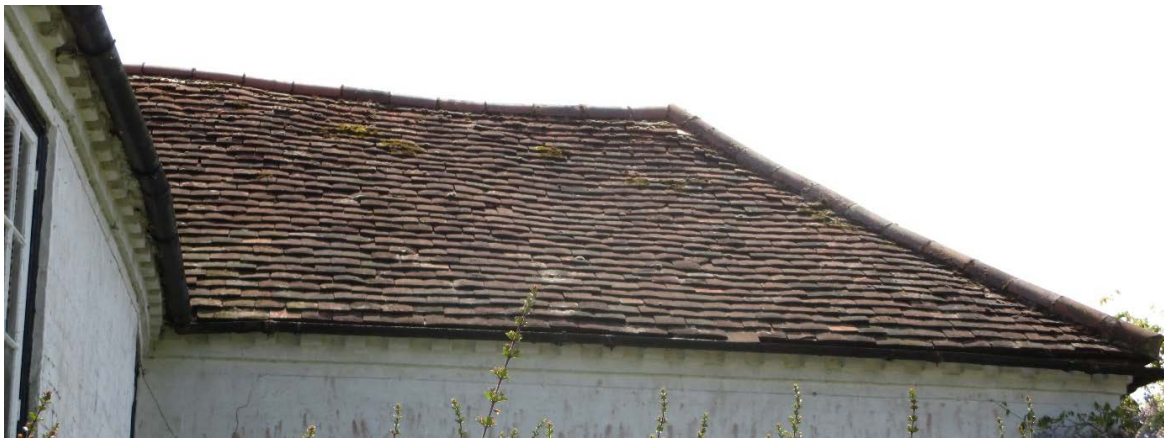
North facing roof pitch of Post Office

6. Take down existing cast gutters from North (Return) Post Office elevation, lower carefully to ground level and separate individual components. Where assessed capable of further service, sand-blast iron sections to remove loose decoration or rust and repaint in a red oxide primer, followed by grey undercoat and black top-coat. Label each element to facilitate reassembly, using locations invisible from ground level. Furnish new or good second-hand sections of matching cast-iron guttering to replace any sections assessed incapable of repair.

7. Strip roof tiling to this face, taking care to remove ridge tiles intact for re-use. Inspect and re-make back gutter if necessary. Redecorate gutter bracketry if found in serviceable condition, or renew to match. Furnish two new gutter brackets to replace those missing at west end. Assess condition of lead valley at east end and renew if defective in Code 5 lead. Renew battens and felt and re-tile using reusable clay tiles from this pitch, supplemented by good tiles from other pitches where any shortfall occurs. All tiles without nibs shall be fixed with two stainless steel nails.

8. On completion, refit refurbished or replacement gutters, re-making all joints and sealing against leaks. Remove any identification tags or labels visible from the ground.

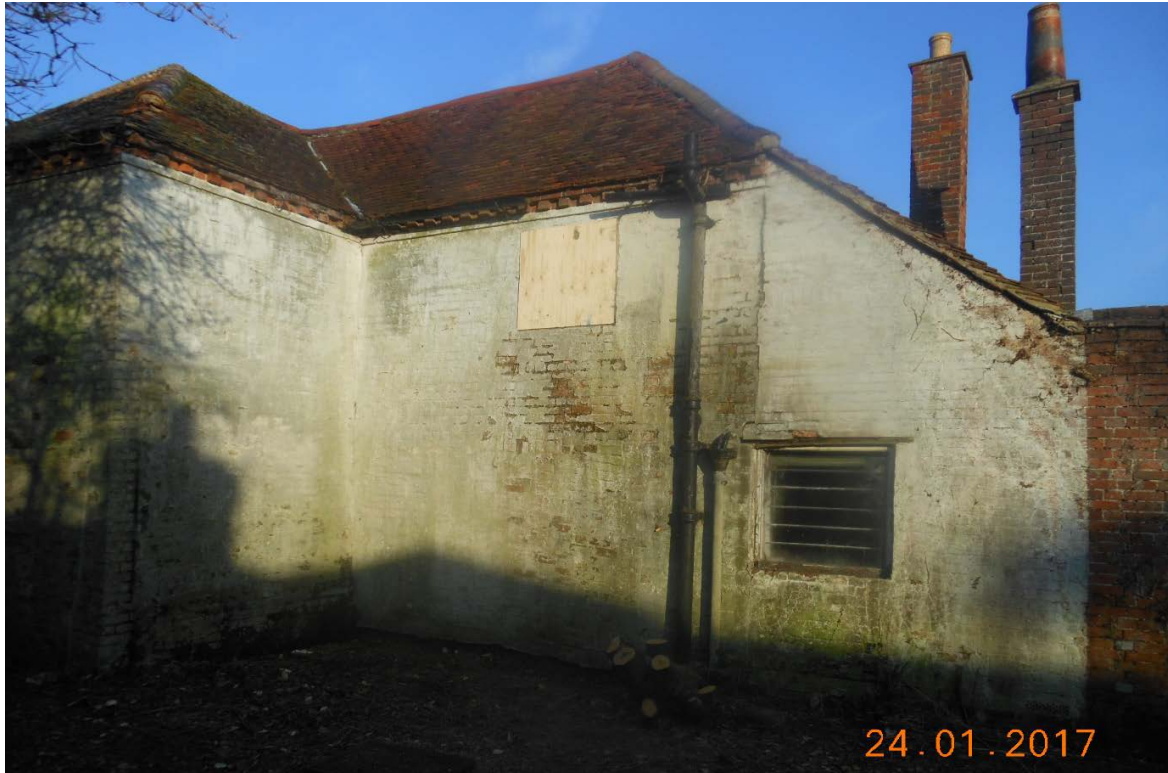
East and South Return faces of Post Office and Cottage to the garden

13. Take down existing cast gutters to both faces and the downpipe on the south face, lower carefully to ground level and separate individual components. Where assessed capable of further service, sand-blast iron sections to remove loose decoration or rust and repaint in a red oxide primer, followed by grey undercoat and black top-coat. Label each element to facilitate reassembly, using locations invisible from ground level.

14. Furnish new or good second-hand sections of matching cast-iron guttering to replace missing or irreparable sections.
15. Strip roof tiling to these pitches. Remove ridge tiles intact for re-use and furnish matching replacements for the missing hip tiles. Inspect and re-make back gutter if necessary. Redecorate gutter and downpipe bracketry if found in serviceable condition, or renew to match. Inspect valley leadwork and if necessary renew in Code 5 lead. Renew battens and felt and re-tile. If there is an overall shortfall in reusable tiles from the roof overall, new clay tiles of matching colour and texture to the originals may be used to cover these two pitches. If new supplementary tiles are nibbed, every second course shall be nailed.

16. Re-bed original and supplementary hip tiles, taking care to minimise evidence of revealed mortar at joints.
17. On completion, refit refurbished and supplementary replacement gutters, the hopper and downpipe, re-making all joints and sealing against leaks.

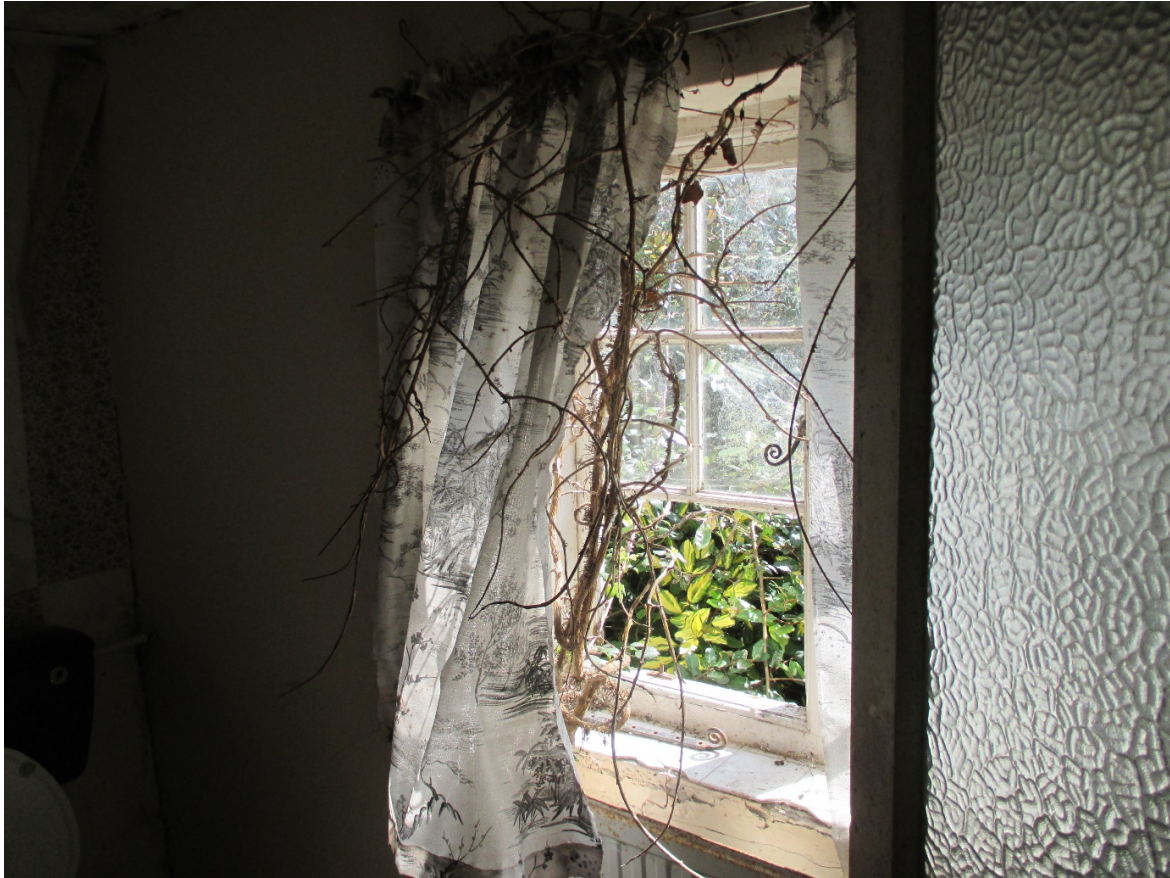
Broken window frame and glazing, seen internally from bathroom

21. Remove window board and inspect upper floor window. If beyond repair, replace with a replica frame and casement, fabricated in Western Red Cedar, primed and undercoated in grey. Glaze casement, fixing with traditional putty. Topcoat in white.

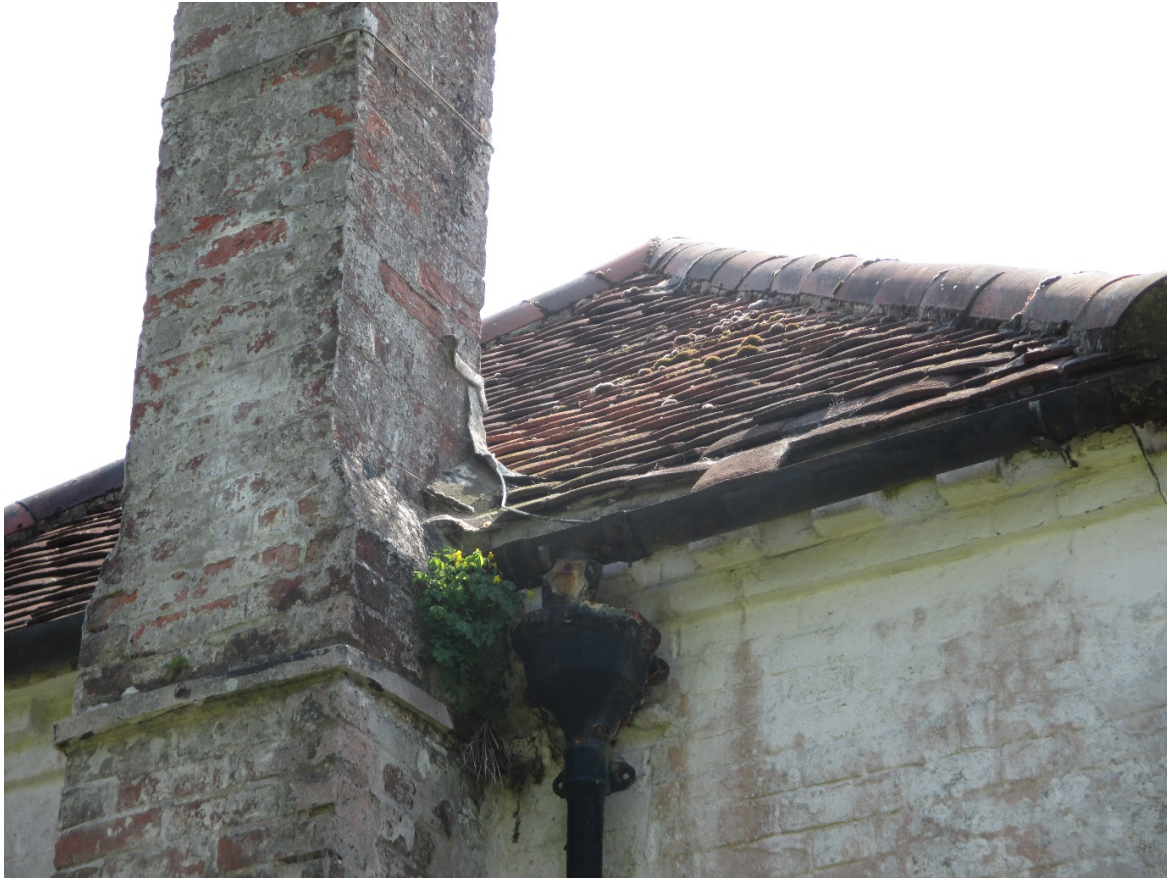
North Roof Pitch and Chimney Stack of Cottage

33. Remove the cast gutters to this elevation. Inspect condition of hopper and downpipe beside chimney stack, removing vegetation and any other blockage ensuring water conducts away freely, without significant leaks.

34. Strip roof tiling to the hip, strip chimney lead flashings and remake back gutter. Redecorate gutter bracketry if found in serviceable condition, or renew to match. Reform chimney flashings in new Code 4 lead. Renew battens and felt and re-tile using reusable clay tiles from this pitch, supplemented by good tiles from other pitches where any shortfall occurs. All tiles without nibs shall be fixed with two stainless steel nails.

35. Re-bed original ridge and hip tiles, taking care to minimise evidence of revealed mortar at joints.
36. On completion, refit refurbished gutters as 37, below, re-making all joints and sealing against leaks. Remove any labels visible from the ground.

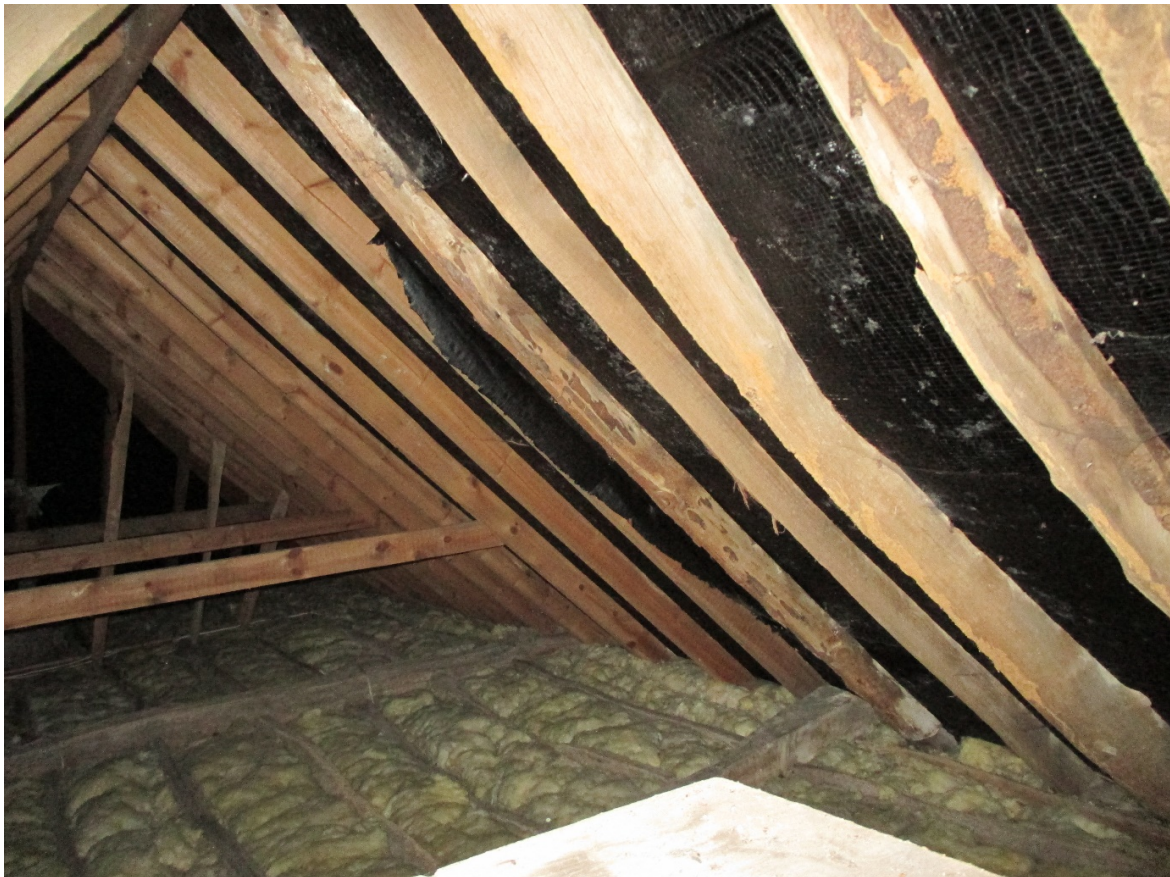
Primary area of over-stressed rafters supporting rear cat slide roof pitch

45. Alongside roof tile removal and before felting and roof re-battening, arrange safe access to loft space and renew any cracked or broken rear rafters. Introduce additional cross ties and collars as necessary to support and distribute roof load.

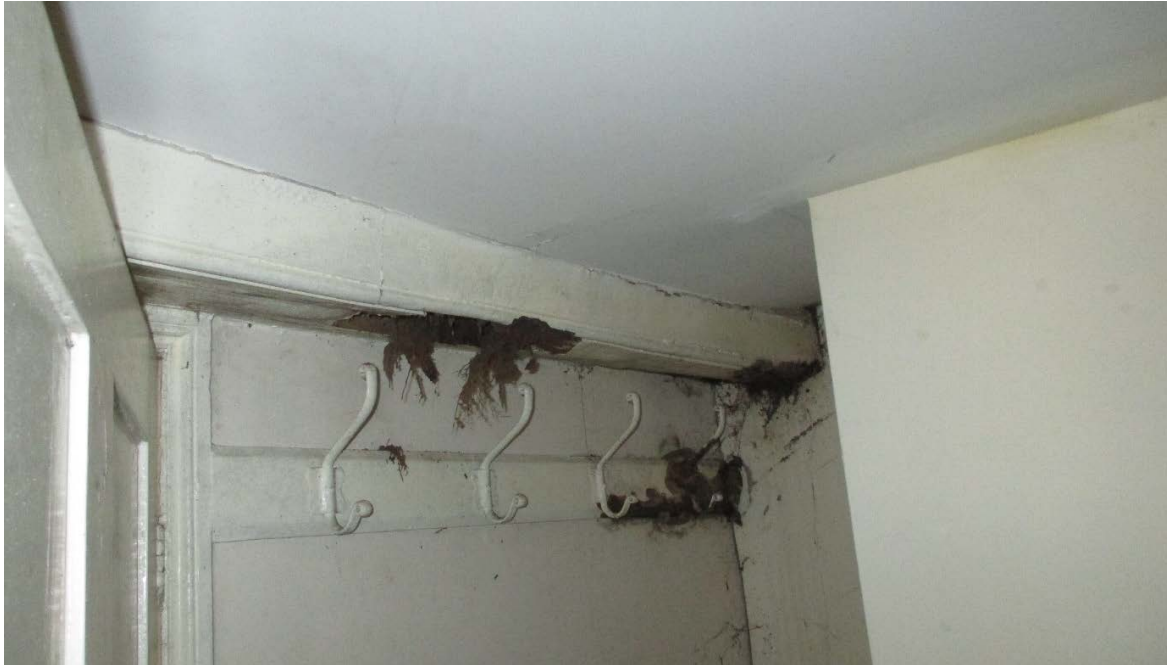
Decayed wall plate

46. Obtain advice from a Structural Engineer on the suitability of the decayed wall plate to carry roof loadings and follow his specification for renewal. Remove any rot-decayed skirting boards and remove them from the building for disposal.
