Report to	Director of Planning
Date	1 April 2020
By	Conservation Officer
Title of Report	Fulking Conservation Area Appraisal and Management Plan
Purpose of Report	To approve the Fulking Conservation Area Appraisal and Management Plan for adoption

Conservation Area Character Appraisal and Management Plan

Fulking April 2020

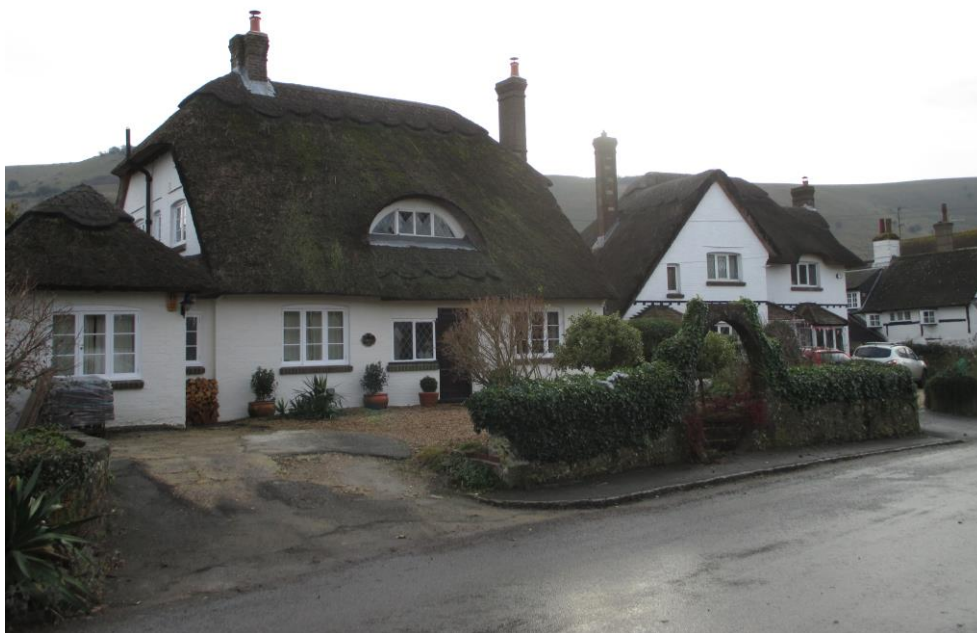
Thatchly and Broadreeds date from the late 1930s

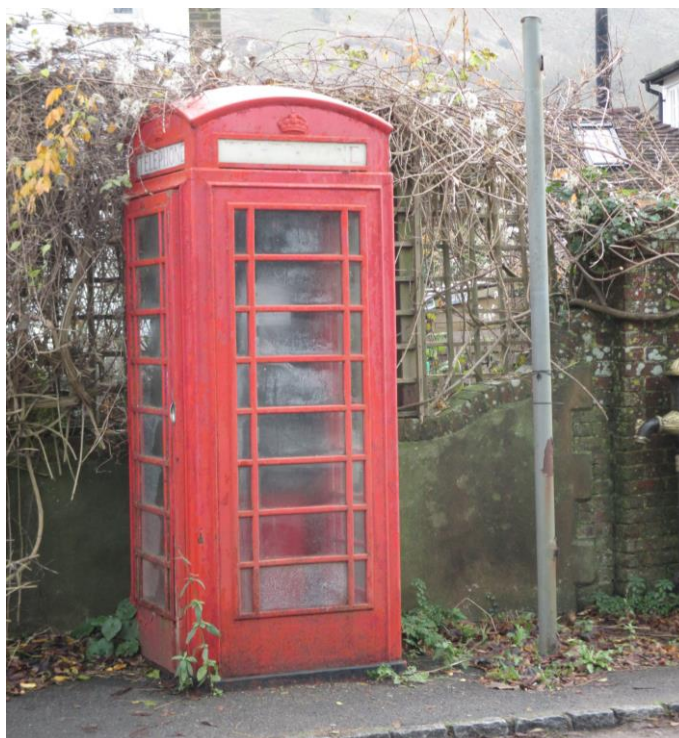
A K6 telephone kiosk and water pump are located fronting Broadreeds

4.17 Street furniture features on the pavement in front of *Broadreeds*, firstly a listed K6 'Jubilee' telephone kiosk, as designed by Giles Gilbert Scott in 1935, installed across the nation by Royal Mail Telephones until the 1960s, but now becoming rare. Secondly, the other surviving water pump of 1886, this one with a fluted and domed top with finial and an embellished feature spout with the cast letters 'Warner' and 'London'. The shaft displays a plaque stating 'C.A.Wells Engineers, Lewes'.

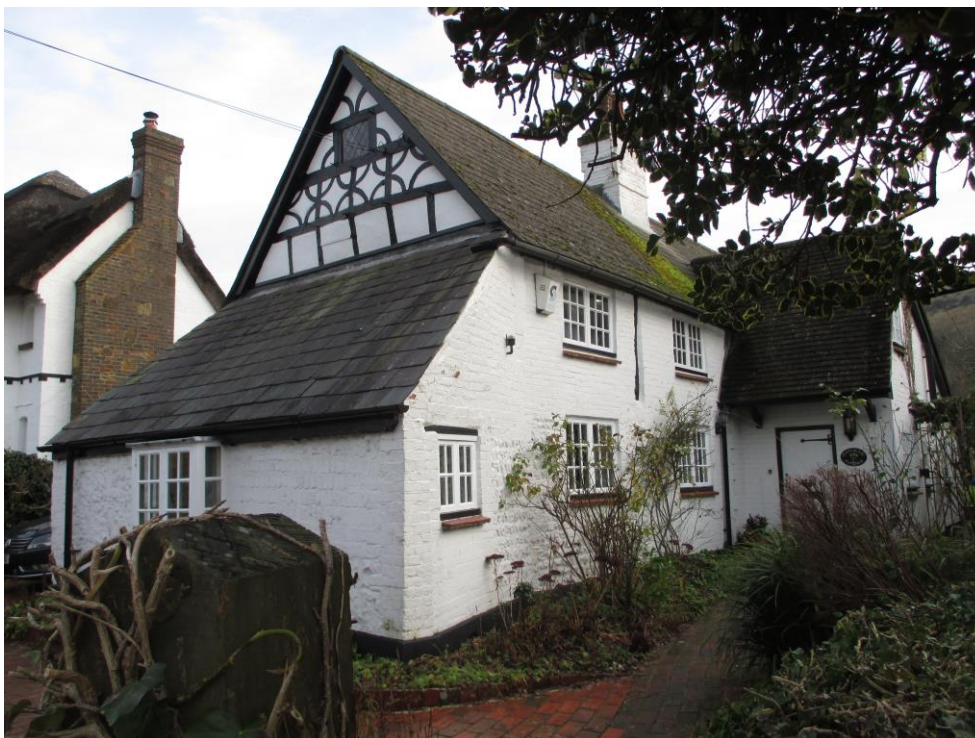
Customary Cottage

4.18 Located next to these relatively modern houses is the far older *Customary Cottage* dating back to the Seventeenth Century. Timber-framed, it incorporates brick and flint facings. The north gable end, facing the road exhibits decorative framing reminiscent of Northern traditions. Some contend that the small upper opening is an 'owl window' built to encourage owls into the loft to catch mice feeding off grain once stored there. Over the years, this building has had many functions; a communal wash house, office for the Registrar and Relieving Officer and as a weekly surgery for a visiting doctor.

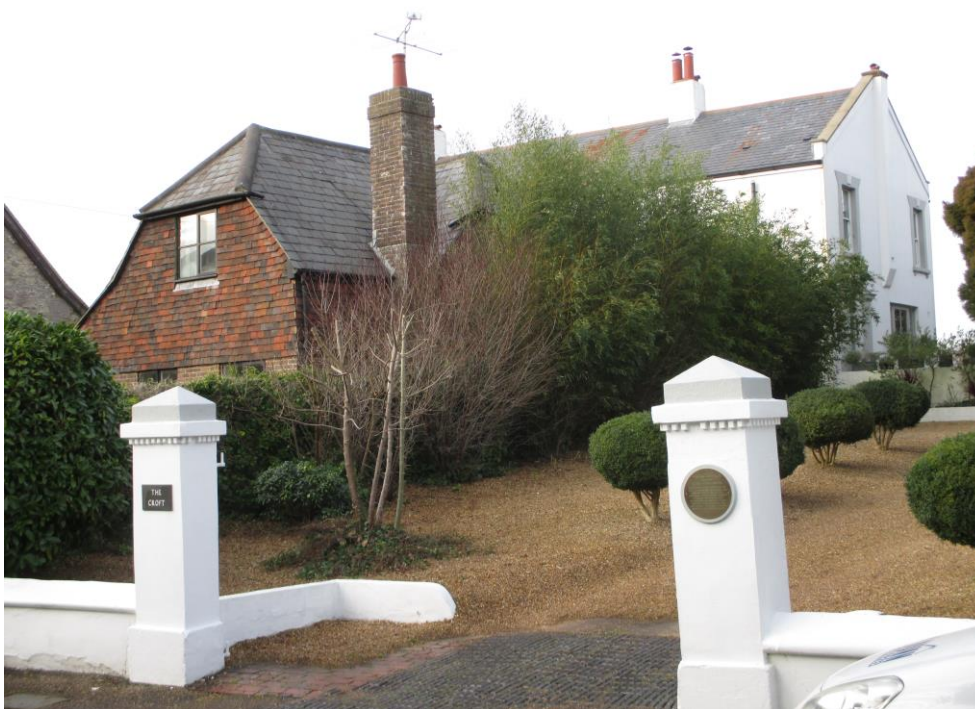
Painted gate piers mark the entrance to The Croft

4.22 The imposing gate piers and gravelled driveway next door lead to *The Croft*, a large Victorian house of 1890, set back but quite prominent from the road. It has a generous three-bay front with central entrance, faced in smooth stucco. The building used to have a large conservatory located on its eastern wall. A brass plaque commemorates the residence of Dr William Moon during the final years of his life, inventor of an embossed alphabet designed to enable the blind to read by touch. Because of its relatively late date, *The Croft* is not a listed building but officers consider that it should be considered for inclusion on a future Local Heritage List.

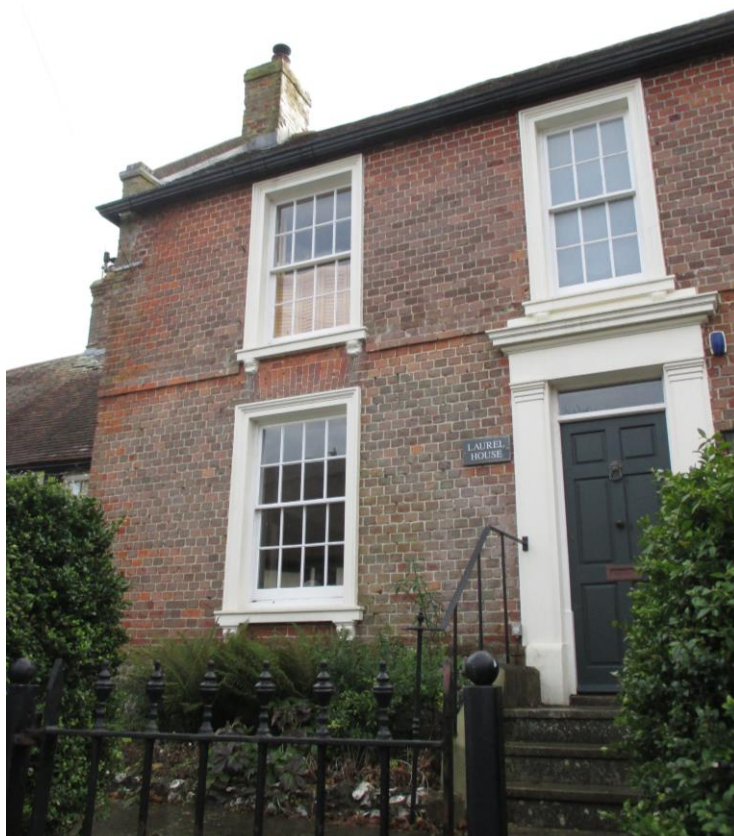
Georgian frontage of Laurel House

4.31 Next door is the Georgian elegance of *Laurel House*. Over two hundred years old, the header-bond brick façade is graced by moulded surrounds for the five sash windows and an attractive pilaster doorcase with cornice and fanlight. The window heads suggest that the window openings were originally a little narrower and were elaborated in the mid-Nineteenth Century.

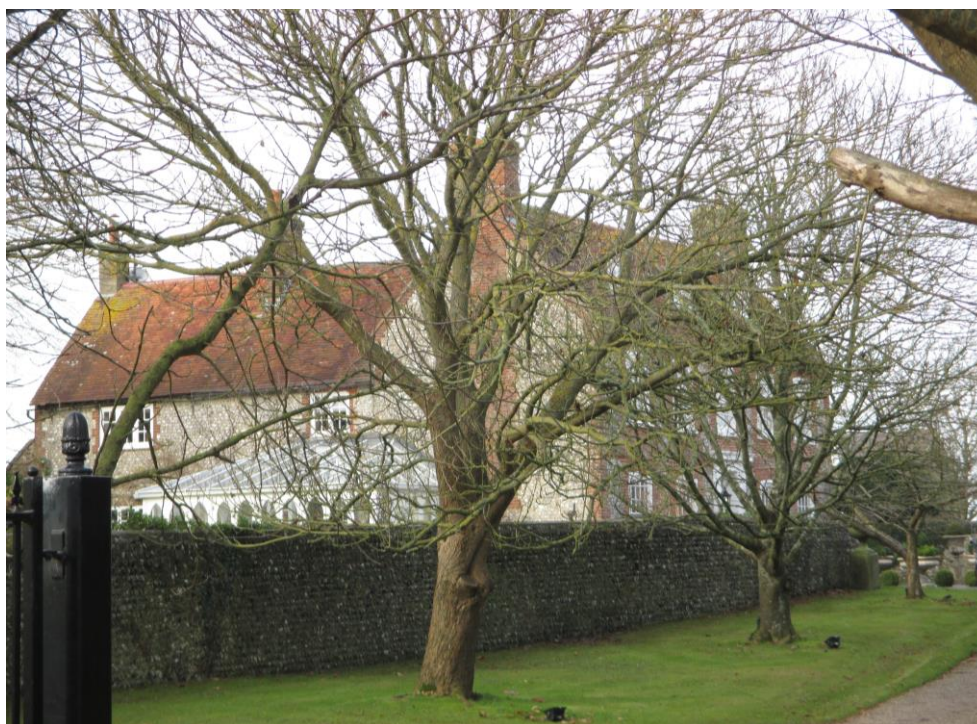
Perching Manor Farmhouse, already Grade II listed and now proposed for inclusion within Fulking Conservation Area*

4.43 Though beyond the current boundaries, it is only appropriate to mention *Perching Manor Farmhouse* a little to the west, the only Grade II* listed building in Fulking. This is a fine Eighteenth Century house on an L-shaped plan faced with very fine, labour-intensive, square-knapped flints with brick dressings and stringcourse. The primary elevation windows are sashes incorporating 'Gothick' glazing bars. The doorcase is pilastered and the fanlight repeats the highly characteristic fenestration. The front door itself is of six fielded panels.

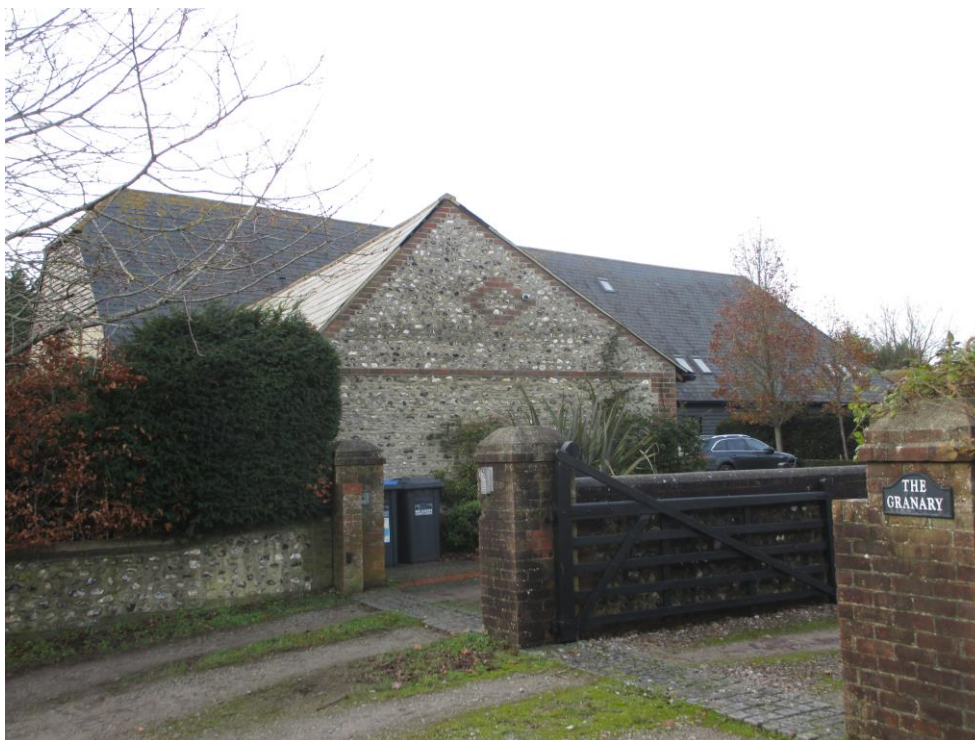
The listed Perching Barn (above) with The Granary (below).

4.44 The farmstead survives in a recognisable form, though is now wholly converted to residential uses. *Perching Barn* is Grade II listed, but suffered severe damage in the Great Storm of 1987. After several years in a vulnerable state it was converted to a large house in the 1990s, though the restoration looks a little heavy-handed. It is a particularly large barn to find in Sussex; most of the internal frame survives.

4.46 Two other farmyard survivors converted into residences are *The Granary* and *Stable Cottage*, these names reflecting former uses. Both have been heavily restored.

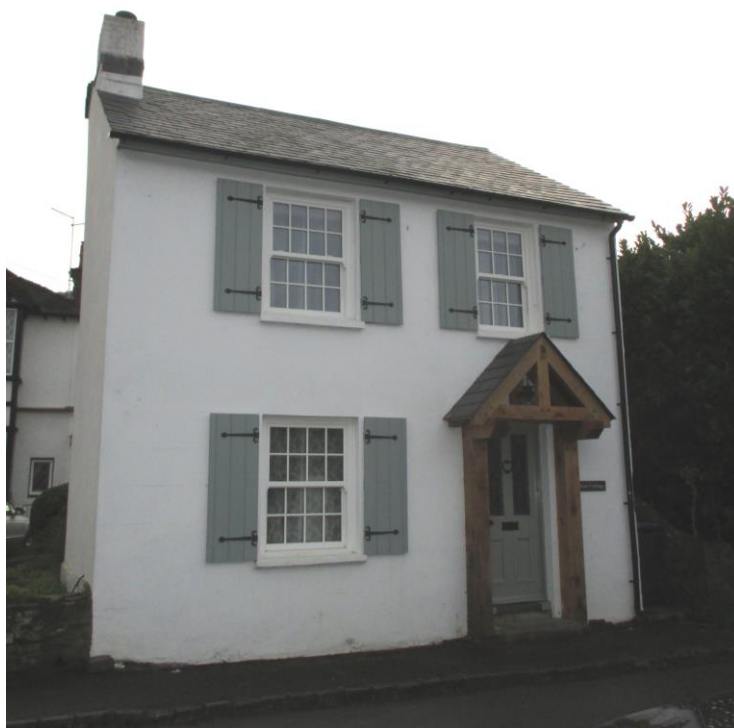
Porch or other additions and replacement of fenestration cause cumulative harm.

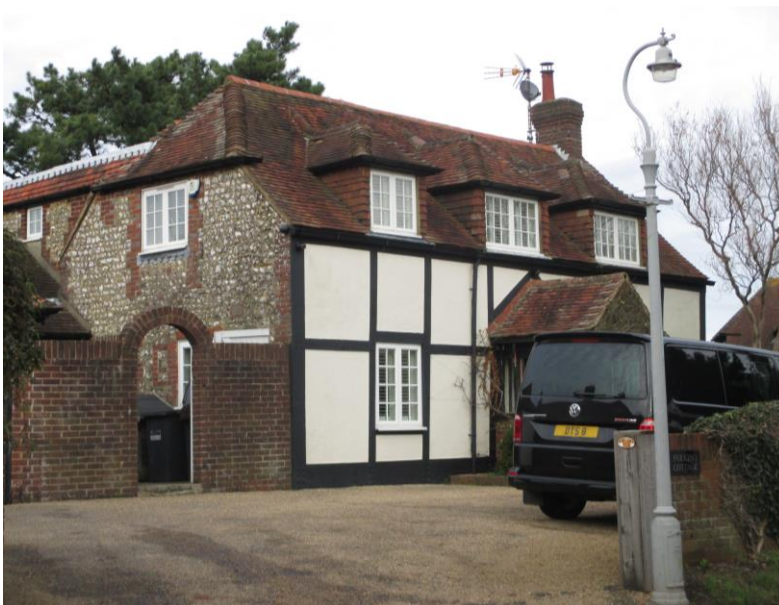
Figure 2: **Fulking Cottage**, an early barn conversion

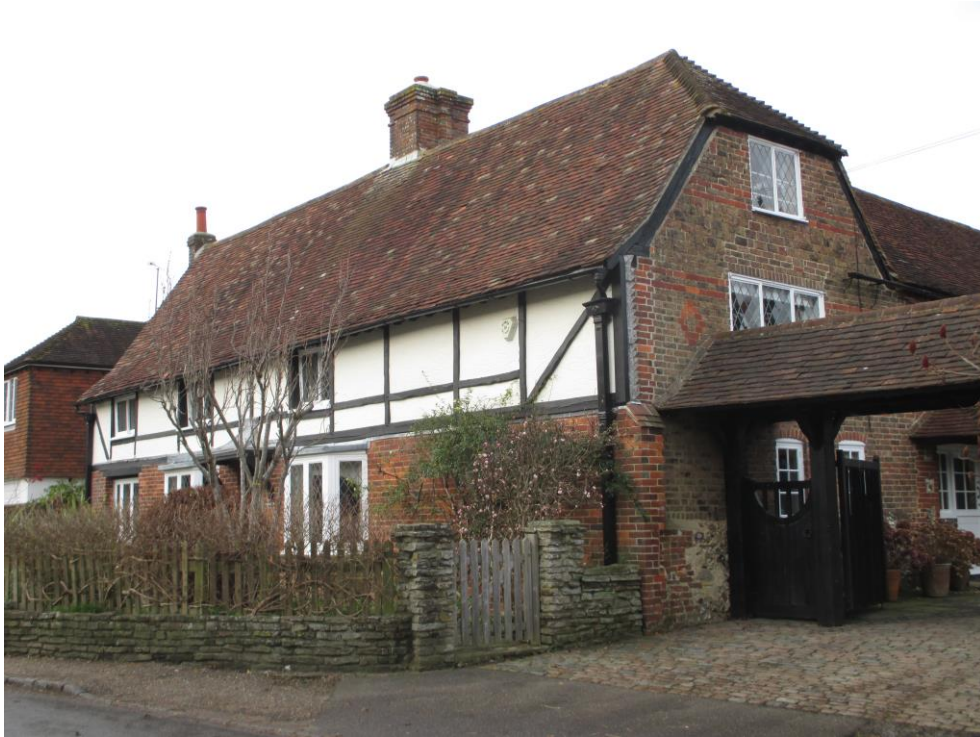
Figure 3: **Fulking Farmhouse** has a Seventeenth Century core. The frontage was heavily remodelled inter-war, when a plain Georgian façade was removed.

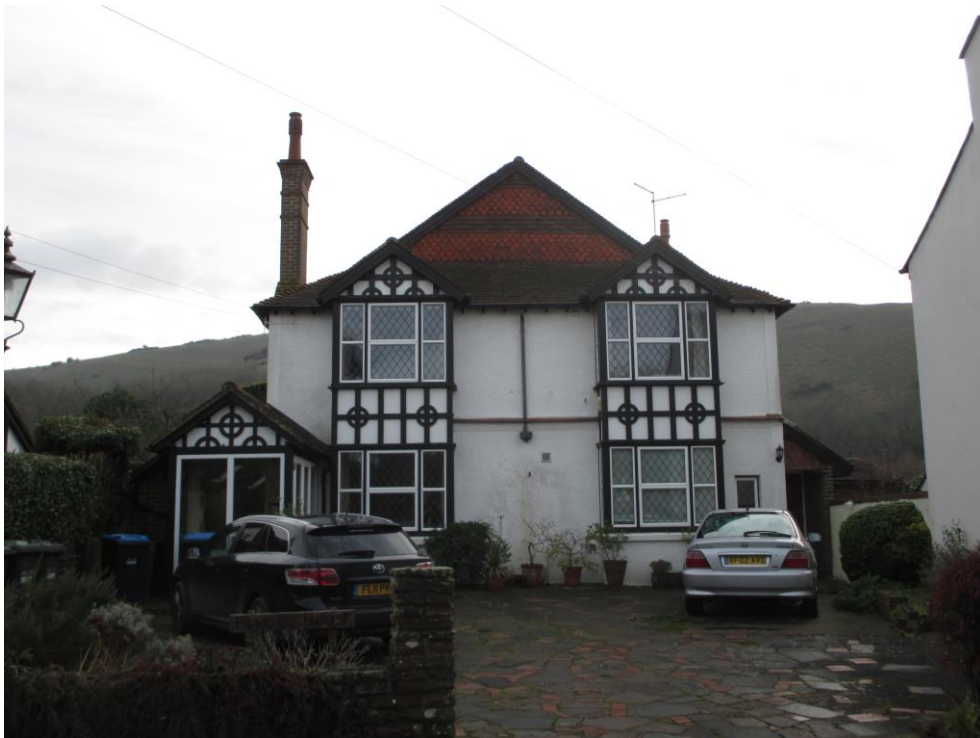
Figure 4: **Fulking House**, across the road is a villa dating from the Edwardian period.

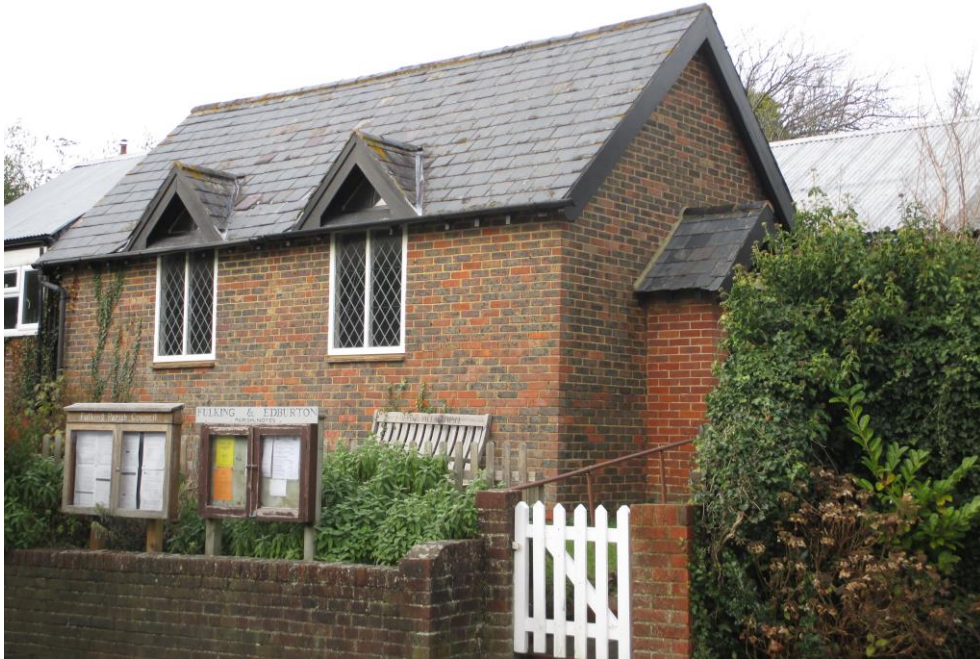
Figure 5: **Former Chapel and the Village Hall** (to rear) date from 1925

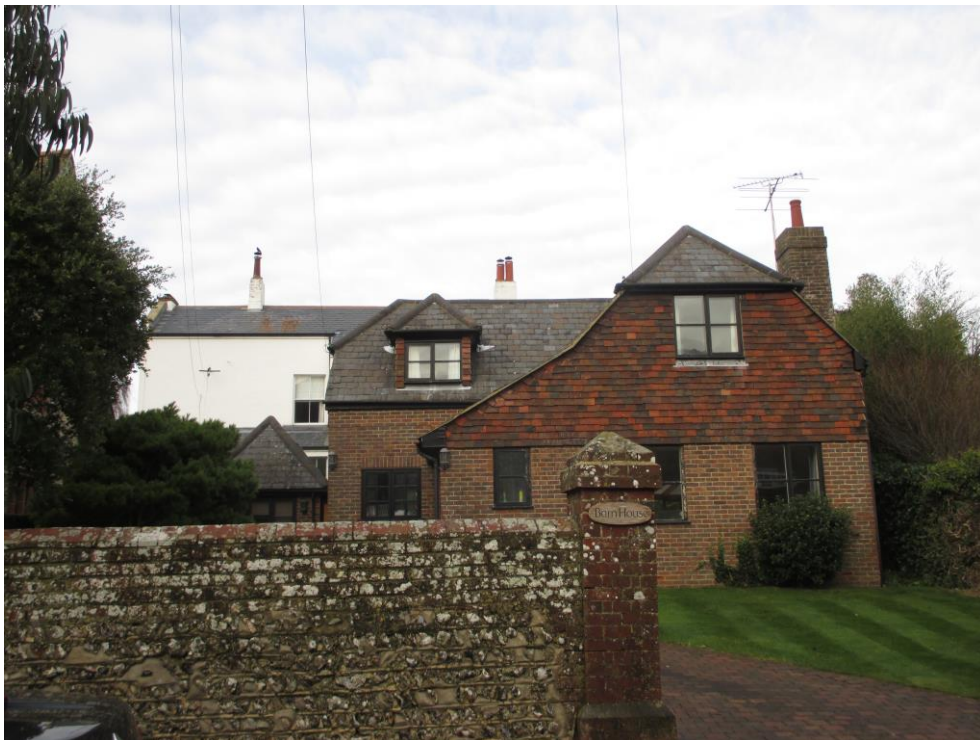
Figure 6: **Barn House** with **The Croft**, a Victorian stucco villa, set to its rear.

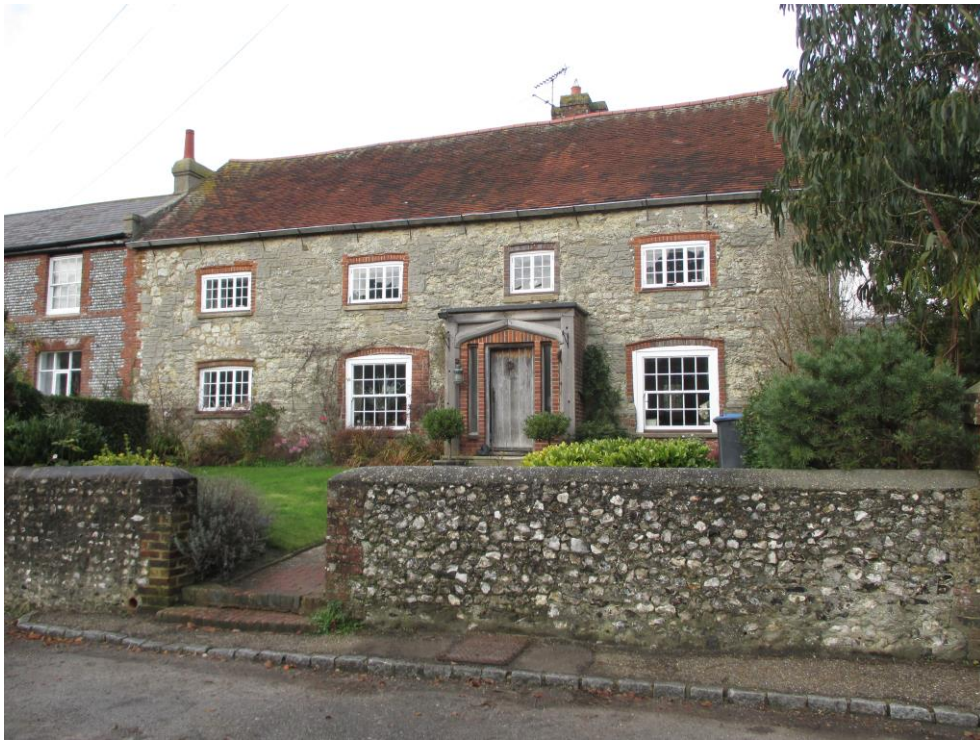
Figure 7: **Old Farmhouse** is one of the oldest houses in the village with a colourful history.

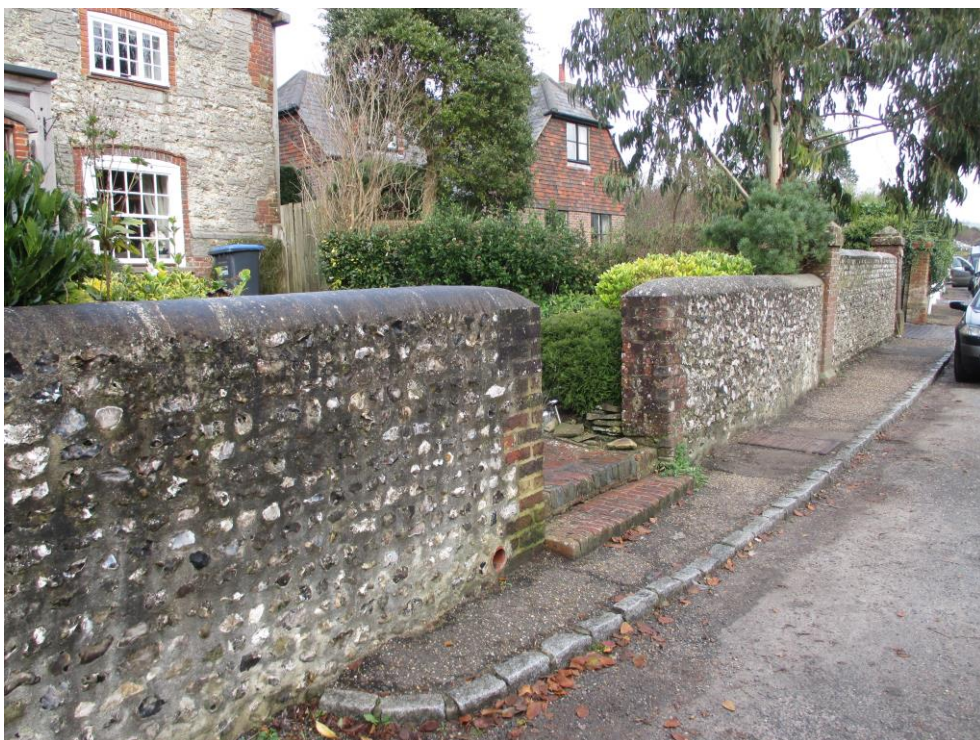
Figure 8: **Flint Boundary Walls** form a strong unifying element within the village and care should be taken to preserve and maintain them in original form.

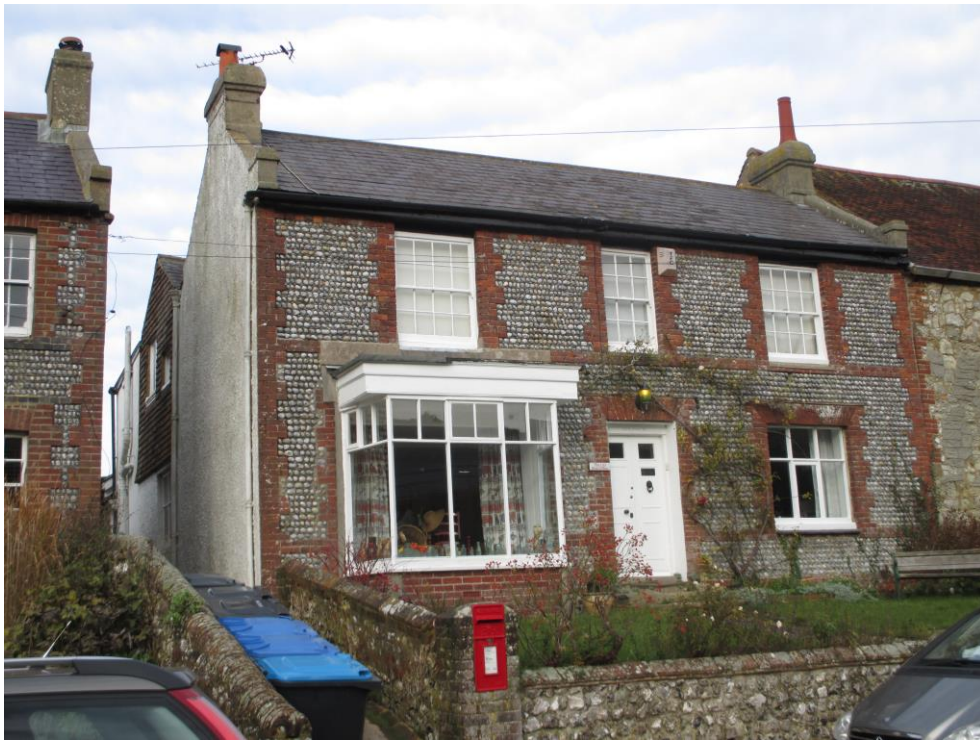
Figure 9: **The Old Post Office** also housed the bakery in the early Twentieth Century. It is faced in marine or river cobbles with brick dressings.

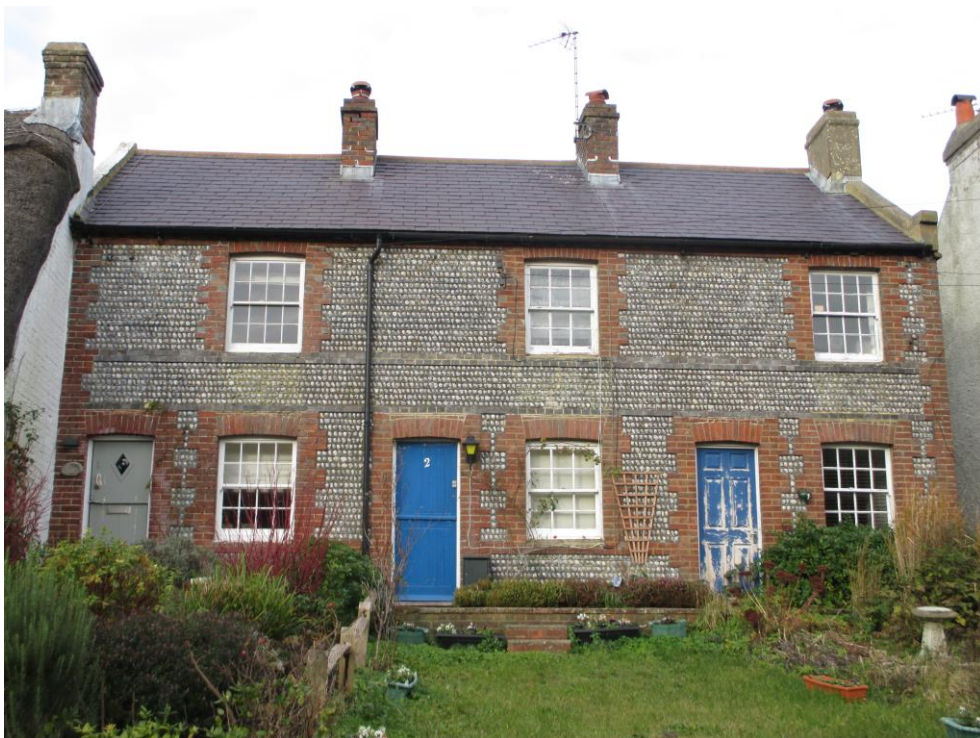
Figure 10: **Teapot Row** is a well-preserved terrace of cottages dating from c.1840. The panelled front door probably represents the original joinery design.

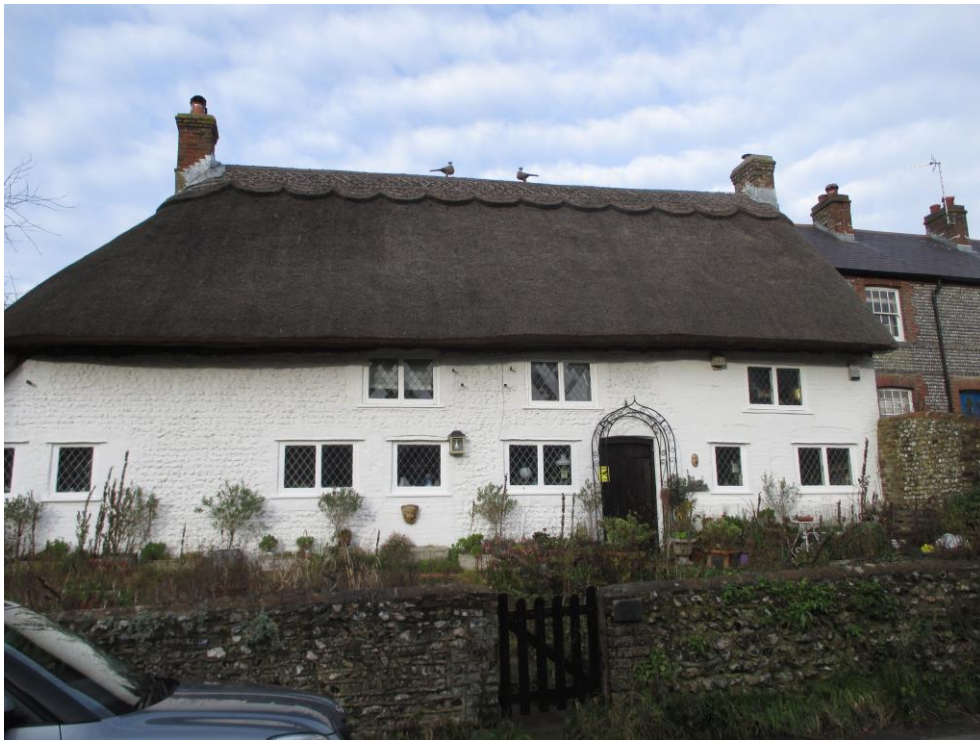
Figure 11: **Old Thatch** was once a terrace of small cottages, now combined into a single house. It is timber-framed behind its brick and flint front elevation.

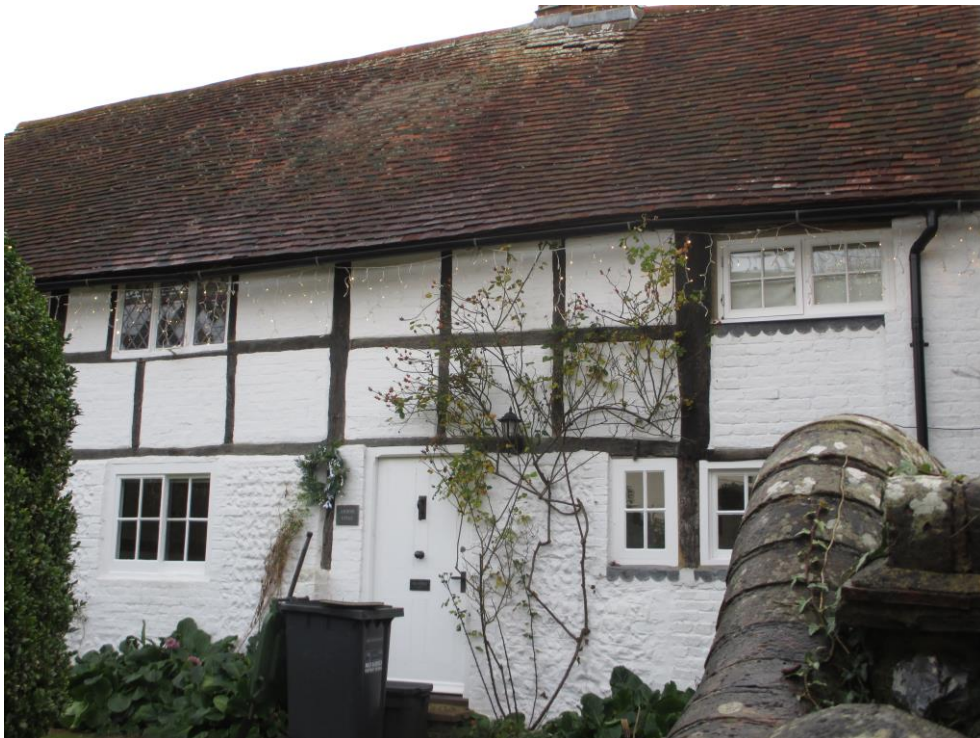
Figure 12: To the south side of The Street, a continuous run of Grade II listed buildings commences with **Arbor Vitae**, timber-framed and of the Seventeenth Century. The building displays an interesting variety of historic window types.

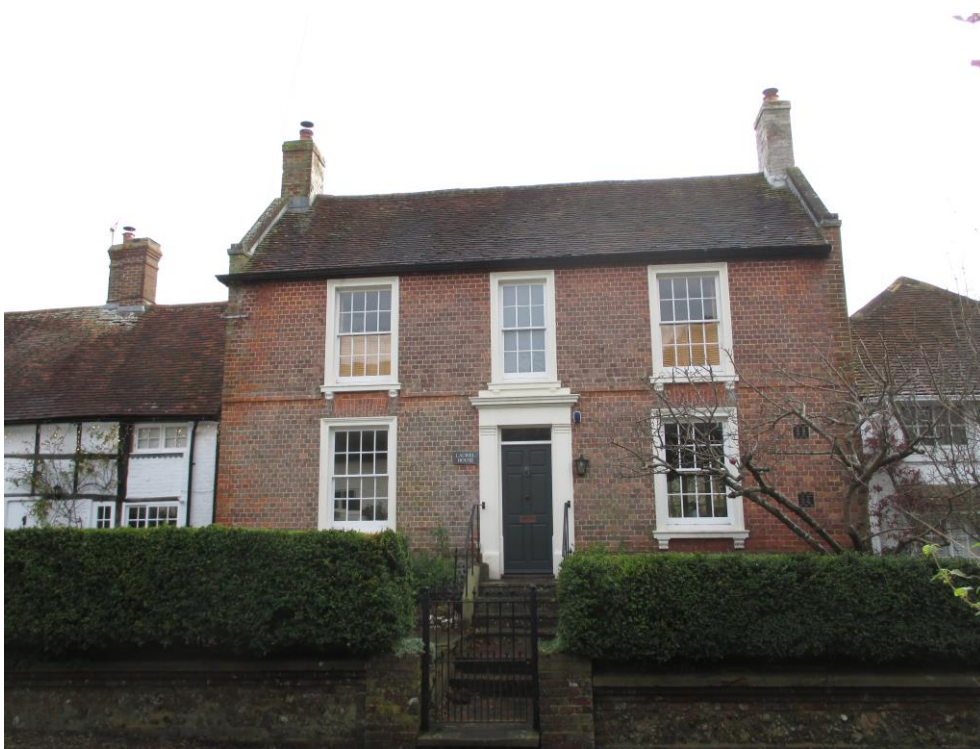
Figure 13: **Laurel House** is Georgian, faced in showy header-bond brickwork. The front elevation was elaborated with moulded window surrounds and a formal doorcase in the early-to-mid Nineteenth Century and is highly attractive.

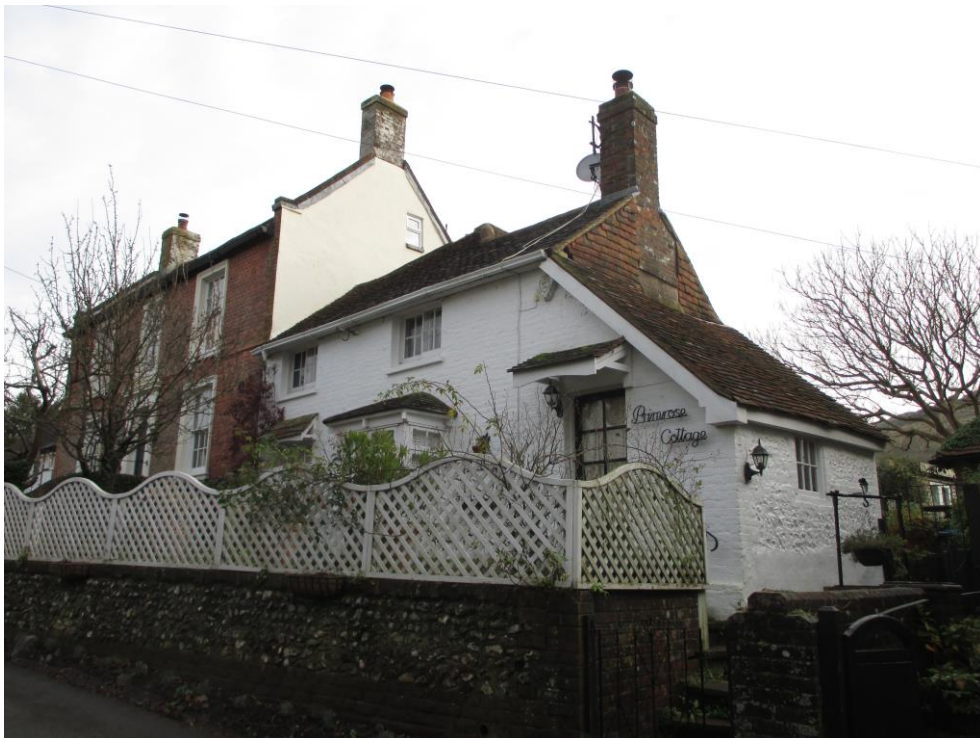
Figure 14: Immediately to the west stands **Primrose Cottage**, Seventeenth Century but faced in flintwork to the road.

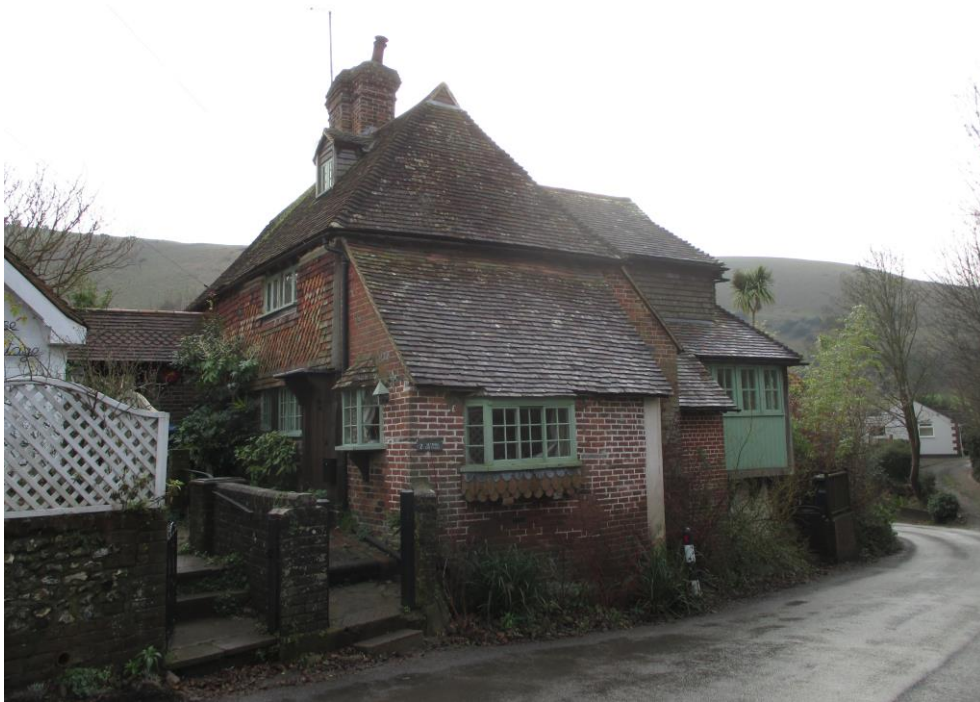
Figure 15: **1 and 2, Septima Cottages** complete the run of listed buildings to the sweep of the road downhill. The extension of 2006 can be judged a success.

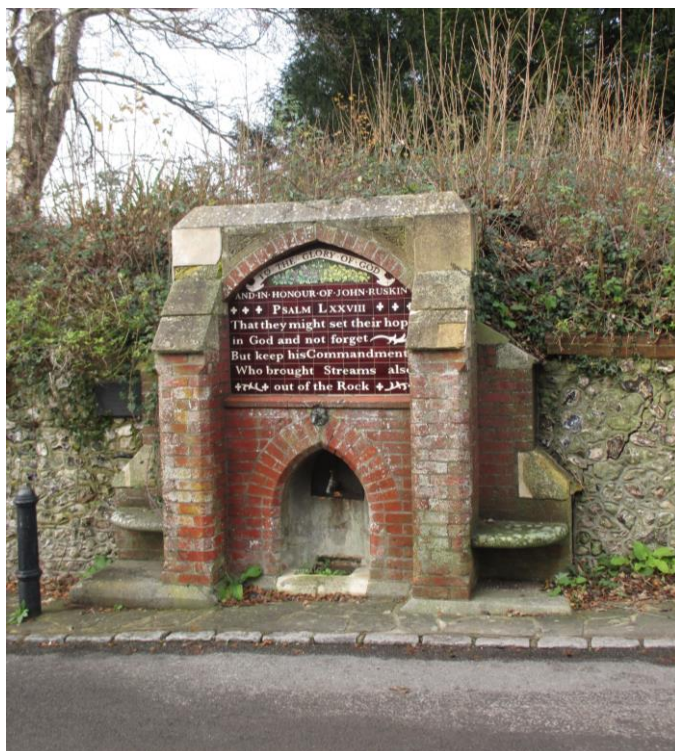
Figure 16: To the opposite side of the road stands the most elaborate component of the 1886 water supply system, the **Drinking Fountain**.

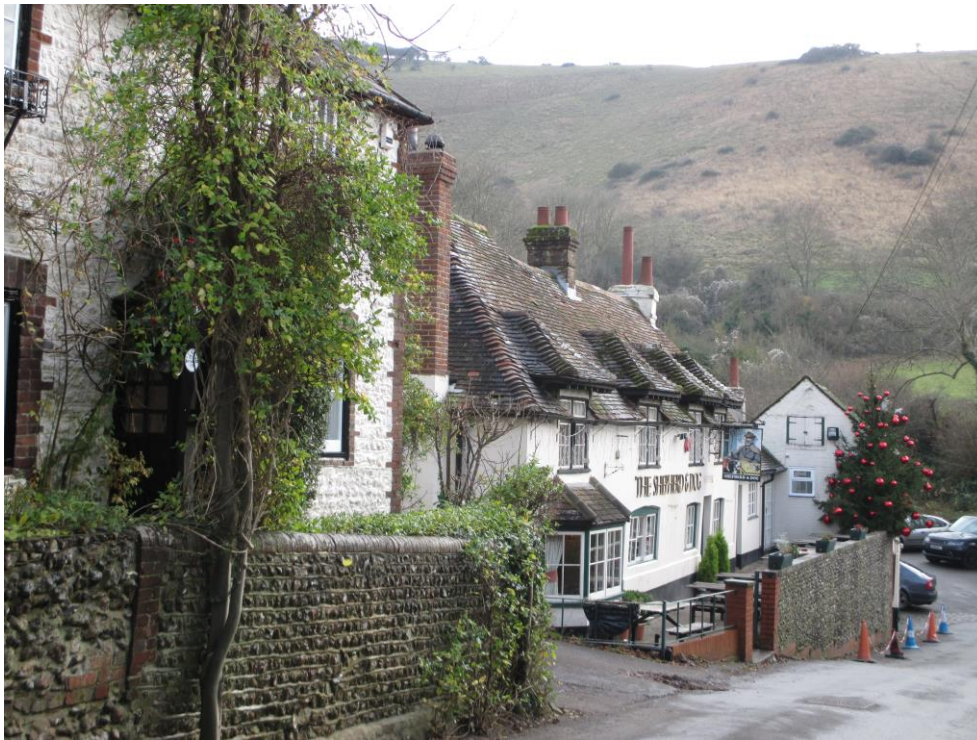
Figure 17: **The Old Bakehouse** and **The Shepherd and Dog Public House** form a picturesque grouping of listed buildings descending the hill.

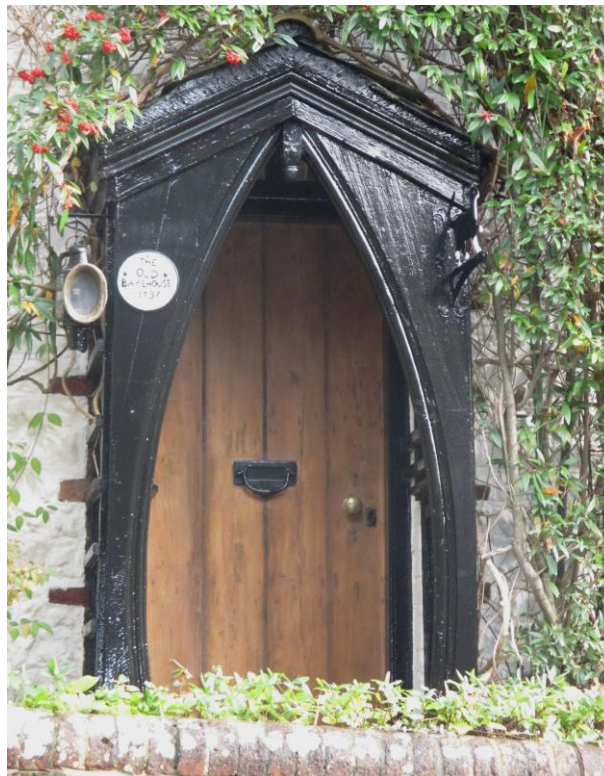
Figure 18: **Highly Distinctive Porch** on The Old Bakehouse.

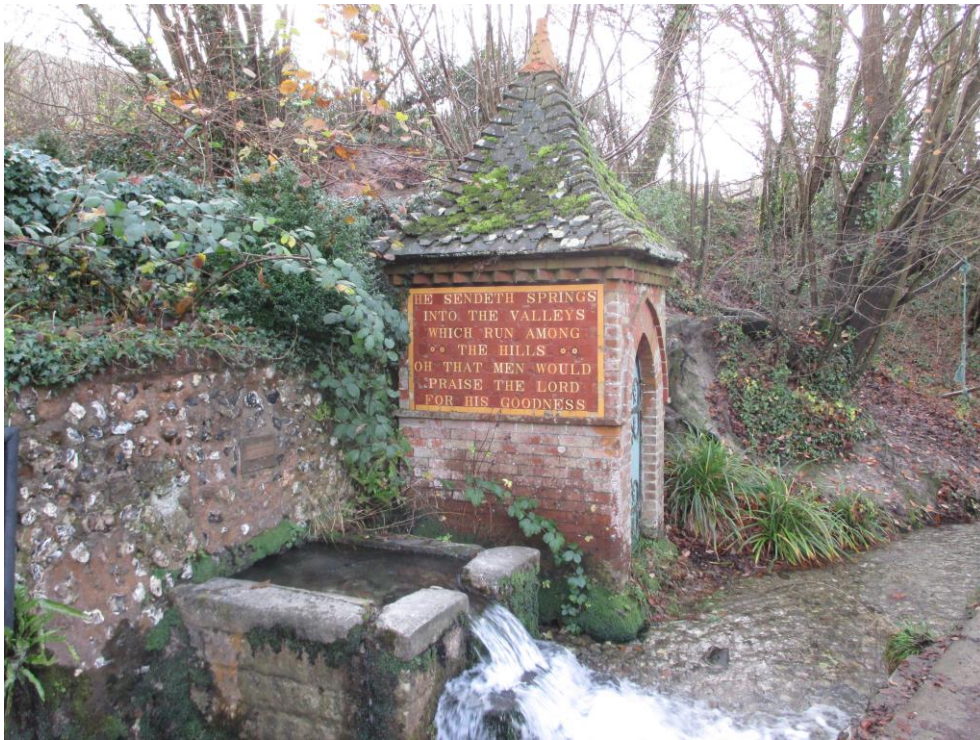
Figure 19: The **Ram House** at Fulking Spring.

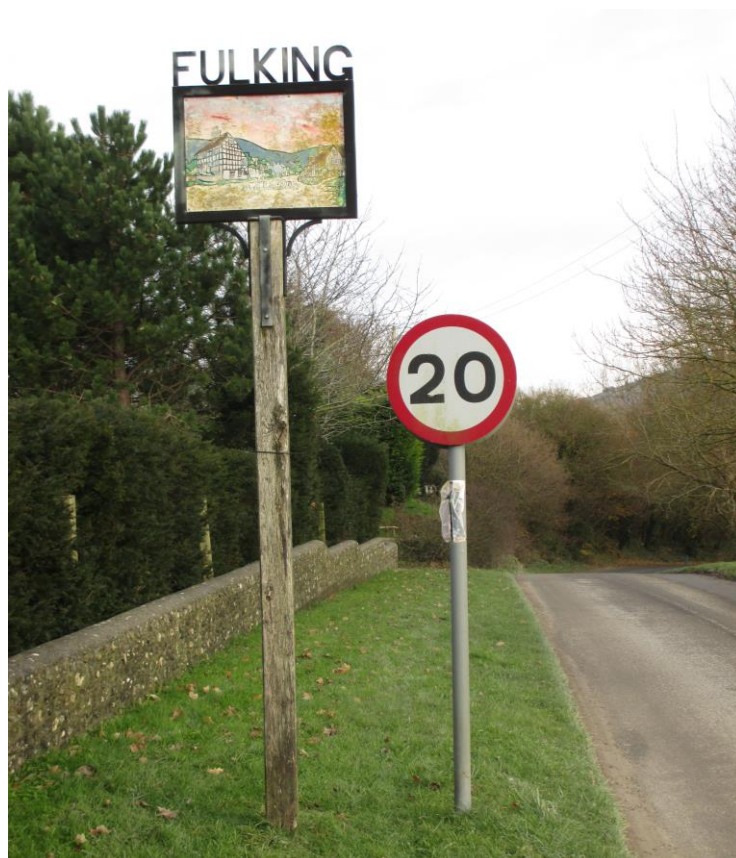
Figure 20: **Insensitive highways signage** at Edburton Lane.

ACTION 8 – that the National Park Authority supports, in principle and in association with other partners, the undergrounding of overhead wires and the replacement of modern street name plates with signs of a more traditional appearance, attached to walls wherever possible.

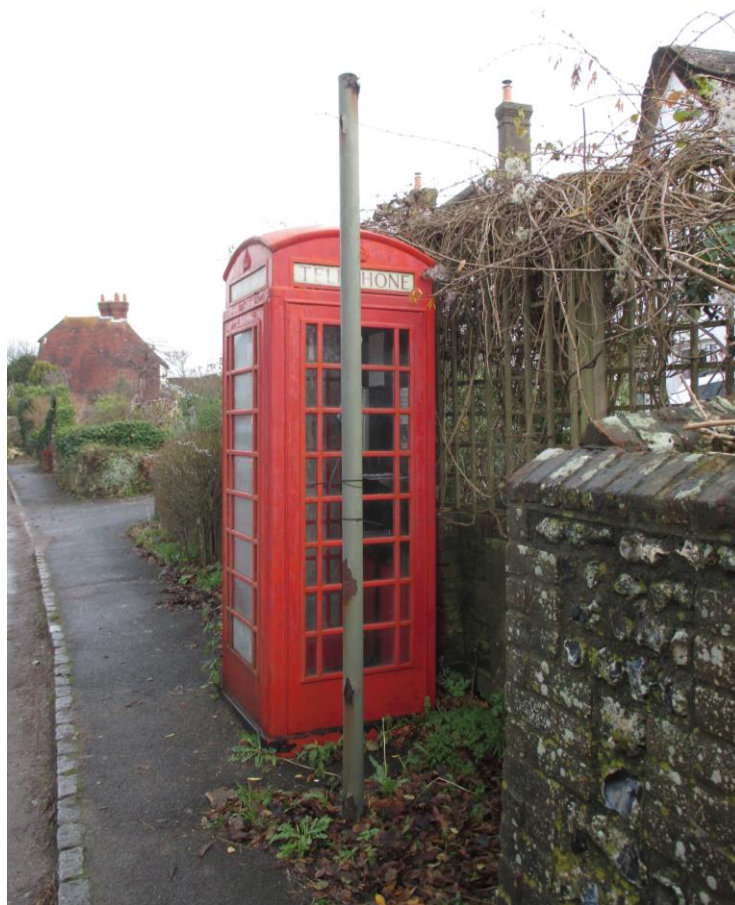
Figure 21: **Redundant and rusty Sign Post** harms setting of the K6 telephone kiosk and the adjacent water pump, both listed structures.

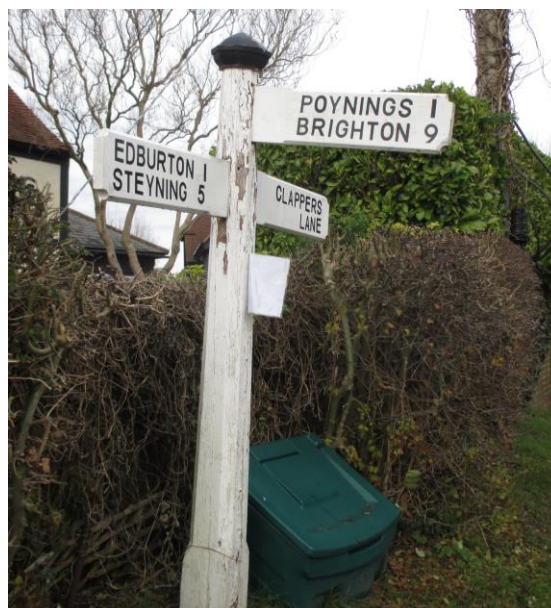
Figure 22: **Timber Directional Finger Post** is an attractive survival.

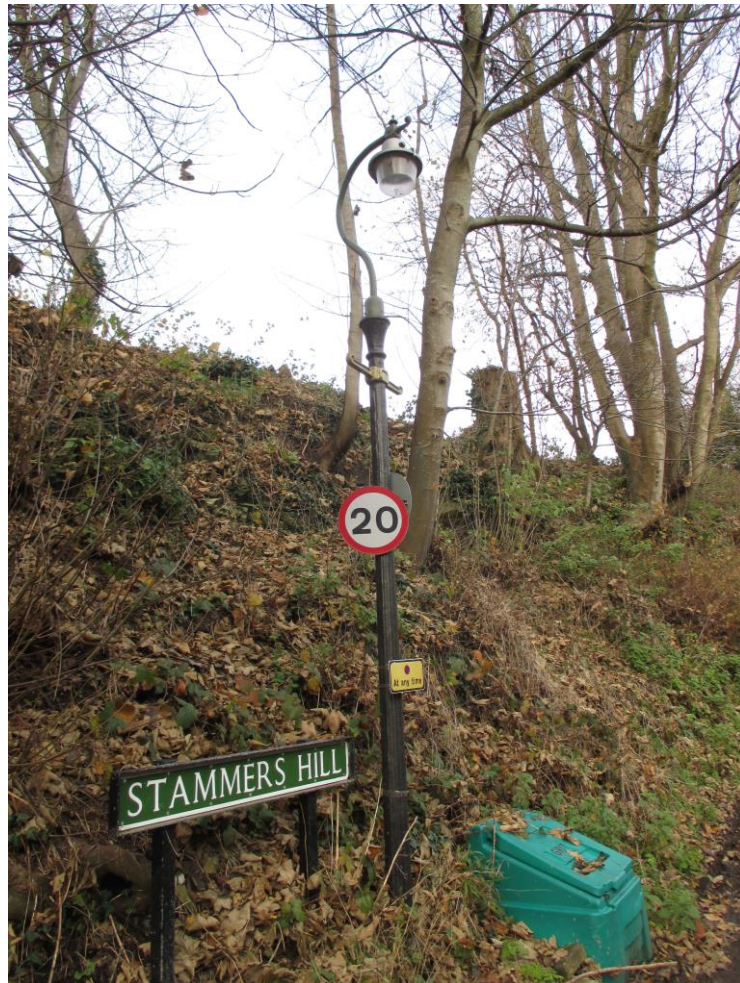
Figure 23: One of three surviving **Pre-War Lamp Posts**. While the use of existing street furniture to install supplementary signage is usually a sensible thing, it is less desirable to clutter a surviving historic feature with extraneous items.

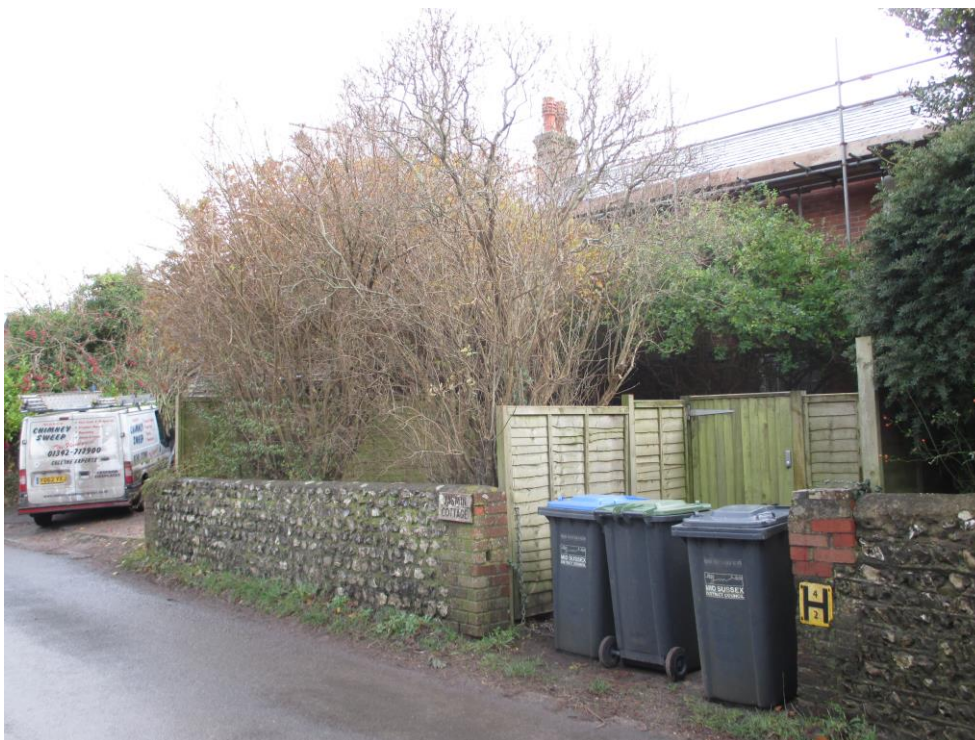
4.29 *Jasmine Cottage* was an attractive Nineteenth Century dwelling in brick, now rather hidden by an overgrown hedge to the front. Unfortunately, the most prominent part of this house from The Street is a rather ugly, boxy extension to the eastern side and a dilapidated timber garage.

6.19 As reported in paragraph 5.7, the historic building stock in Fulking is generally in good condition but there is a building which requires enhancement, this being **Jasmine Cottage** and the timber garage adjacent to it.

Jasmine Cottage has an overgrown frontage, needlessly high timber fence and gates, a boxy side extension visible from the road and an unsightly timber garage, all of which combine to form a significant visual detractor to The Street.

ACTION 3 – that the existing Buildings at Risk survey for Fulking commissioned by the National Park Authority be enhanced with more photographs to form a reasonably comprehensive overview of the condition of the historic environment.
